## Exploratory Excavation in the Yard of the John Fox House

EXPLORATORY EXCAVATION IN THE YARD OF THE  
JOHN FOX HOUSE (38LX31)

Prepared by the  
INSTITUTE OF ARCHEOLOGY AND ANTHROPOLOGY  
UNIVERSITY OF SOUTH CAROLINA  
September 1971

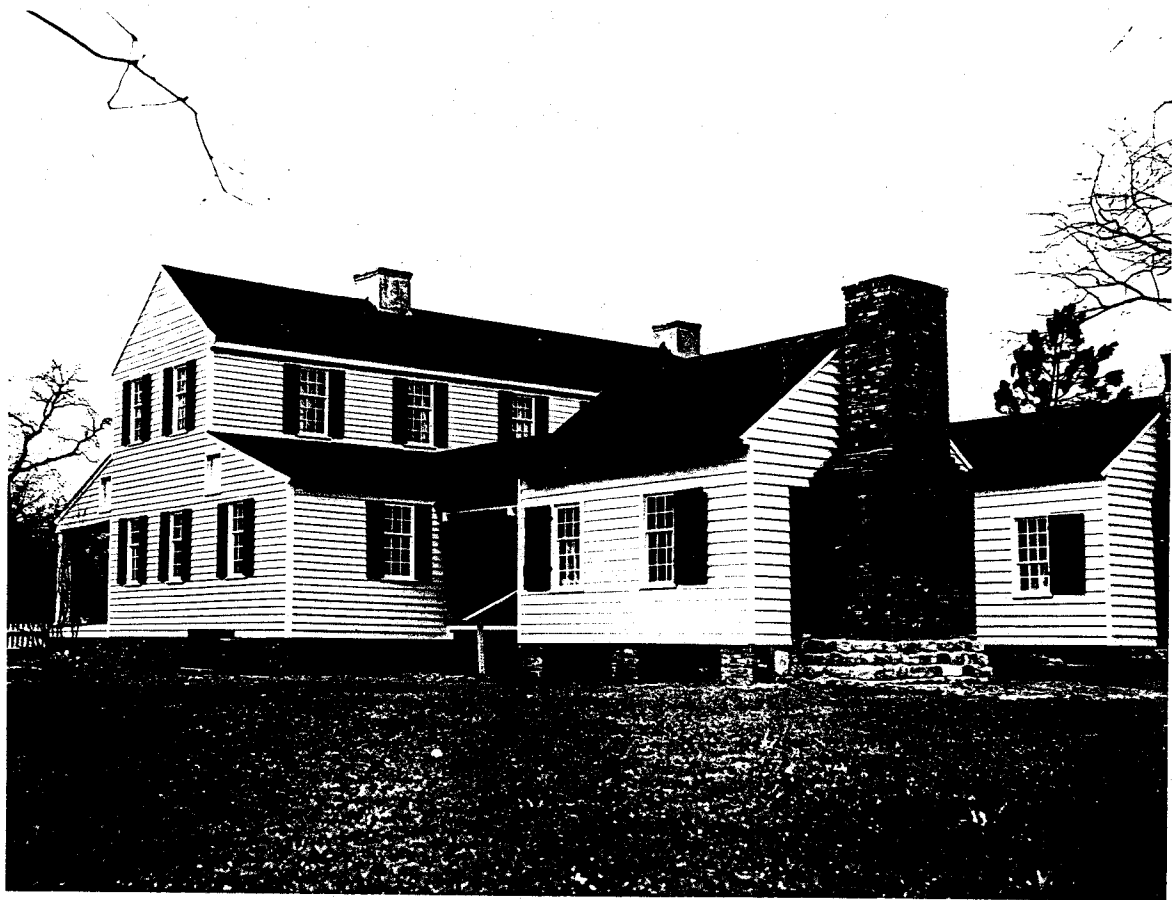
FIGURE 1

Present day view of the rear of the John Fox House from the southeast showing the later additions to the original structure.

The main frame house structure is almost entirely original although several subsequent additions to the rear of the house have altered its appearance somewhat (Figure 1). The central portion of the two story rectangular structure measures 16 feet by 60 feet, flanked by a full length front porch and back porch, each 16 feet in width. The original kitchen, represented by foundations 82 feet behind the left rear portion of the house, was constructed at the time the house was built. At a later date, possibly when John Fox acquired the property in 1858, the rear porch was enclosed to form a number of additional rooms. John Fox may have added the building adjoining the right rear portion of the house at the same time. This building is presently used as the Lexington County Museum Office. The final addition to the rear of the house was made in recent years when a structure identified as the second kitchen was moved to a position on the left rear portion of the house from a point 100 feet northeast of the house. The second kitchen was probably constructed shortly after John Fox acquired the property. The construction techniques, hewn sills, and form of square cut nails found in the second kitchen match those in the building used as the museum office and the two structures appear to be of contemporary construction. The last building presently standing on the lot, is a log structure moved onto the property within the last ten years, from a location behind a house at 225 Columbia Avenue. The lot from which it was removed was once occupied by Dr. Ernest Hazelius, First President of the Lutheran

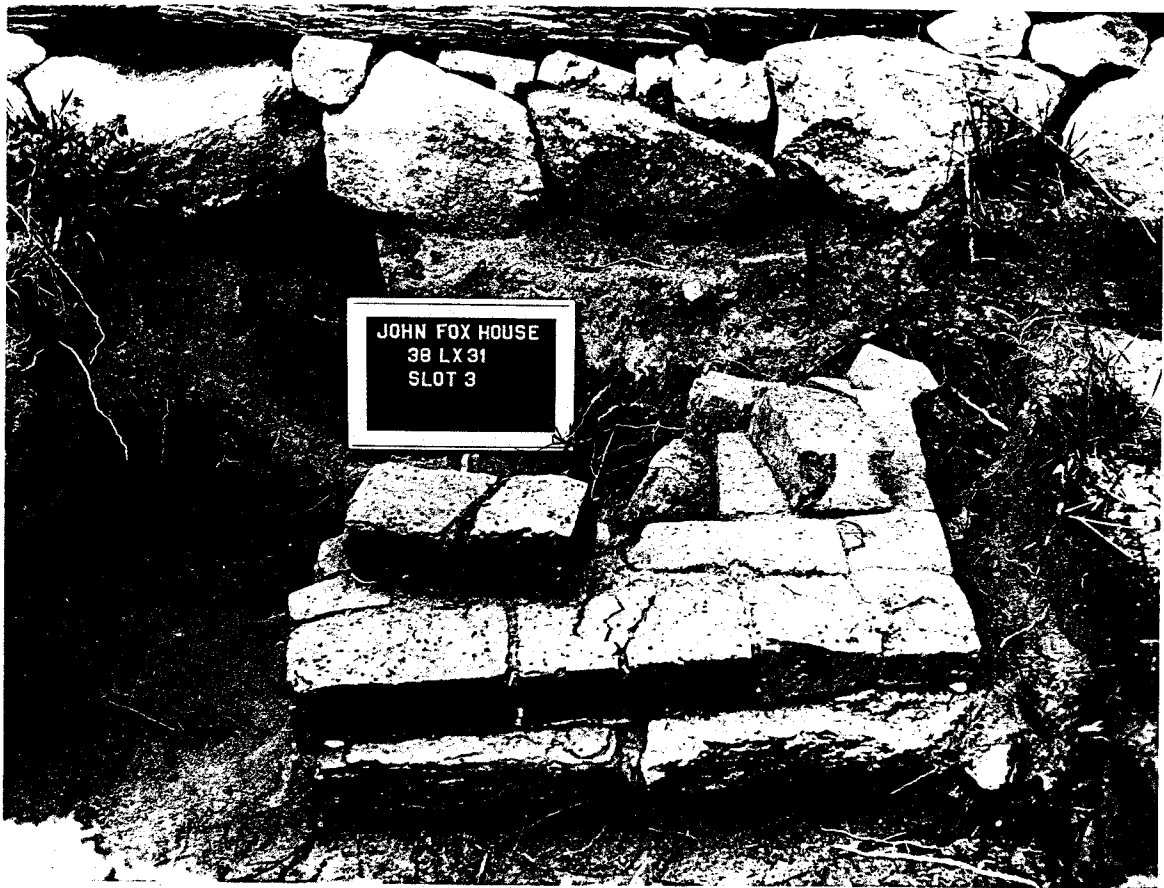
FIGURE 3

Northeast corner foundation of granite slabs overlain by brick footing. Recently moved log smokehouse foundation in background.

The foundations are made up of a base of roughly squared granite slabs set in a wide, shallow, builder's trench overlain by a single course of brick footings. The eight inch wooden sills are supported at intervals by the brick footings. The brick used for the kitchen chimney and footings match those of the original house footings and chimney. Traces of the eight inch wooden sills remained in place on the single-course brick footings. The foundations have been disturbed to a great extent in some areas suggesting that some stone and bricks may have been reused elsewhere. The chimney foundation is made up of a single course of large, irregular blocks of granite showing drill marks on them, overlain by the bottom course of the brick chimney (Figure 3). The remaining bricks were frost-broken when exposed. A well-defined builders' trench was present around the back wall of the chimney foundation. The sandy subsoil in the hearth area is burned red.
