A House on Cambridge Hill (38GN2): An Excavation Report

A HOUSE ON CAMBRIDGE HILL (38GN2):
AN EXCAVATION REPORT

Prepared by the
INSTITUTE OF ARCHEOLOGY AND ANTHROPOLOGY
UNIVERSITY OF SOUTH CAROLINA
March 1972

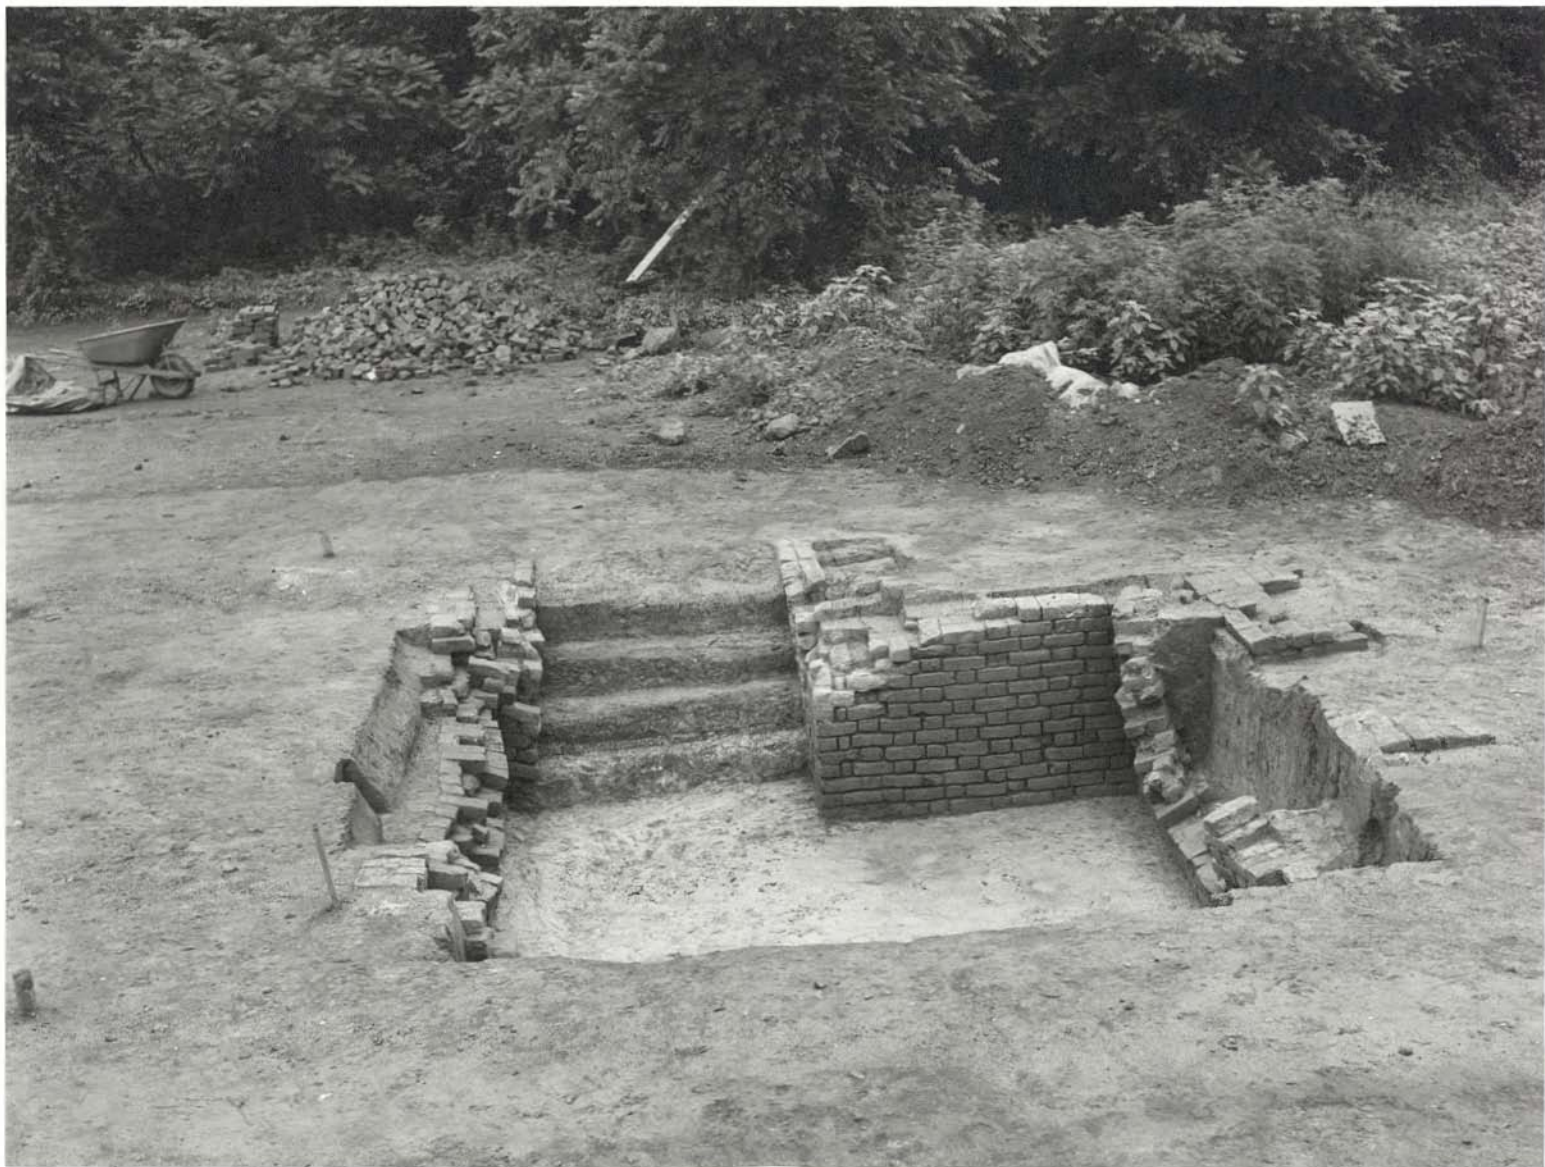
Postexcavation view of cellar entrance. View is to the north.

The cellar lining was composed of handmade brick laid in a Flemish bond (Fig. 2, 6). The bricks were reasonably well fired and of dimensions approaching $2 \frac{3}{4}$ by 4 by $8 \frac{1}{2}$ inches. The average brick sizes from this cellar indicate that they very nearly approach the size of the

The very well executed pattern of Flemish bond as shown by Figure 2 was interrupted at only two points in the entire perimeter of the cellar. There is a very distinct seam in the bond of the east wall near the south corner (Fig. 3, 8). This break is marked by a straight seam caused by a lack of bonding so that the bricks simply meet end to end as opposed to the normal interlocking seen in other parts of the cellar. Where there is one joint of this type suggesting replacement of a wall there has to be a companion joint to mark the other side of the replaced section. There is no other joint in the near vicinity of the previously mentioned one such as we might expect if there had been an earlier entrance which had been sealed off. There is, however, a very apparent discontinuity in the bonding of the south wall near the southwest corner. This seam which can be seen in Figures 4 and 8 indicates that the entire south wall was replaced.

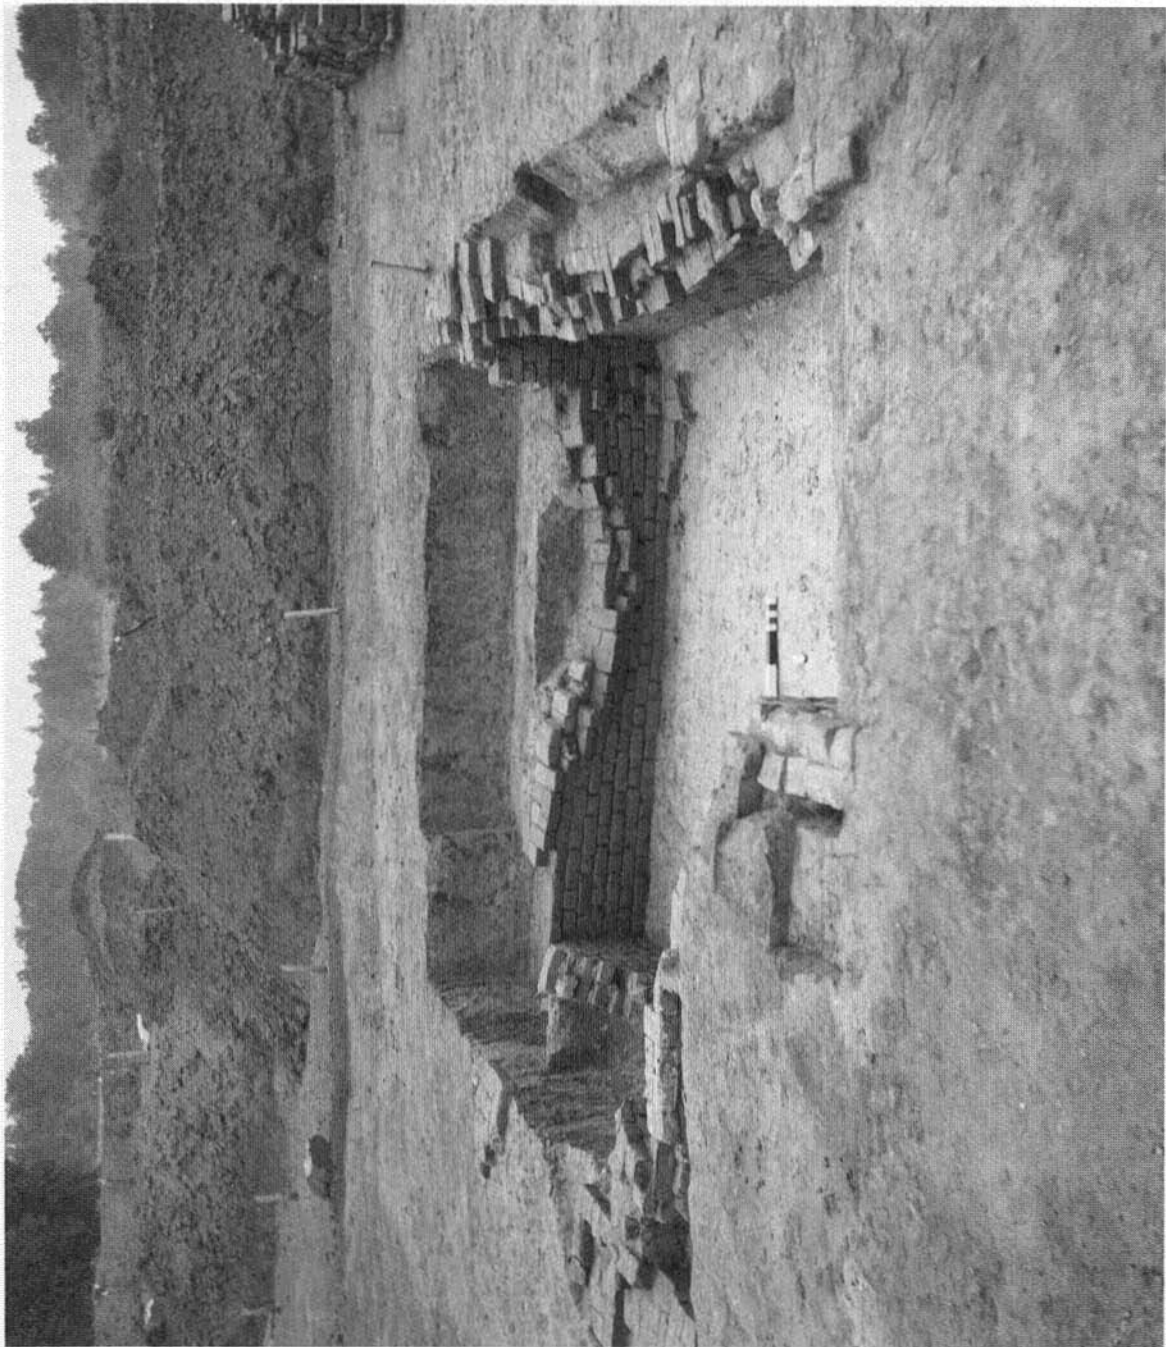
Figure 4

Postexcavation view of south cellar wall. View is to the south with a portion of a 2' scale oriented east and west.

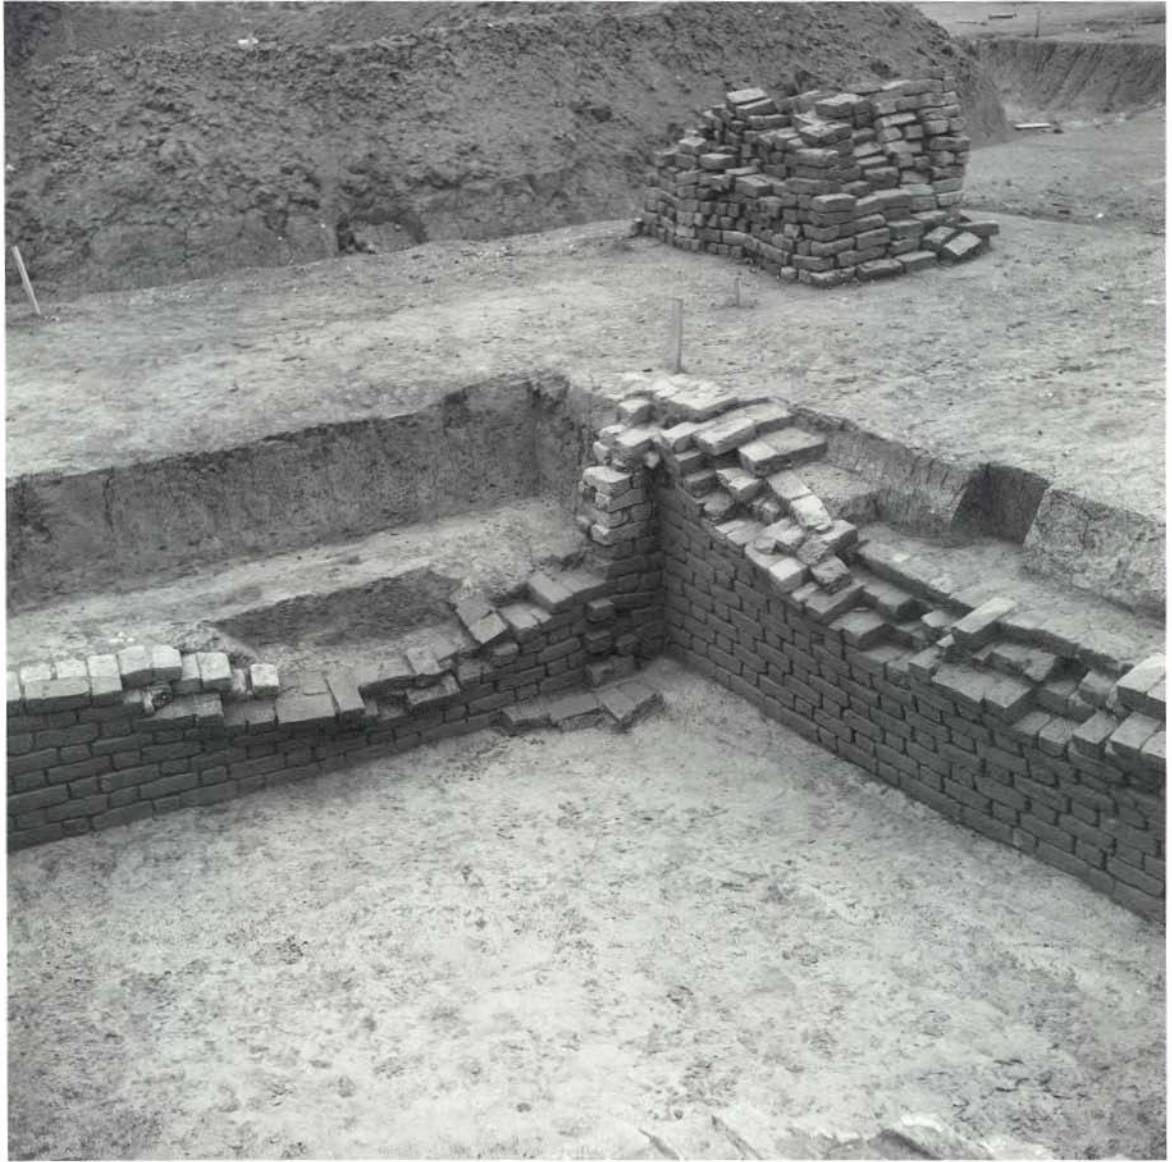
Figure 5

Postexcavation view of southwest corner of cellar. Shows seam and bonding pattern of replaced brick wall section. Moat of northwest bastion of Ft. Holmes shows in the background.

After the replaced south wall section was tied back into the original wall by the seam shown in Figures 5 and 8, it then continued to the

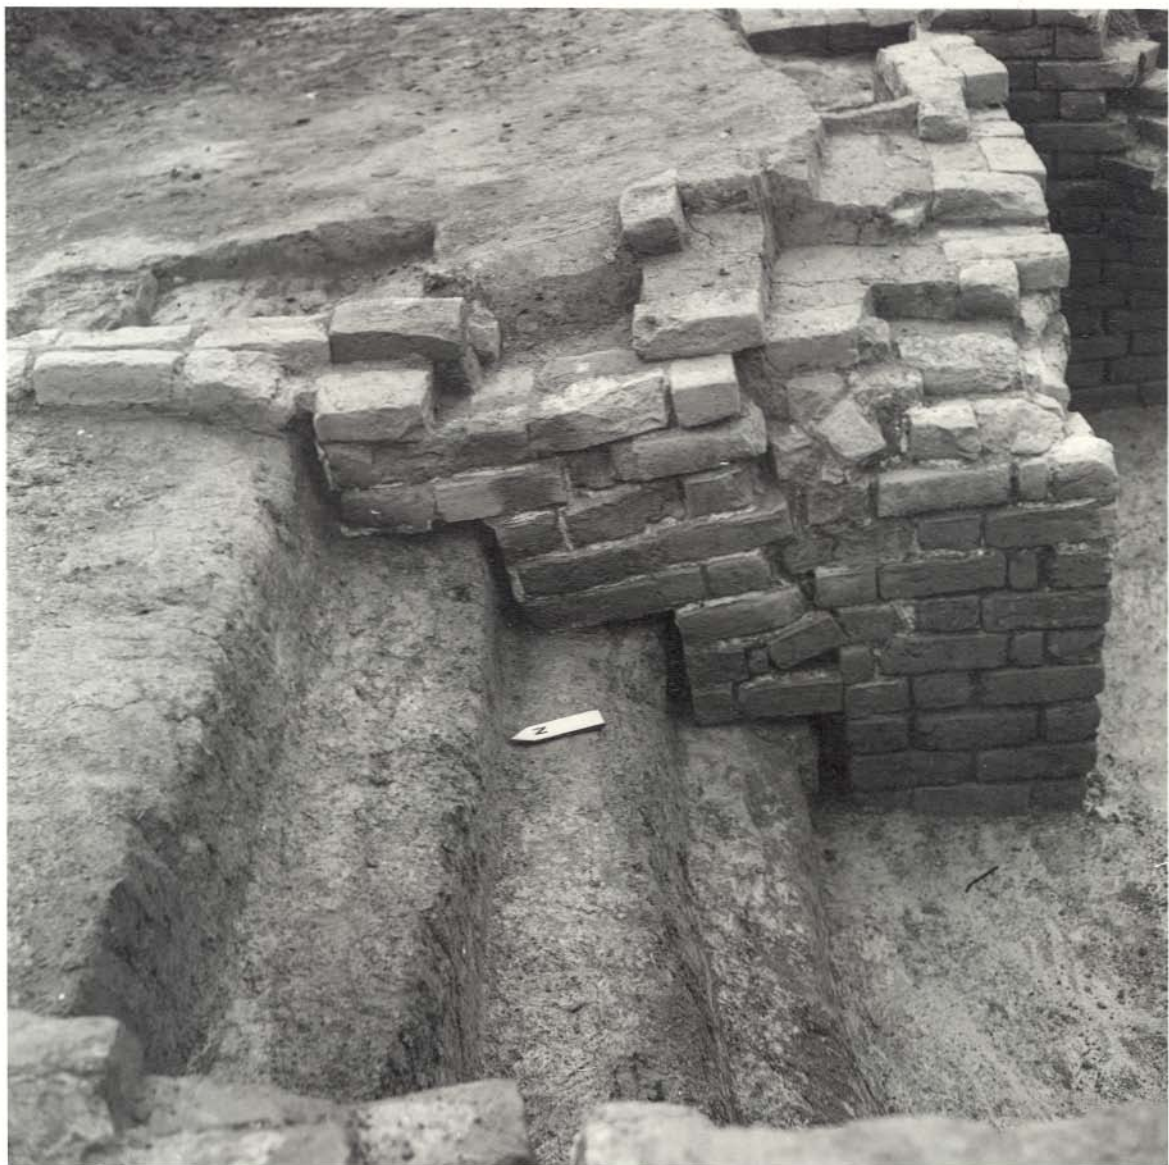
Figure 7

Postexcavation view of east wall of the cellar entrance with slots for wooden treads and risers visible at the end of clay steps.

Neatly bonded into the north and west walls of the cellar are the walls of the entryway (Fig. 1, 7). The entrance remains consist of a brick wall on each side of a sloping clay bank into which have been cut three steps (Fig. 7). The bond of the brick entrance is Flemish, as with the rest of the cellar. The entryway was apparently constructed at the same time as the rest of the cellar. The steps were 4.5 feet wide and the rise of the steps were individually about .9 of a foot. The tread width of the steps varied between 1 and 1.5 feet. Figure 8 shows that the steps rose about 3.4 feet in height within 4 feet of horizontal distance. The grade of such steps is steep.

Distinct slots were present in the walls of the cellar entrance at the end of each step (Fig. 7). These slots indicate that both the tread and riser of each step had been covered with wood. The slots would tend to hold each board in place and the boards protected the steps from wearing down and crumbling away. Boards to fit these slots would have been one to two inches thick.

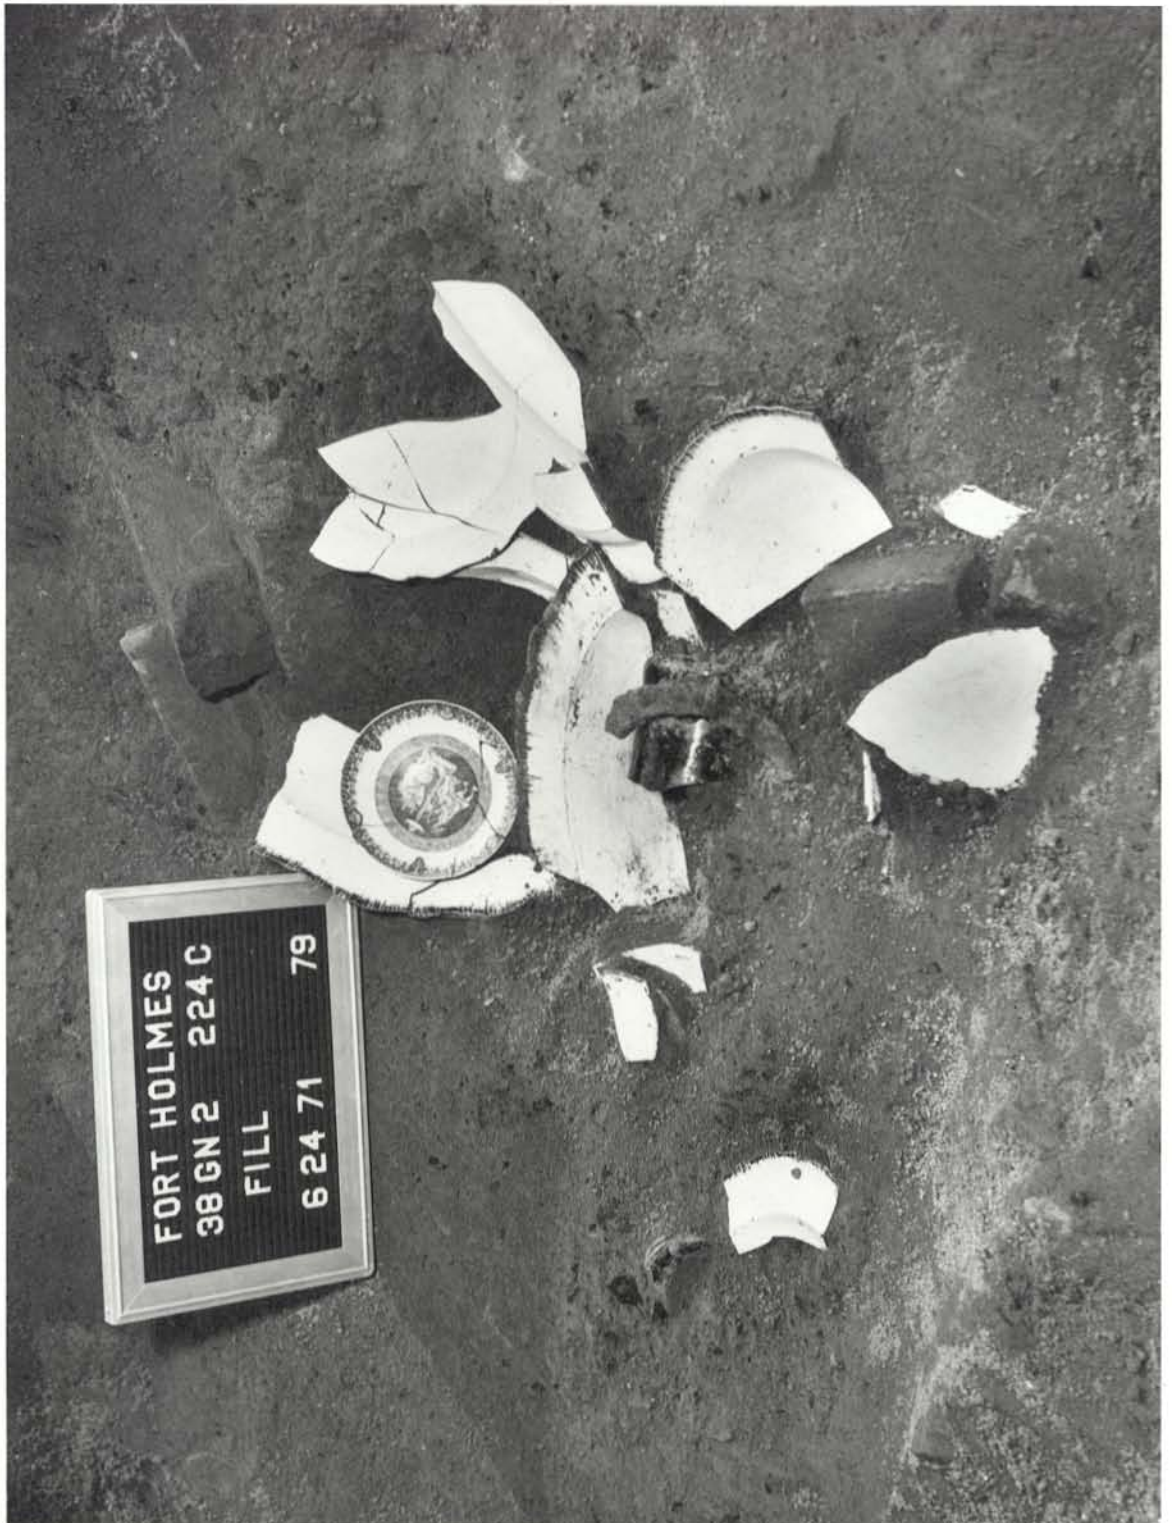
Figure 12

Photograph of unusual transfer printed pearlware bowl and other ceramics typical of those found throughout the cellar fill.

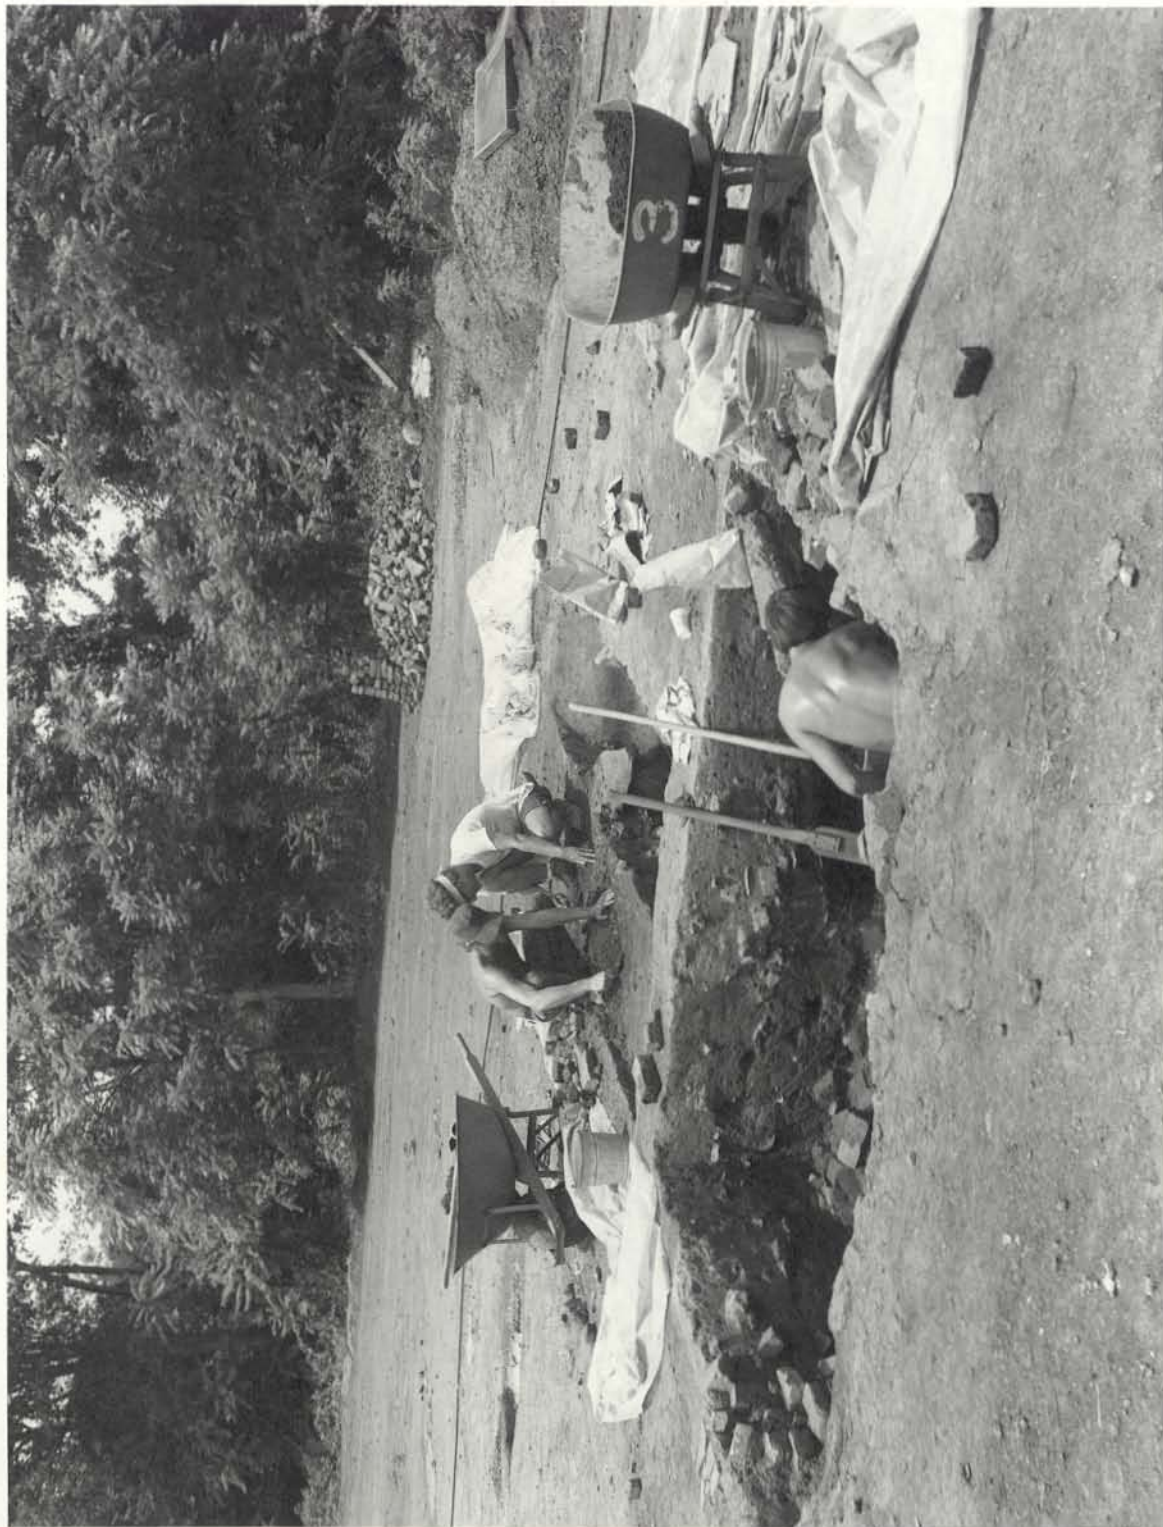
Figure 13

General view of excavation in progress on July 1, 1971.

View is to the north.

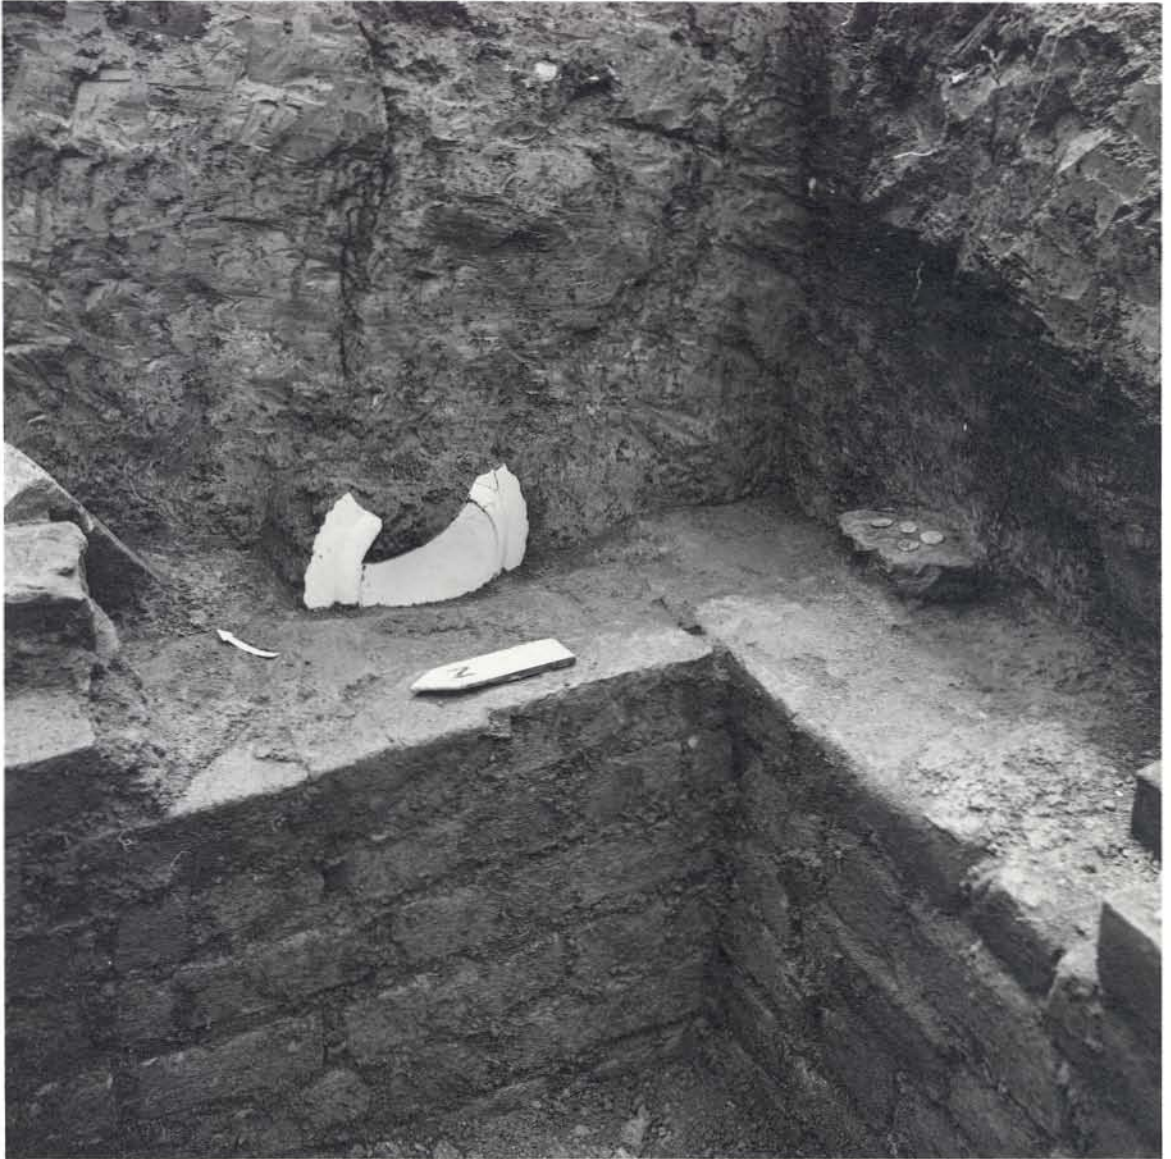
Figure 16

Photo showing location of small cache of coins,
jewelry, and a pearlware plate behind the replaced
section of the southeast cellar wall.

A small cache of coins and jewelry were recovered from the construction space behind the replaced brick wall of the cellar lining (Fig. 16). This cache of coins and jewelry consisted of a brass chain, four Spanish silver coins¹, a cut quartz set from a sleeve link or earring, a small brass buckle, and two buttons. There was also an almost complete green shell edged pearlware dinner plate wedged behind the brick (Fig. 16). The location of this cluster of materials which were all found within six inches of each other and with the coins and jewelry in a pile was designated 224 M. It is possible, but doubtful, that this material was the result of general trash falling down the construction space either during or even after the wall was replaced.
