Exploratory Excavation at the Price House (38SP1)

EXPLORATORY EXCAVATION AT THE PRICE HOUSE (38SP1)

RESEARCH MANUSCRIPT SERIES 5

July 1970

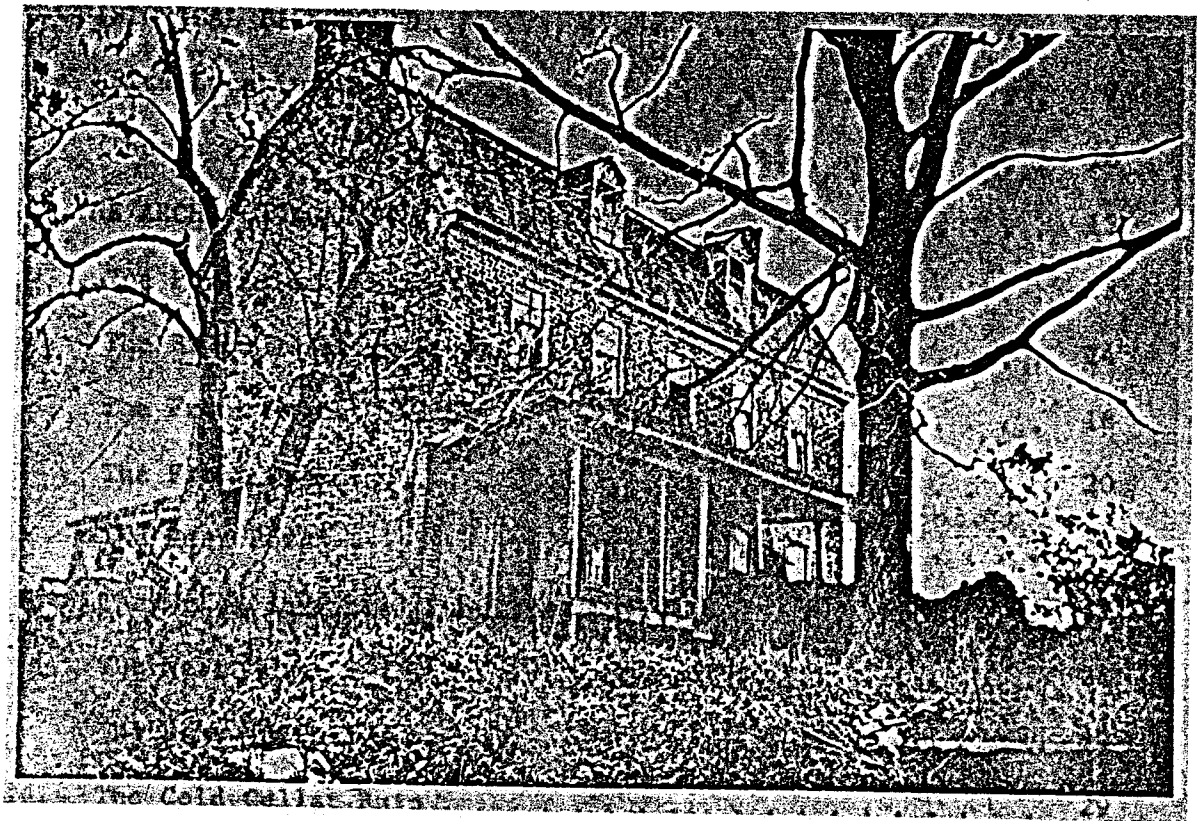
Frontispiece

View of the Price House taken in 1939.

This picture was taken when a portion of the front porch was still attached to the house. Note the fence to the left, found archeologically.

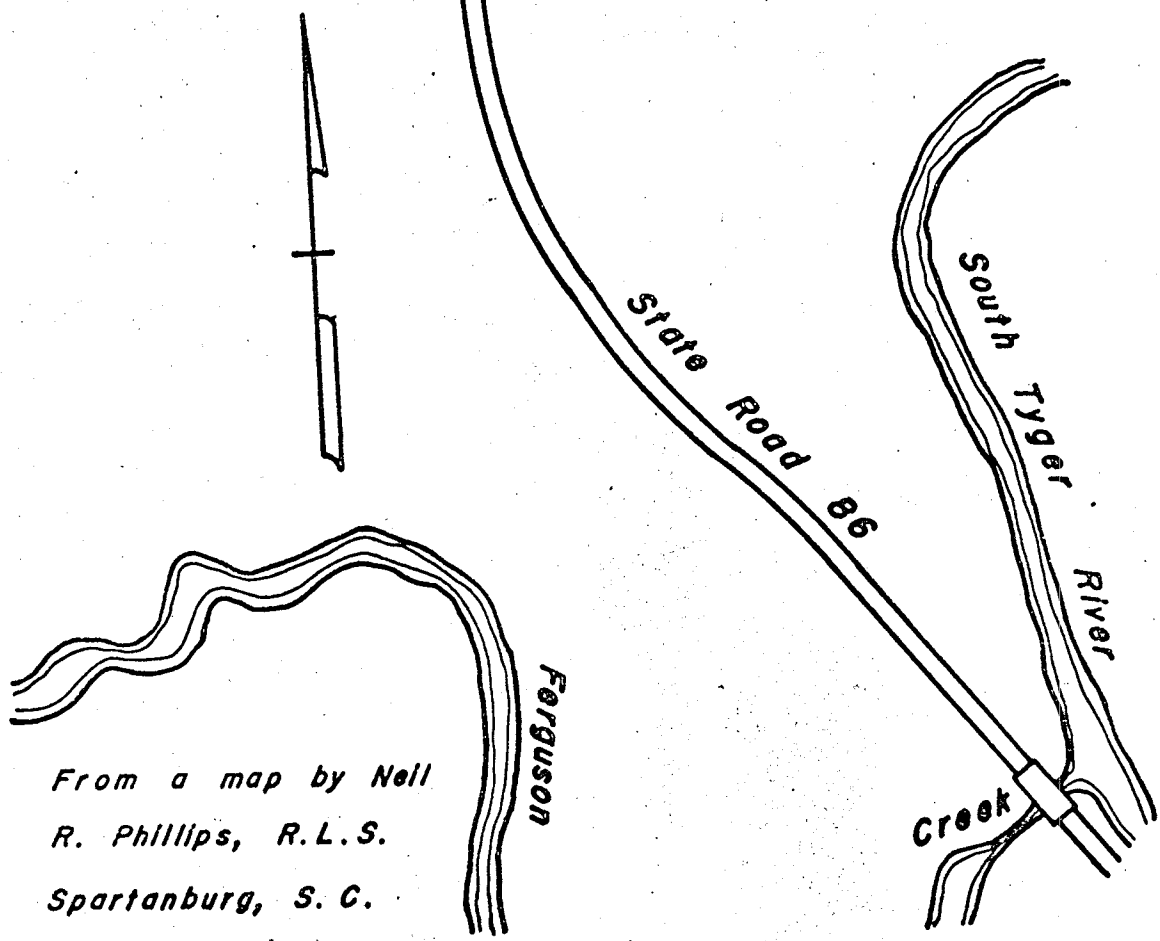
FIGURE 2

Map Showing the Location of
 38 SP 1
THE PRICE HOUSE
 Spartanburg County
 South Carolina
 Institute of Archeology and
 Anthropology
 University of South Carolina

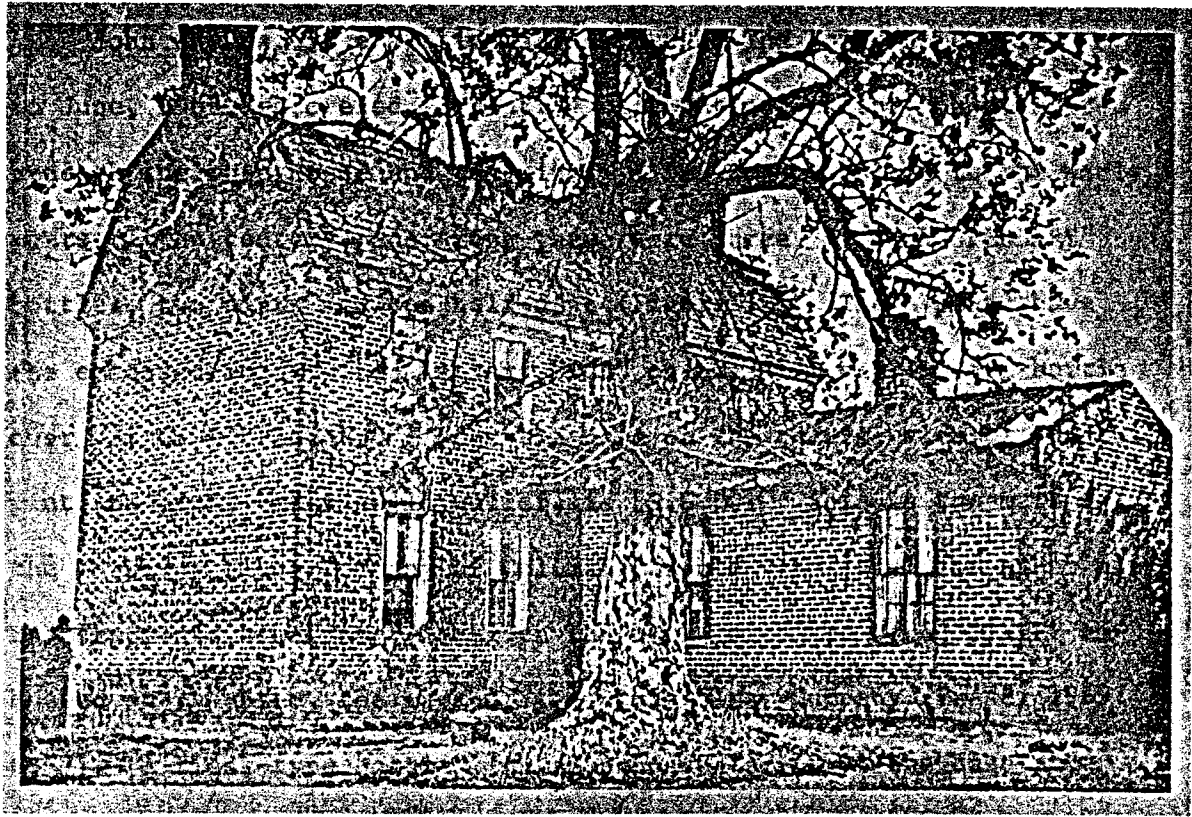
Notice the vents for circulation beneath the floor in the house and the servants' quarters.

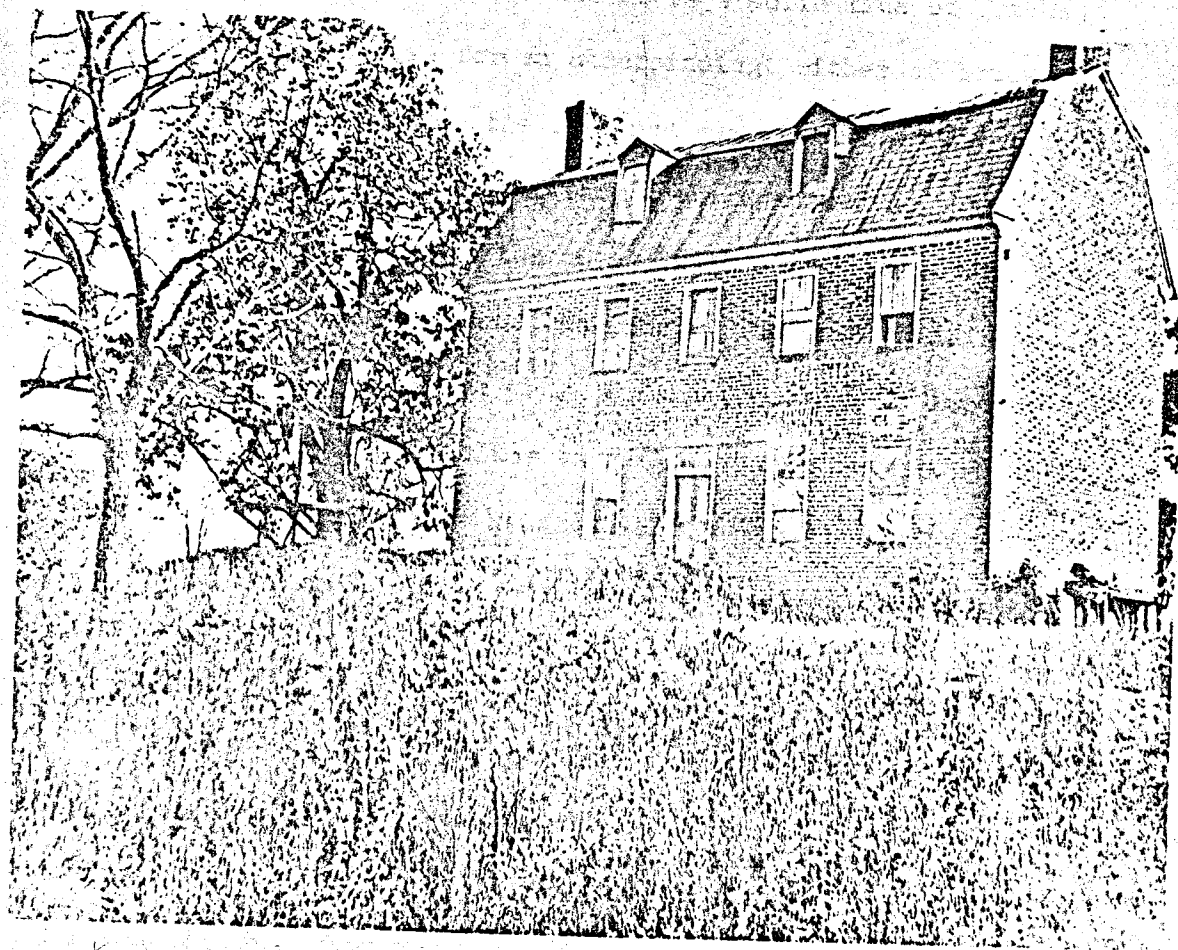
Notice the outline of the porch ceiling against the side of the house and the two central windows and door with original vertical capstone bricks in place (since removed).

The roof line of the porch seen against the house and the footing for this porch is evidence that the porch extended all the way across the front of the house. This footing could represent a base for the porch support, but since it is a solid line of bricks, it was very likely the base for an underpinning, either of brick or perhaps wooden lattice. From the evidence seen in the ground and from the house itself, it is clear that a porch measuring nine by forty feet was on the front of the house, with a roof extending the full forty-two feet length across the front. The date of this porch construction is after the house was completed, perhaps as late as the 1820's, in any event, evidence for an earlier porch has not been found, either in the ground or on the house itself. More excavation in front of the door might reveal further evidence not seen in this study.

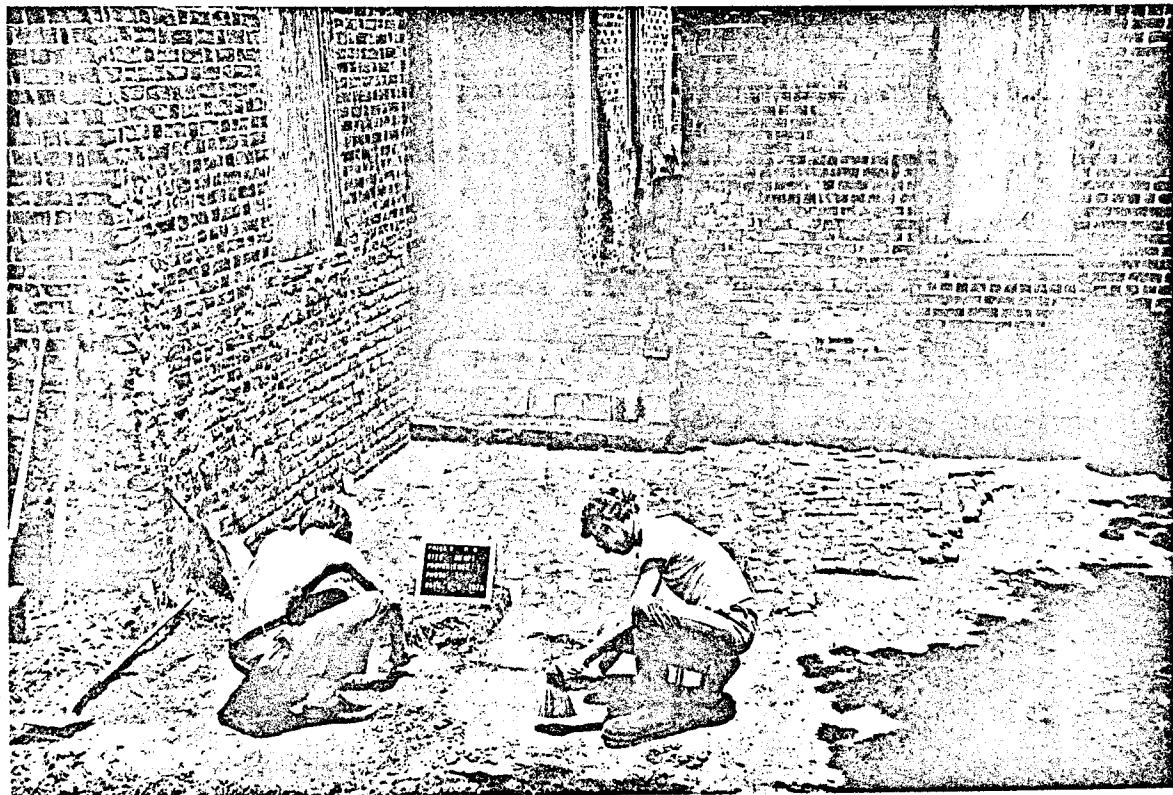
The Brick Walk with a Section Removed.

Features predating the walk can be seen where the bricks have been removed. Note the smeared-on cement over the bricks, done in recent years, which must now be removed.

Competent architectural guidance from one experienced in structural repair and restoration of historic buildings has recently been secured in Mr. Henry Boykin. His recommendations should be closely followed regarding the proper strengthening of the foundation walls of the house. It is the archeologist's opinion that a really proper job could only be done by contractors, under the guidance of Mr. Boykin. It will be necessary to remove the present ground floor, to allow for access to the foundation wall and thoroughly strengthen the interior base of the walls of the house by removing loose brick and properly buttressing along the entire foundation wall with brick or cement. The crack in the east wall is only a symptom of the structural problem, created by the cutting of the door in the wall. This door should be resealed with brick after the wall has been repositioned, but such work must be under the architect's guidance. The front porch was an early added feature of the house and could be rebuilt at the time of restoration or added later on. Original ventilation vents should be located and reopened, instead of artificially creating modern vents by knocking holes through the house wall as someone has suggested.

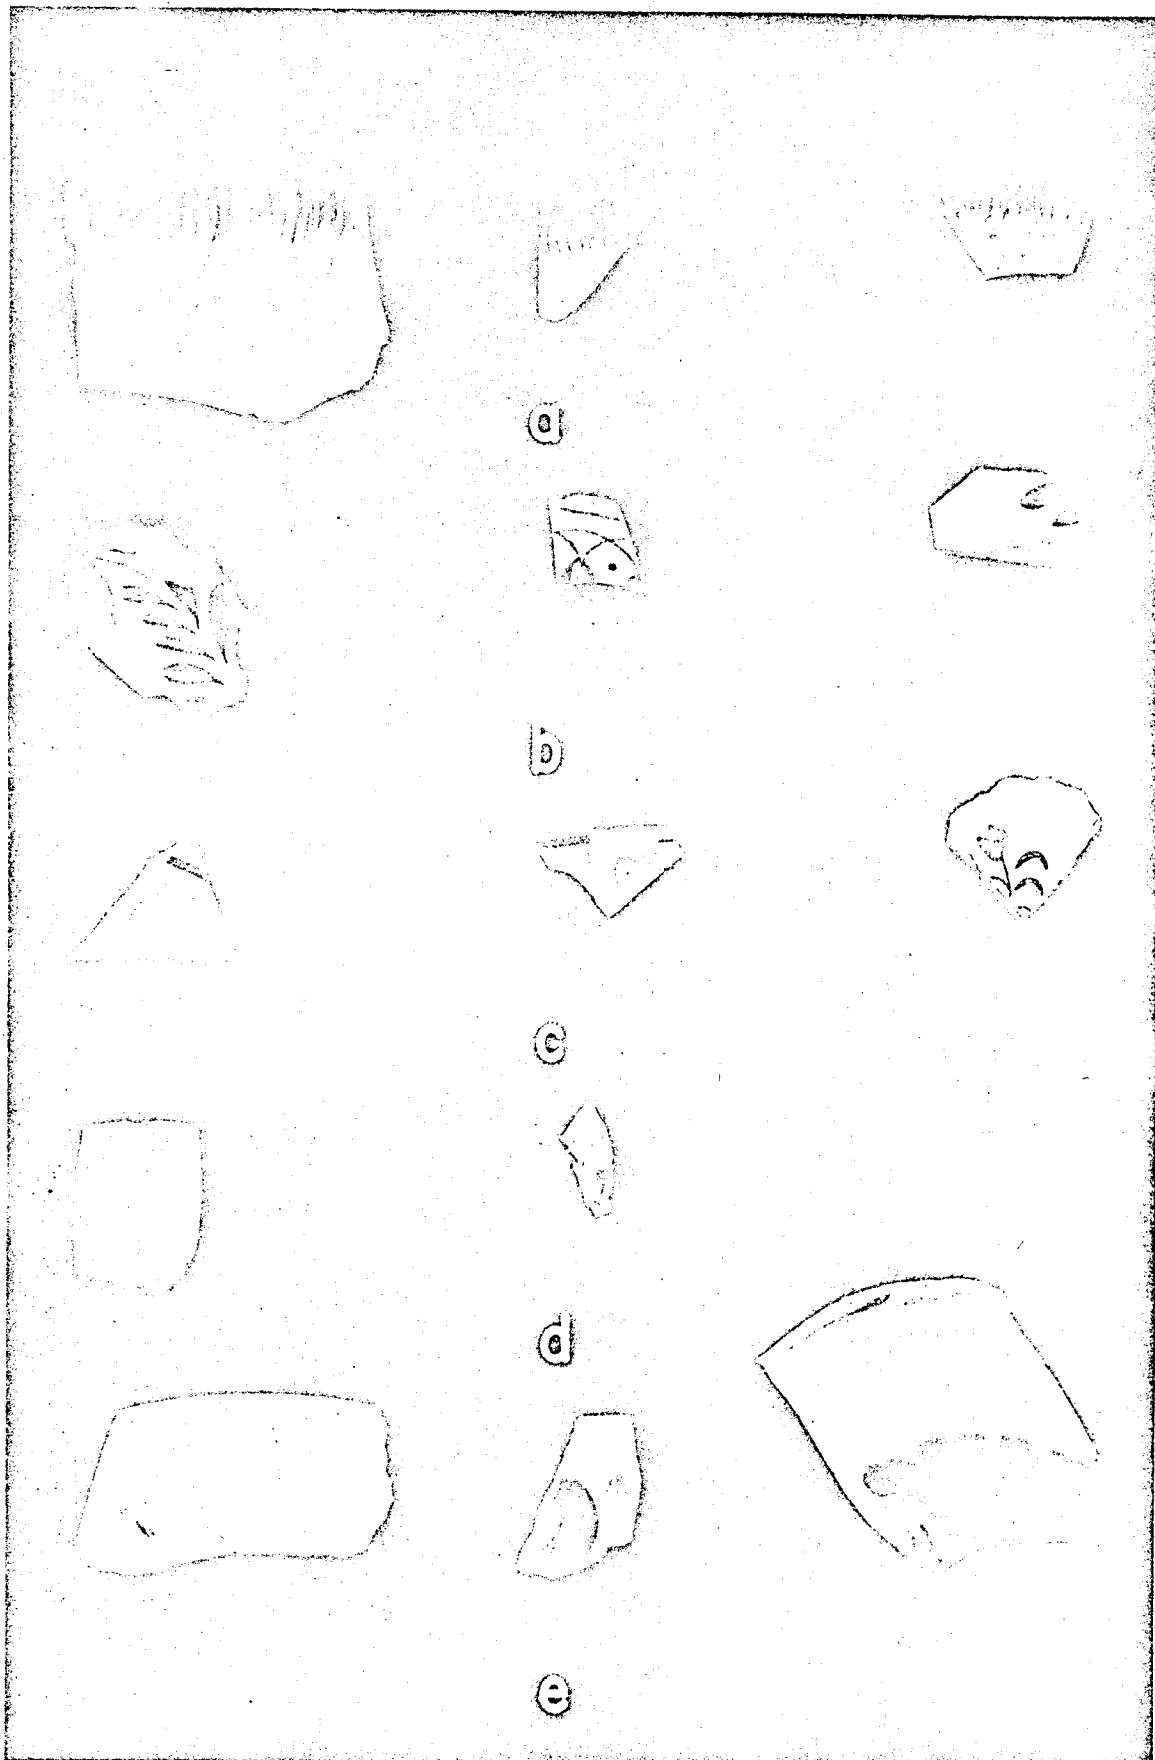
- A. Blue-edged pearlware (38Spl-11C; 12A-37; 9A-2).
- B. Blue-painted pearlware (38Spl-11B-34; 12C-38; 9A-4).
- C. (left) Banded creamware; polychrome pearlware (38Spl-7C-3; 6A-11; 11B-41).
- D. (left) Sponged ware (7B-14).
(center) Red transfer-printed ware (1E-3)
(right) Blue transfer-printed ware (38Spl-11B-42).
- E. (left) Fragment of ironstone alphabet plate (38Spl-11C-1).
(center) Mid-nineteenth century polychrome-painted pearlware (7B-2).
(right) Late nineteenth century faded blue-stenciled ironstone (7A-79).

Types A - D are those most likely to have been used by the Price family, whereas those in E are from the mid- to late nineteenth century. The polychrome-painted pearlware in E-center is identical with whole mugs, cups and saucers recovered from a blockade runner sunk in 1864, and on file at the Institute of Archeology and Anthropology of the University of South Carolina.

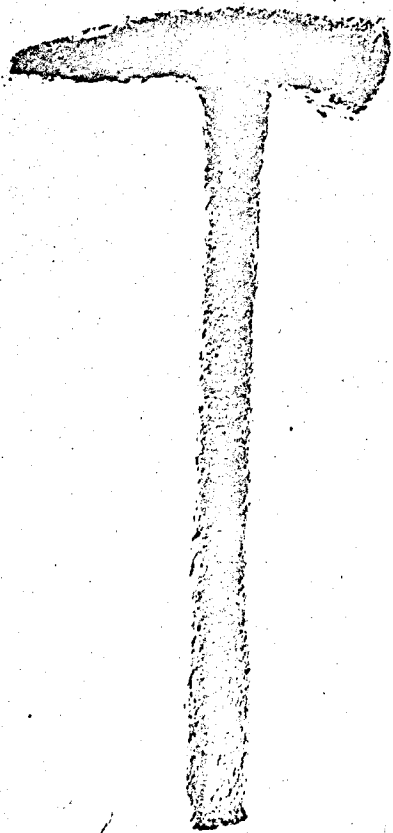
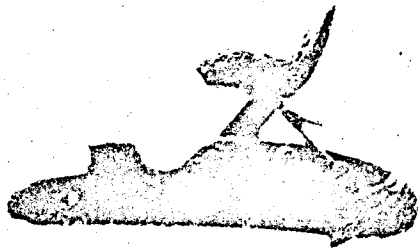
fragments, snuff boxes, milk glass, and recent bottle glass were present. Of particular interest was a lockplate for a flintlock pistol that had been converted into a percussion type weapon (Figure 12).

(Right) Strap hinge.

(Bottom) Flintlock plate converted to
percussion cap.

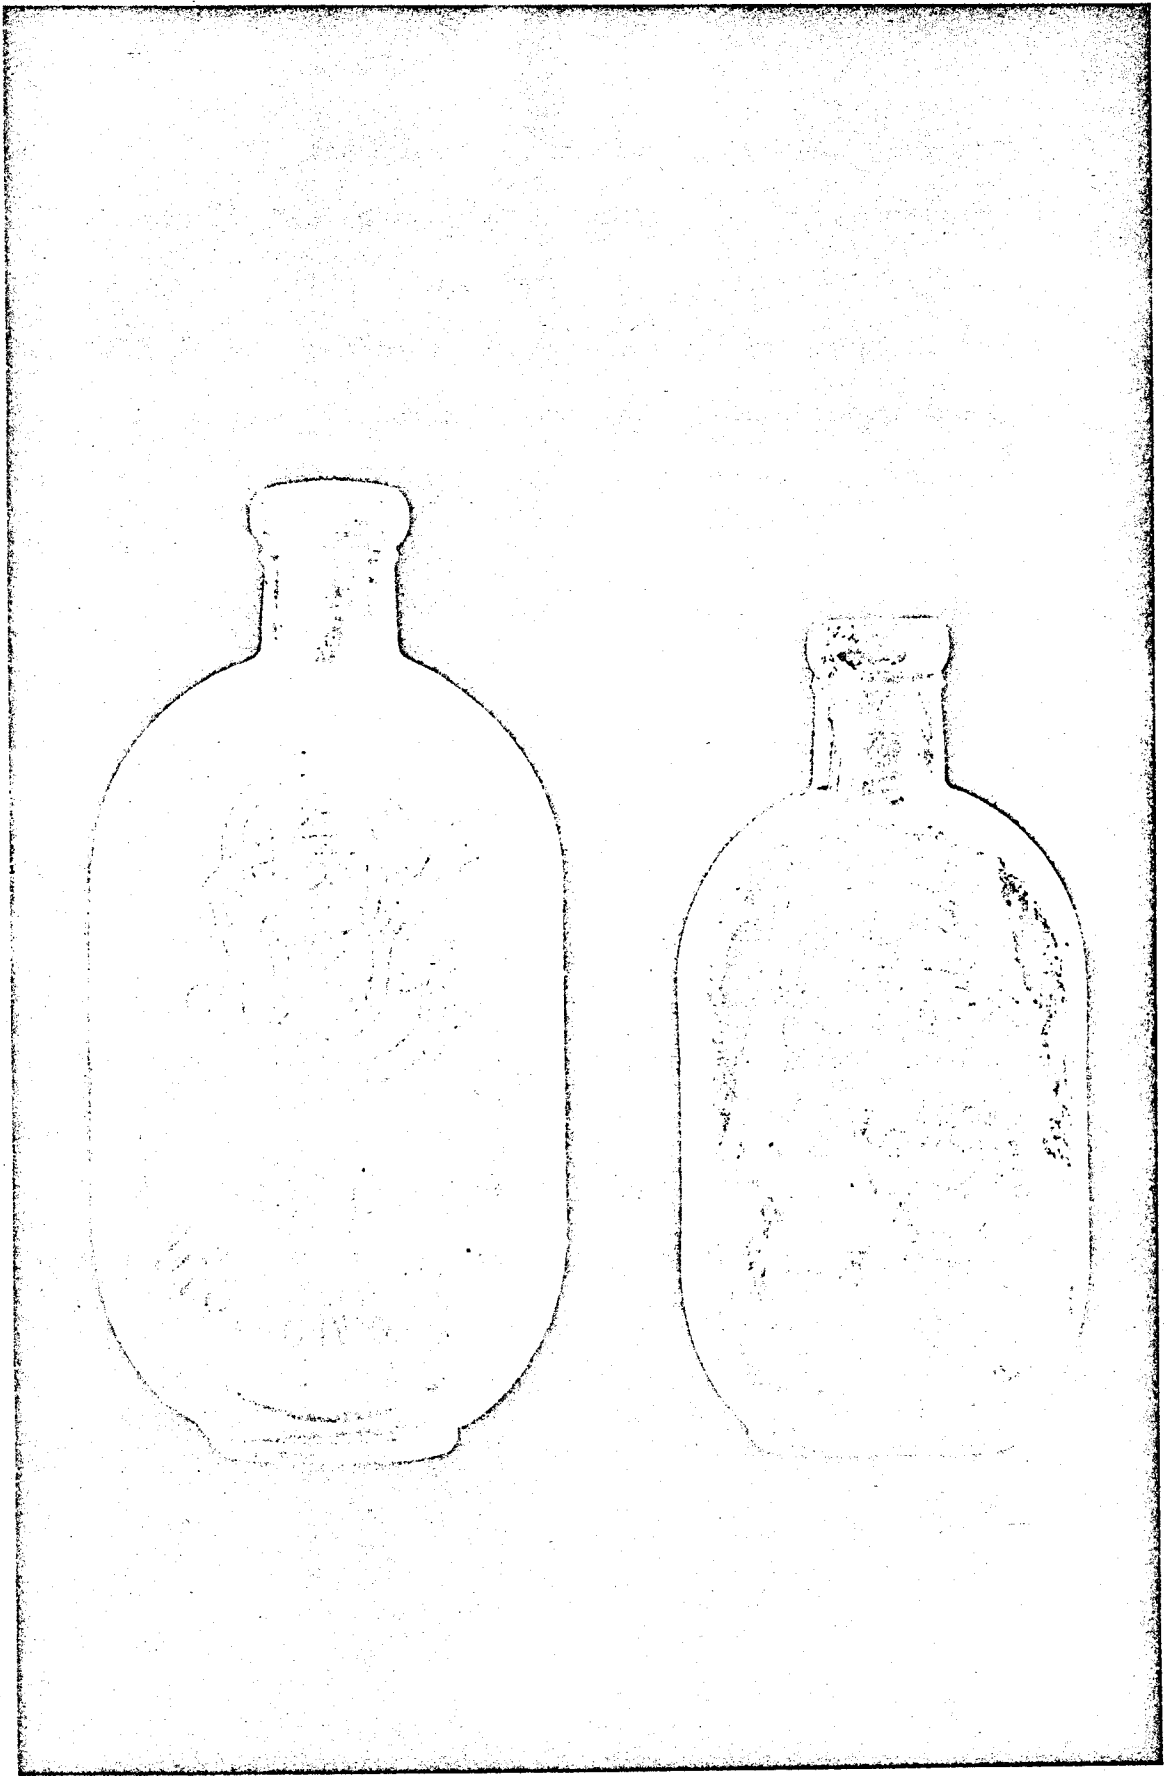
South Carolina Dispensary Bottles.

These were located by John Combes during the preliminary survey of the site (38Sp1-2 and 3).
