Published in *Legacy*, Volume 7/#2-8/#1, 2003, pages 40-41.

Mystery of the Washington Street United Methodist Church's Cornerstone

By Jonathan M. Leader

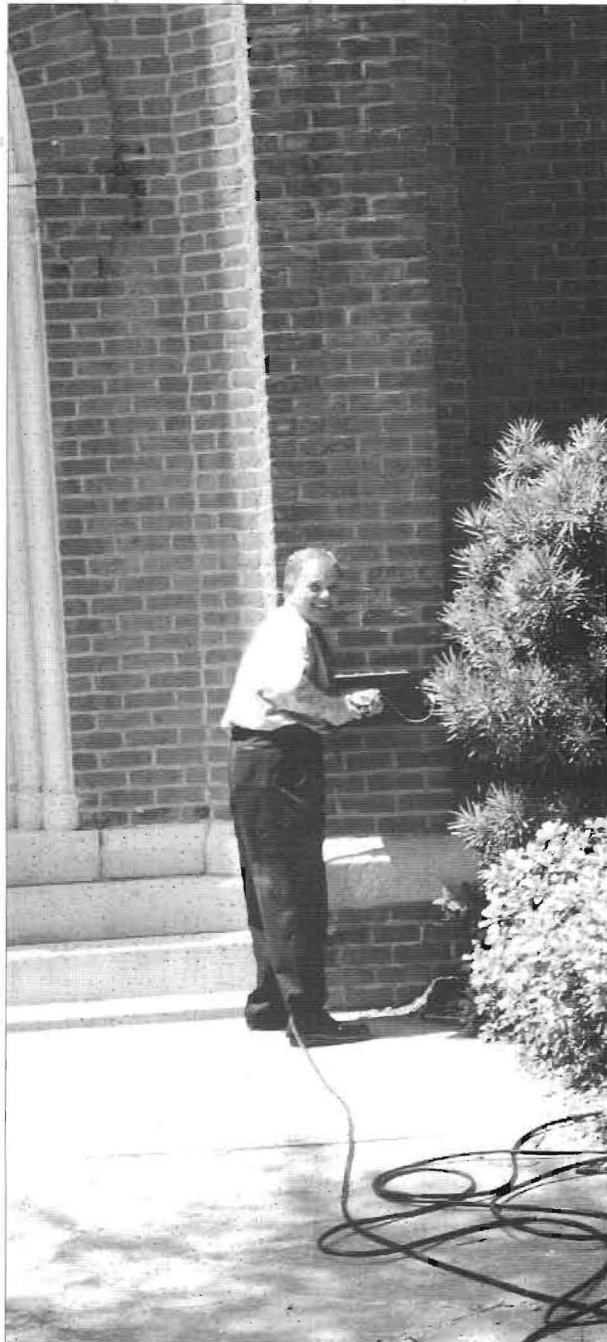
The Reverend Mike Alexander using the GPR on a buttress of Washington Street Methodist Church in Columbia. (SCIAA photo courtesy of Jonathan Leader)

Each corner of the building facing Washington Street was thoroughly tested for voids. The corners produced by the decorative buttresses on either side of the main doors were tested as well. The equipment performed flawlessly showing substrata and other inclusions within the brick facade. Unfortunately, it showed no void or area consistent with a cornerstone.

GPR has been successful in mapping structural walls. In those instances the equipment used a 1.5 GHz antenna that provided a very shallow penetration of the target with fine-grained resolution. The equipment available in Columbia was a 900 MHz antenna that had never been put to this purpose before. Nonetheless, it was agreed that an attempt would be made.

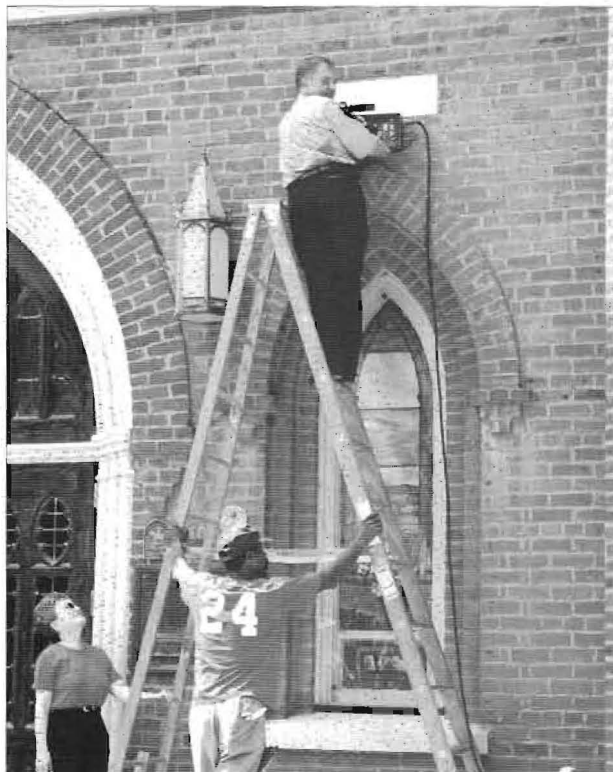
Borrowing equipment used by the craftsmen restoring the exterior of the building, the GPR was raised to the level of the target areas. As before the equipment performed flawlessly and this time identified a void behind the right hand side decorative facing. Since this was a nontraditional location for a cornerstone, a second opinion was sought from the architectural restorers. They concurred that given the description and other available information that the facing was most likely the cornerstone. In due course the facing was removed. The void behind the decorative stone conformed to the space as described, but contained no box or other items.

The Reverend Mike Alexander, Maxine Sullivan, and their assistant locate the void behind the marble marker on the front facade of the Washington Street Methodist Church in Columbia. (SCIAA photo courtesy of Jonathan Leader)

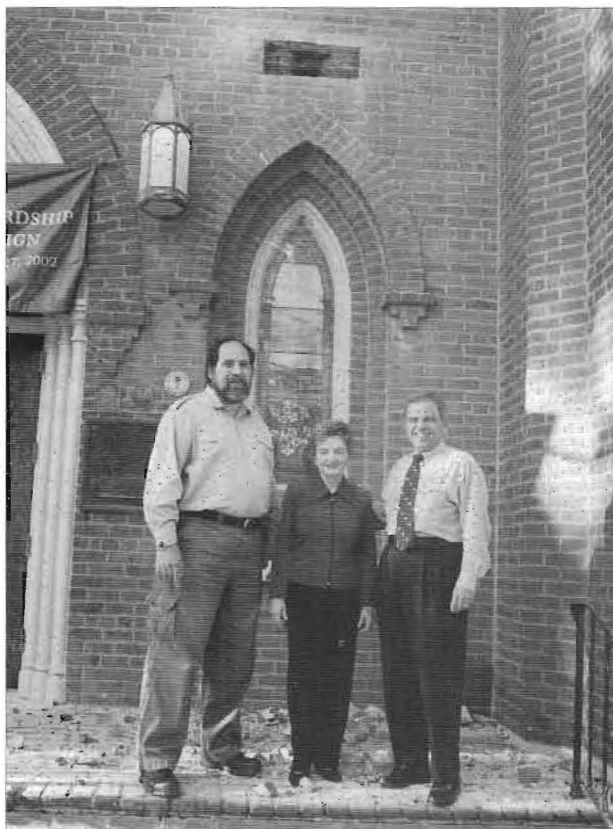
Jonathan Leader, Maxine Sullivan, and Reverend Mike Alexander standing in front of the void exposed during the investigation of the missing cornerstone at the Washington Street Methodist Church in Columbia. (SCIAA photo courtesy of Jonathan Leader)

The mystery of the cornerstone has yet to be solved. The Bicentennial Committee is soliciting information from the congregation and community as to the possible removal of the cornerstone box during repair work or other activities. The Office of the State Archaeologist continues to assist the Washington Street United Methodist Church in their efforts.
