Archeological Investigations at the Kershaw House, Camden (38KE1), Kershaw County, south Carolina

Kenneth E. Lewis

Kenneth E. Lewis
Research Manuscript Series, No. 78

Prepared by the
INSTITUTE OF ARCHEOLOGY AND ANTHROPOLOGY
UNIVERSITY OF SOUTH CAROLINA
September, 1975

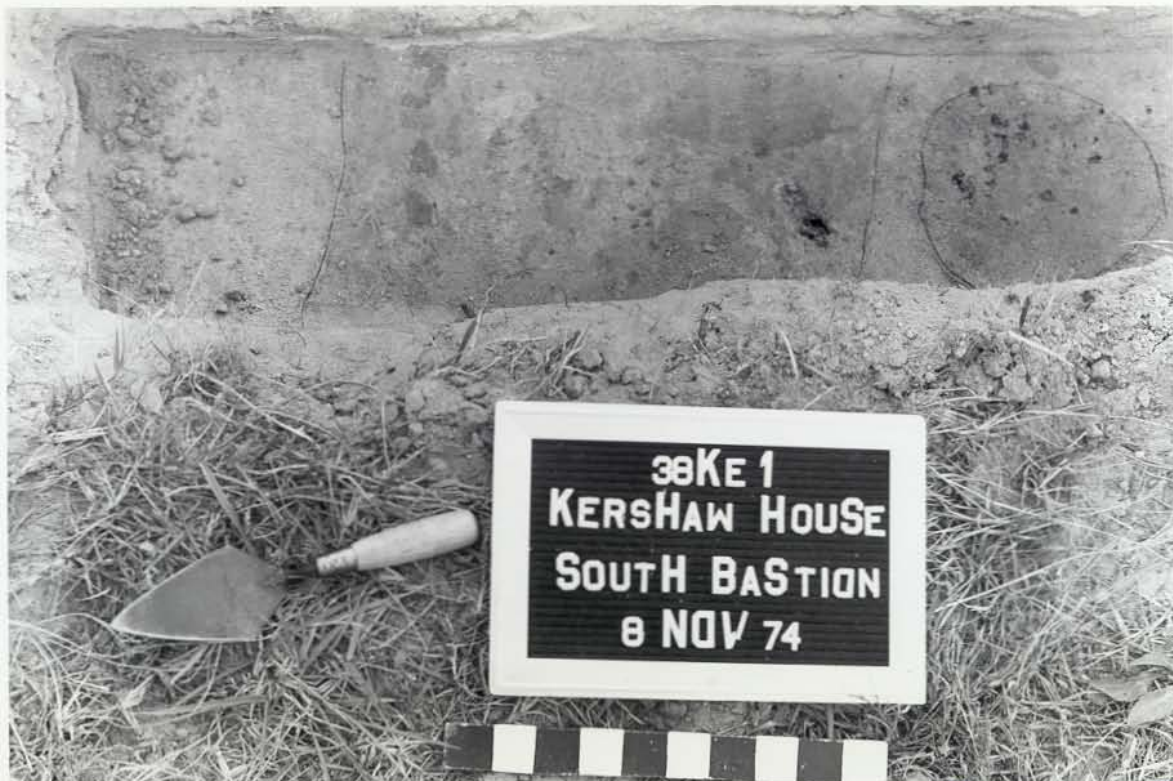
FIGURE 6: Section of the eighteenth century palisade wall trench exposed by exploratory trench.

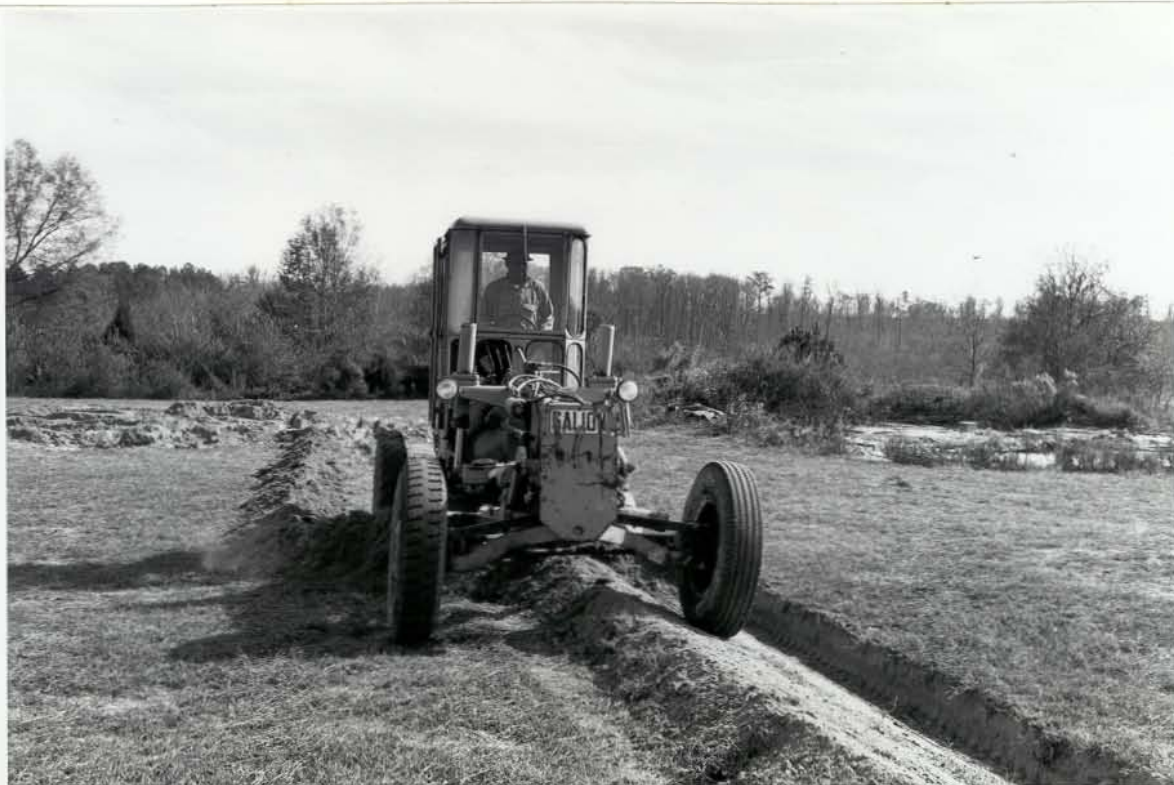
FIGURE 7: Road grader removing overburden covering the palisade trench.

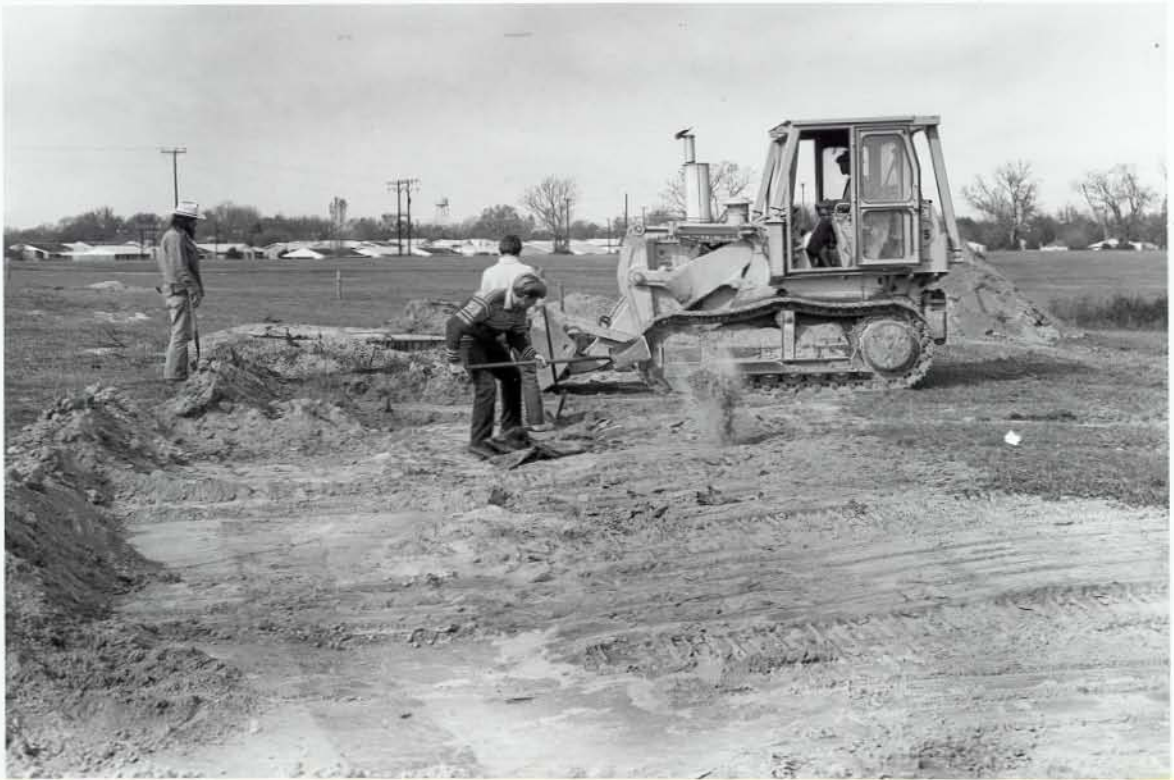
FIGURE 8: Crew members are beginning to shovel-clean the 18th century surface exposed by the bulldozer. The palisade wall trench is visible in the left foreground.

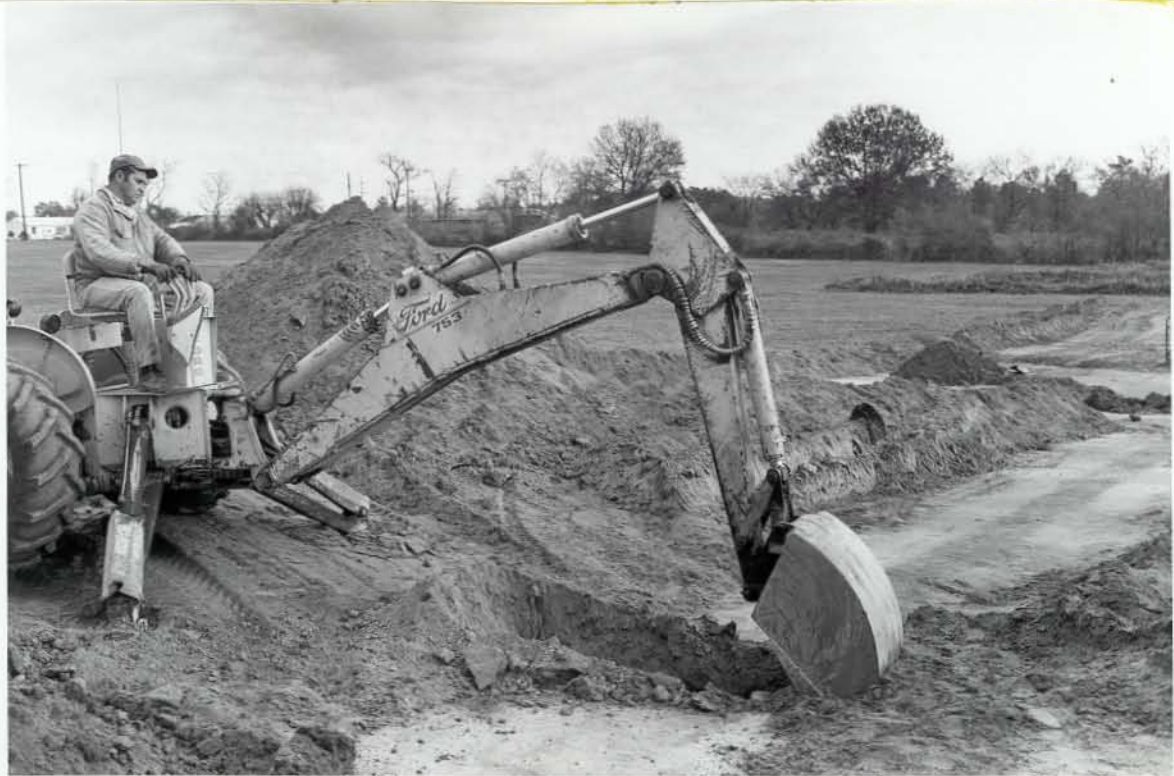
FIGURE 9: Excavation by backhoe to expose cross-sections of the palisade wall trench.

Several interpretive problems, however, arose in connection with the stripping operation. The first occurred while attempting to expose the wall trench in the area directly west of the Kershaw House. This area was explored by Calmes in 1967, at which time it revealed an opening in front of the Kershaw House porch approximately ten feet across (Calmes 1968: 17, Fig. 9). When exposed by the road grader's blade, the old

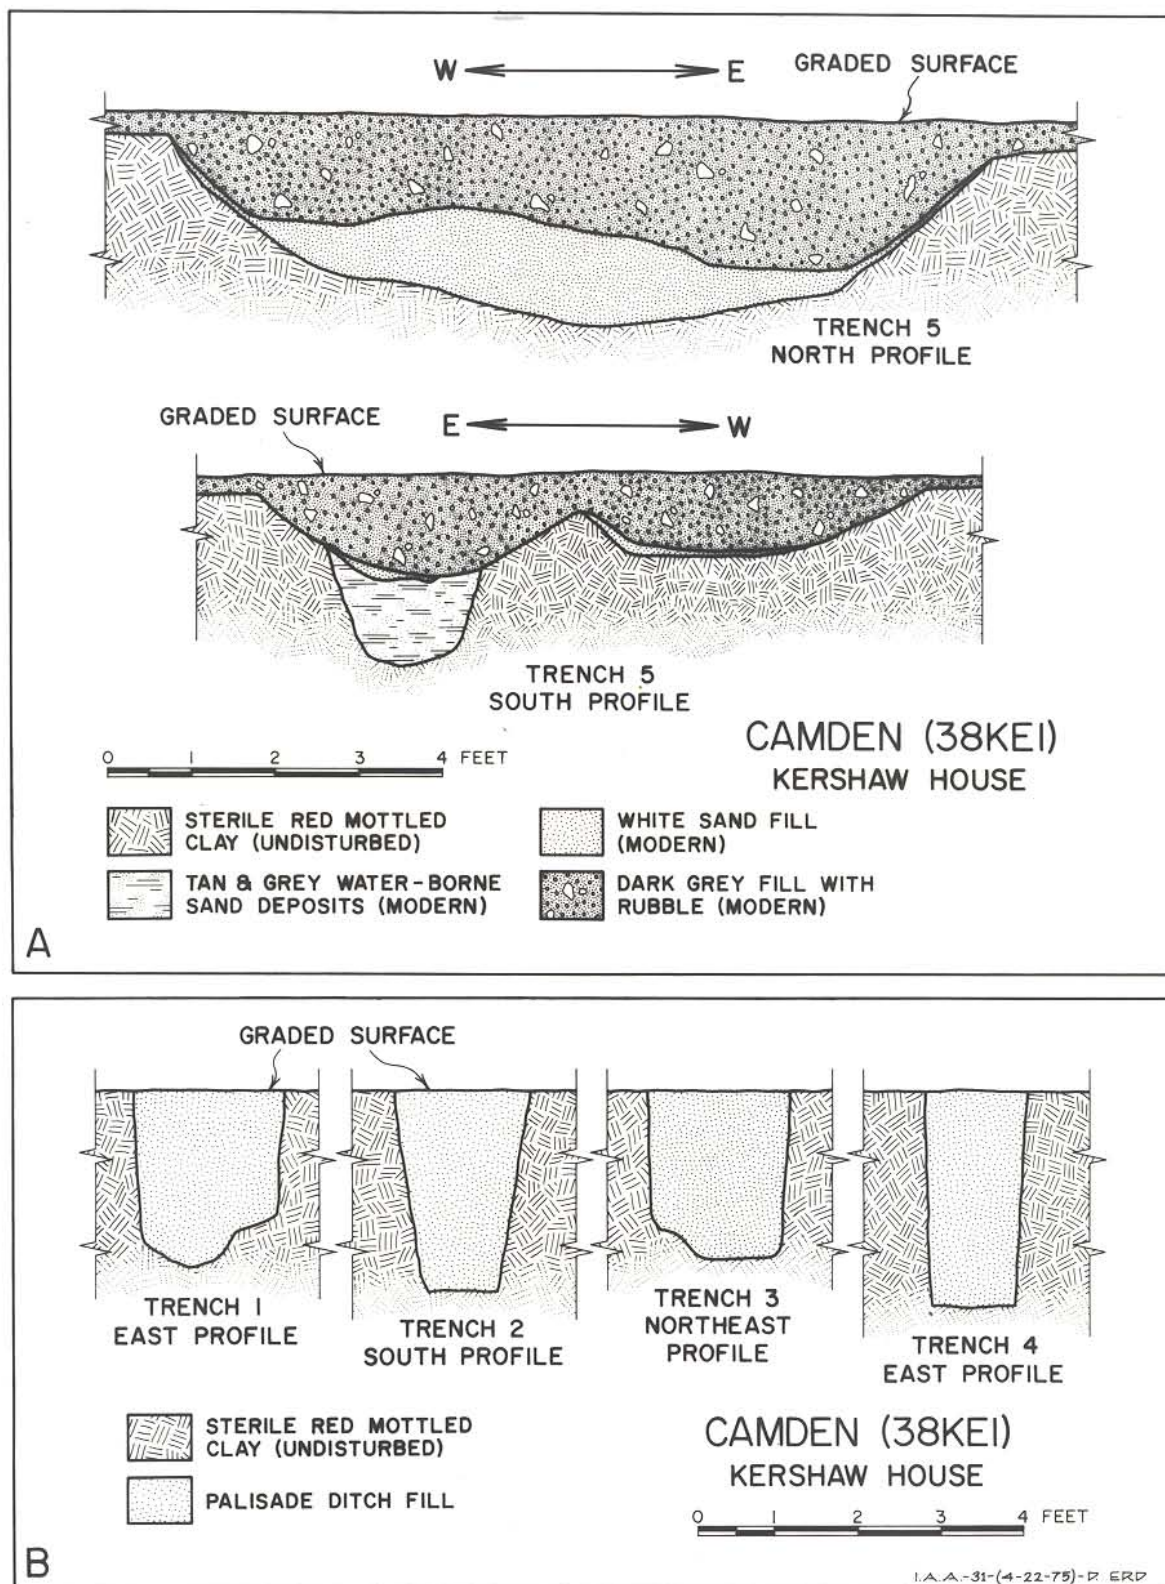
FIGURE 10: Profiles of cross-sections of the palisade wall trench:
A. North and south profiles of the gate in the west wall; B. Profiles of sections of the palisade trench

The south profile plainly exposed the base of the palisade trench (Fig. 10A). This portion of the palisade trench appears to have been previously excavated because the sandy clay palisade trench fill is absent, having been replaced with recent sediment which later drained into the open ditch. Just above the wall trench, a slight depression with two low points is visible in the profile. A layer of white sand is present at the depression's base and is covered by a thick layer of recent grey fill.

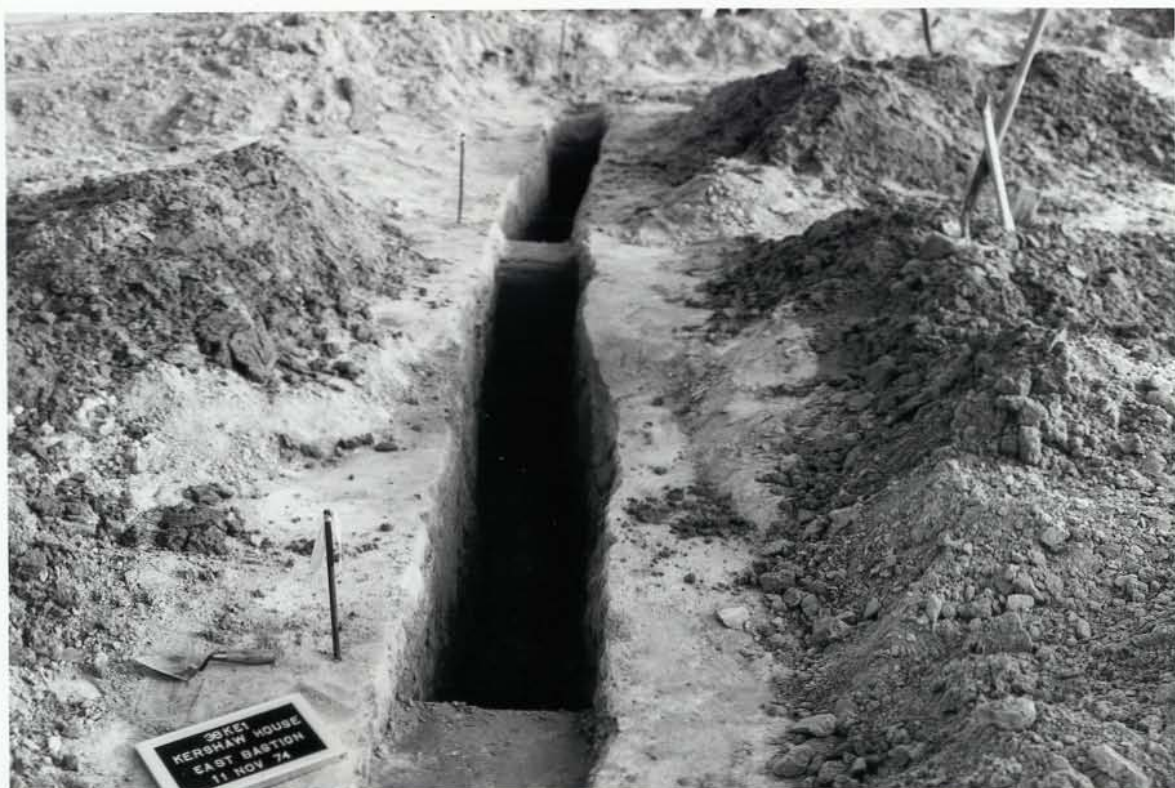
FIGURE 11: Excavated section of the palisade trench in the east bastion.

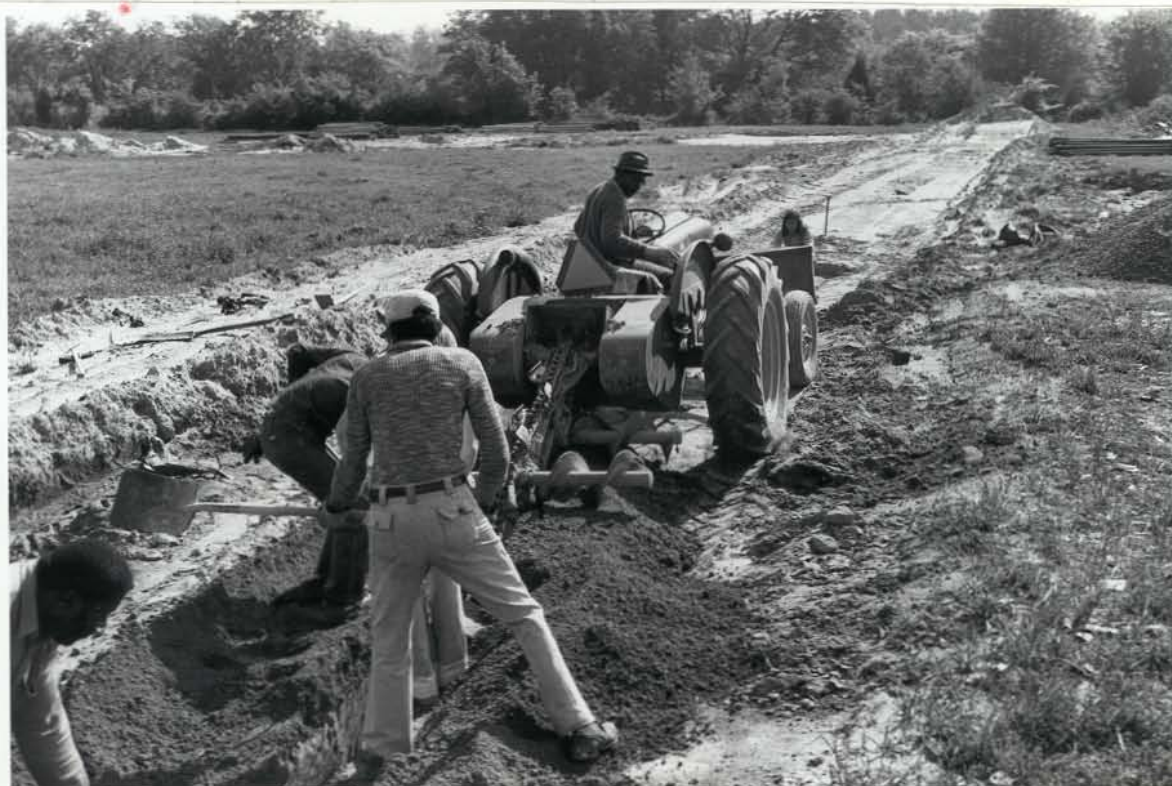
FIGURE 12: Removal of the palisade trench fill by machine.

The ~~excavation~~ of the palisade trench was accomplished through the use of a track-driven belt trenching machine (Fig. 12). Its blades cut a trench approximately 1.0 foot wide allowing it to accurately remove the fill from the trench without disturbing the surrounding soil. An examination of the fill removed by machine was conducted to determine the artifact content. As ~~expected~~, the palisade trench yielded few artifacts making it difficult to assign a date to this feature. No additional construction features were found to be associated with the wall although several non-contemporaneous features were uncovered during the course of the ~~excavations~~. These will be discussed in a later section of this report. In order to facilitate the reconstruction of the palisade wall the actual excavation of the trench was conducted in segments, enabling the placement of the stakes immediately upon removal of the trench fill.

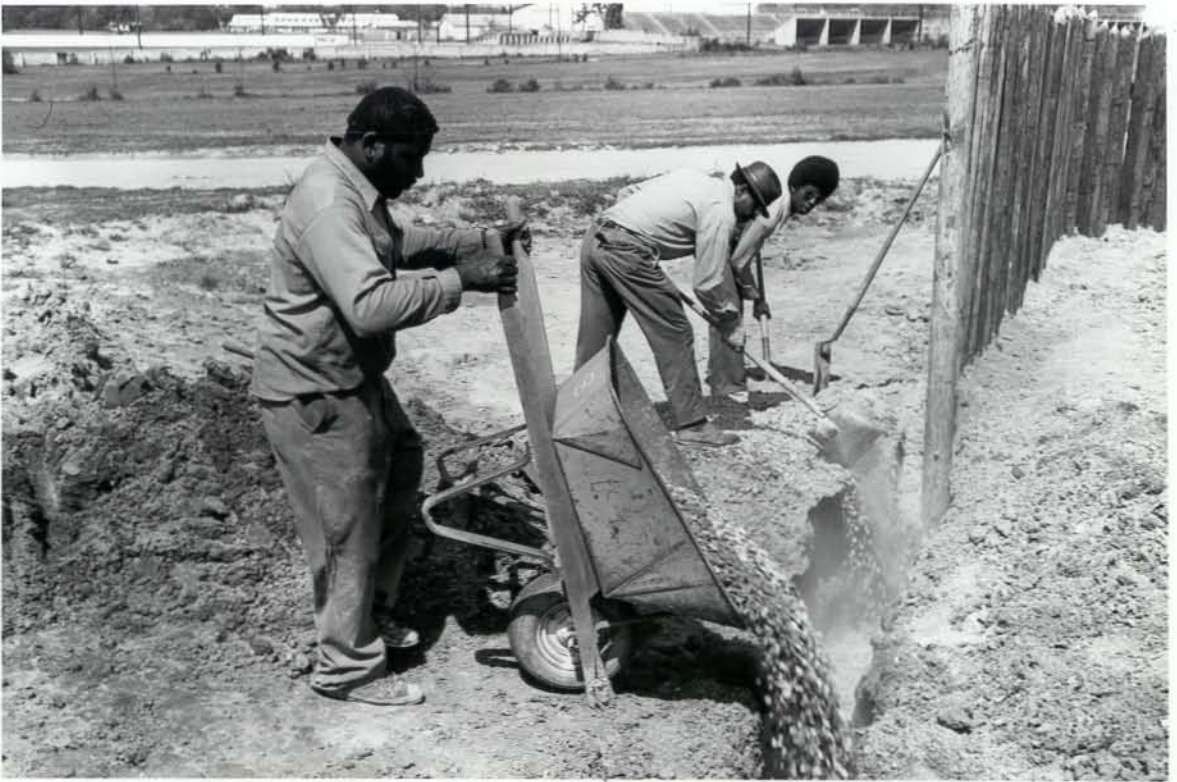
FIGURE 13: Pouring layer of gravel into the palisade trench prior to the erection of the wall.

Following the excavation of the palisade trench the erection of the new palisade wall began. It was designed to resemble as closely as possible an eighteenth century defensive stake wall. John Muller (1968: 227), a British expert on fortification, wrote in 1746 that palisades "are a kind of stakes made of strong split wood about 9 feet long, fixed 3 feet deep in the ground in rows..." To simulate this type of wall, 10 foot long creosoted posts were cut to the appropriate length and sharpened prior to mounting. They were placed in the 3.5 foot deep mechanical dug trench atop 0.5 foot of gravel which permitted the drainage of ground water (Fig. 13). The stakes were then secured in place by packed earth (Fig. 14).

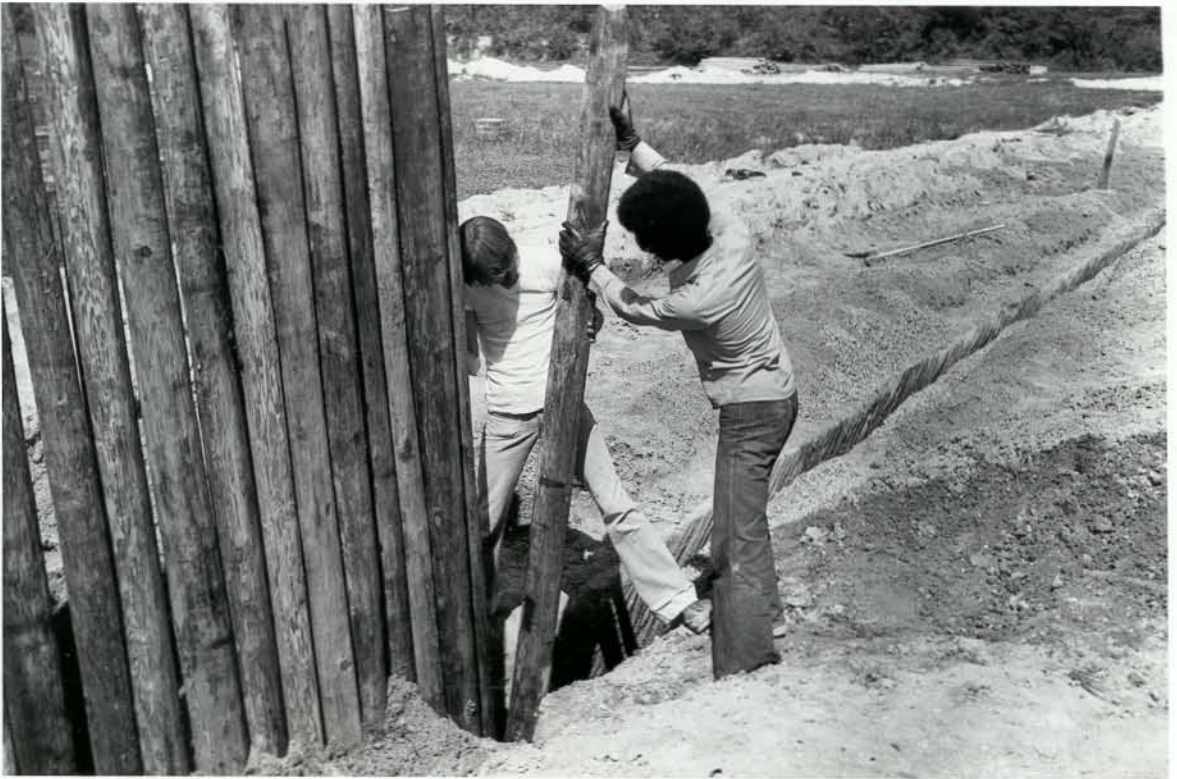
FIGURE 14: Placing the stakes of the palisade wall into the trench.

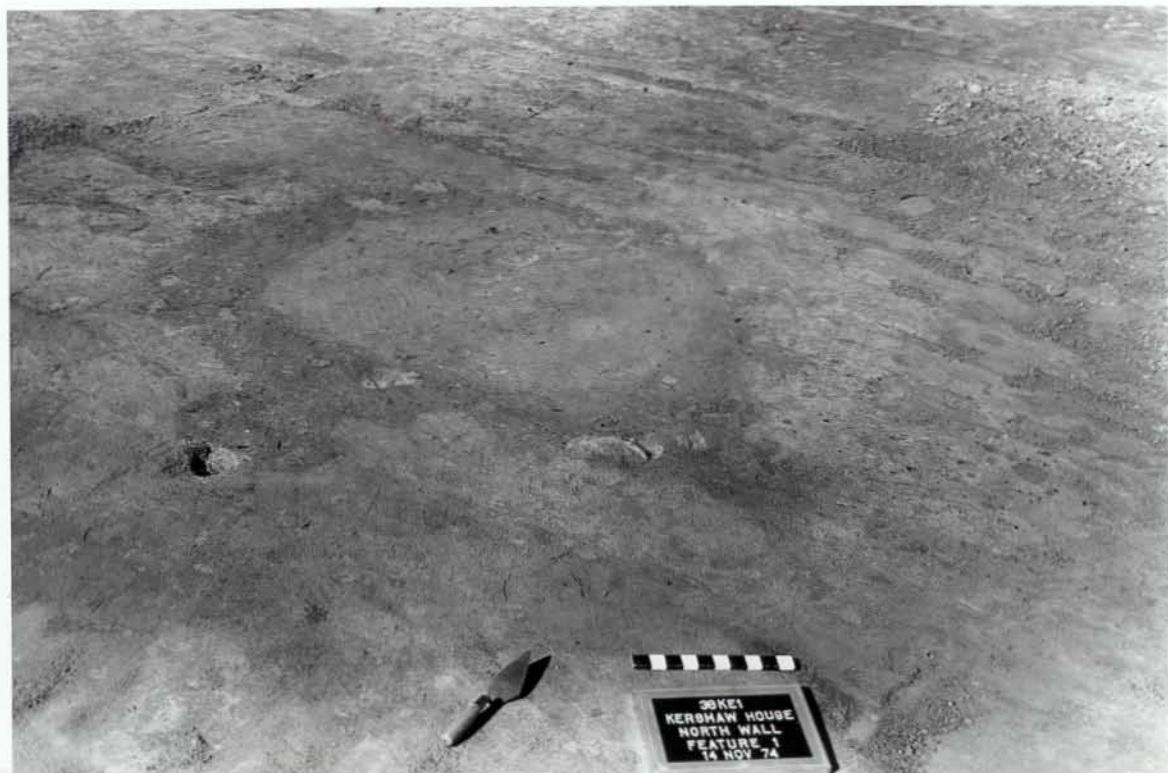
FIGURE 15: Feature 1 prior to excavation, as viewed from the southeast.

The first feature (Feature 1) was discovered in the center of the north palisade during the course of exposing that wall trench (Fig. 2). It first appeared as an abrupt widening of the trench itself but upon careful cleaning was seen to be a circular pit containing light grey sandy fill surrounded by dark grey sand with some brick rubble (Figs. 15 and 17A). On the south side of this feature a slight protrusion was present into which the bottom several inches of an open modern posthole protruded.

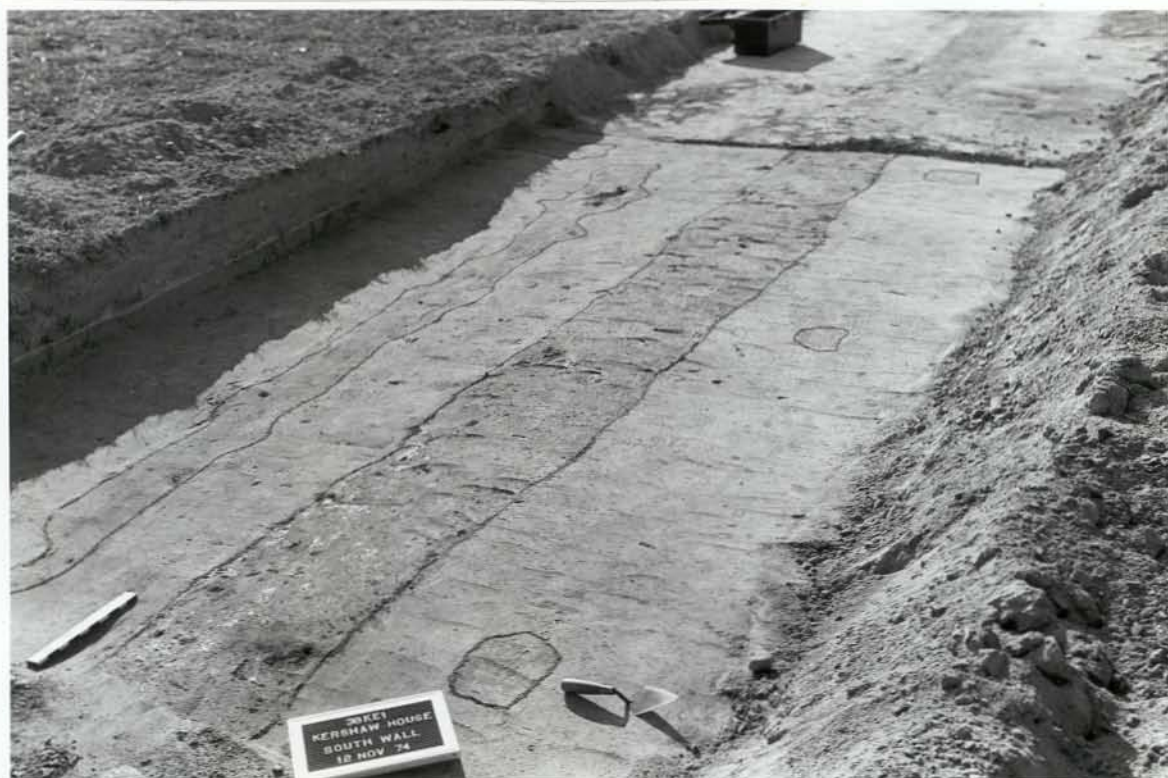
FIGURE 16: Feature 2 fully exposed prior to the excavation of the palisade wall trench. Viewed from the northeast.

A second feature at the Kershaw House was uncovered during the clearing of the south palisade trench. Approximately 25 feet west of the southeast corner of the wall trench evidence of a linear structure appeared, protruding from the edge of the grader cut and crossing the line of the palisade trench (Fig. 2). Feature 2 consists of a stain of dark grey soil which stood out markedly from the yellow sandy soil in which it lies (Fig. 16). It appears to represent one complete wall about 15 feet in length with portions of two other walls protruding from the edge of the grader cut. Three postholes approximately 7 feet apart are situated opposite the complete wall at a distance of 3.5 feet with the palisade trench passing between the postholes and the wall (Fig. 17B). No artifacts or brick rubble are associated with this feature.

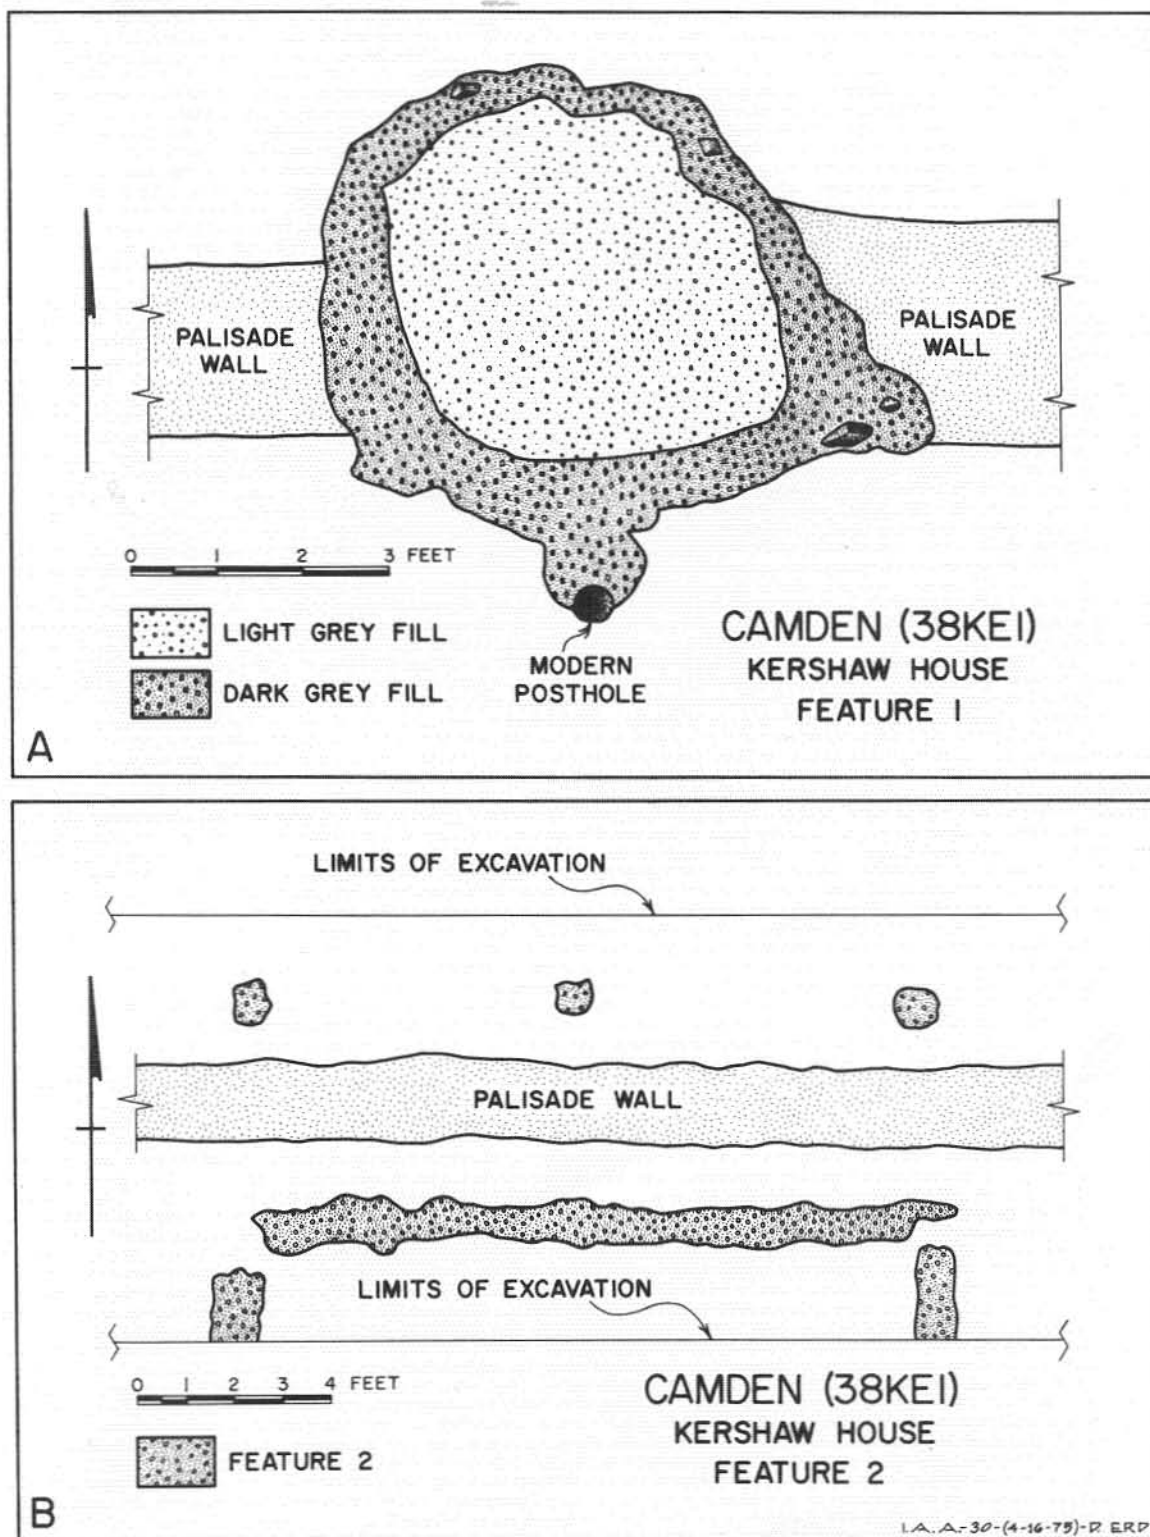
FIGURE 17: Plan of features at the Kershaw House palisade.
A: Feature 1; B: Feature 2.

was not investigated further. It very likely represents a wooden structure, the even tiered horizontal foundation members of which were placed directly on the ground. The presence of a gap near the corners suggests the use of either a shallow corner-post or the "hog-trough" method of corner construction. In the first case the horizontal members would have been set in grooved or morticed vertical posts, while in the second the horizontal members of two walls were secured by spikes or pegs to a vertical "trough" of heavy planks with its apex set in the corner. Horizontal construction with corner posts is generally found in those parts of the United States contiguous to Canada, however, it also occurs in the southern states of Tennessee and Virginia where it was apparently imported from Europe by German immigrants (Kniffen and Glassie 1966: 50-51).

The uneven nature of the stains also suggests the possibility of a vertical log wall composed of puncheons set side by side. The use of vertical planking to provide structural support in place of studding has English precedents, but was used most extensively in America by the French (Weslager 1969: 81). It is likely that the corners would be well-defined on structures of this type as the footing ditch in which the vertical planks were set would have to surround the entire structure except for entryways (see Maxwell and Binford 1961: 80).

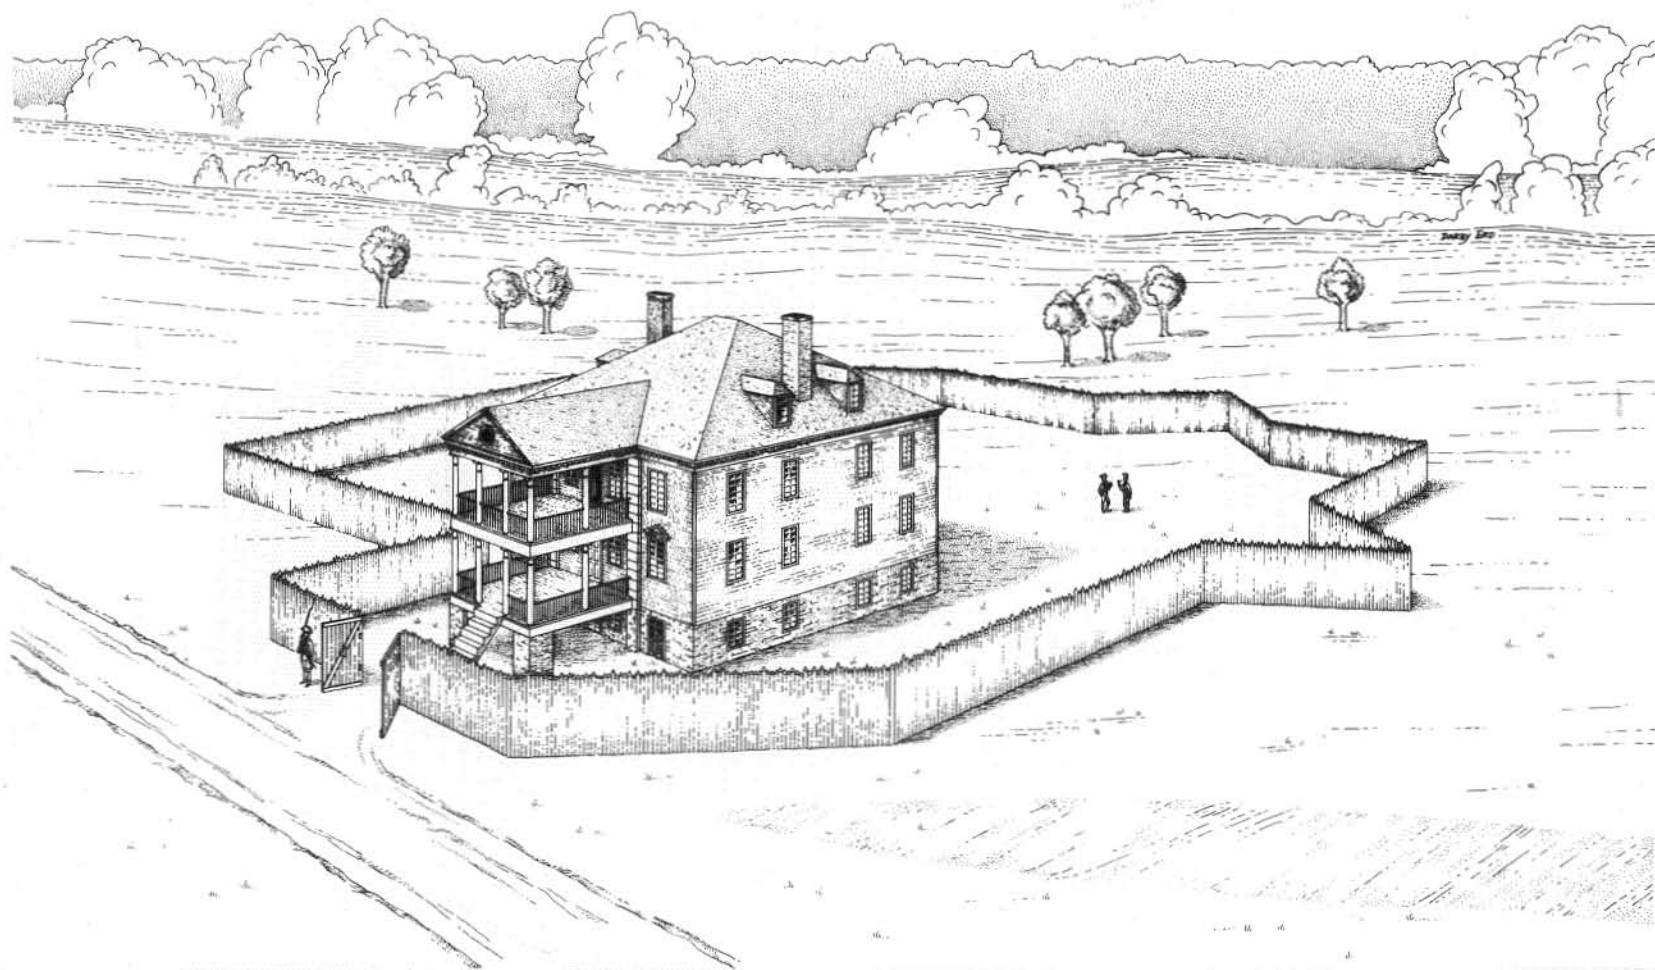
FIGURE 18: Conjectural view of the Kershaw House and palisade as they appeared during the British occupation of Camden, 1780-1781

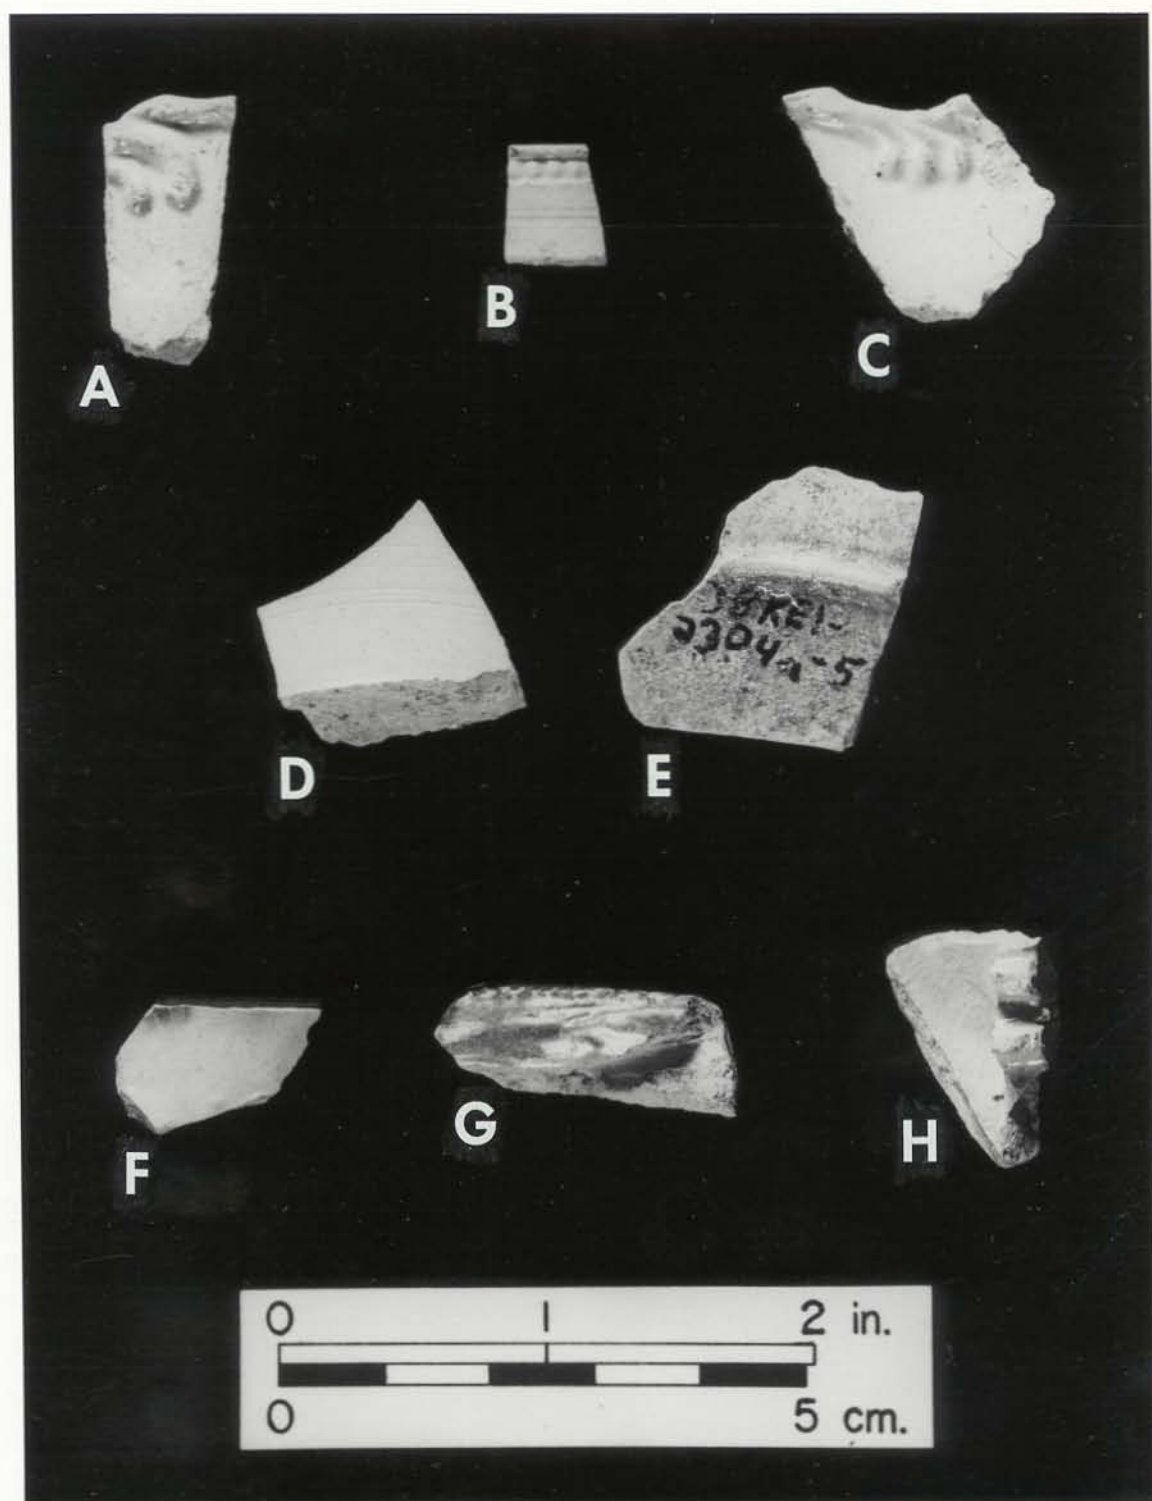
FIGURE 19: Carolina Cream-colored Ware from the Kershaw House: A) Feather-edge relief molding on plate rims; B) Pearl gadroon relief molding below rim; C) Feather-edge relief molding on plate rim; D) Parallel incised lines on vessel exterior; E) Bisque plate base with portion of ring foot visible; F) Monochrome mottled underglaze decoration on vessel exterior; G) Polychrome mottled underglaze decoration on vessel rim; H) Teapot strainer and portion of spout. Straining holes are visible along right edge.

All exhibit a deep cream color and the past is similar to the other Camden specimens. Two sherds exhibit the mottled underglaze decoration characteristic of tortoise shell ware, one specimen being green and the other purple (Fig. 19). It is difficult to determine the forms of the vessels represented by these fragments due to the small size of the latter. Cups, bowls, and plates are definitely represented. A teapot is indicated by a single sherd which contains a portion of the spout and strainer (Fig. 19). Three of the holes through which the tea passed are still intact. The spout itself appears not to have been round in cross-section, for the edge between two flat surfaces is visible. The faceted spout was apparently hand-carved to simulate a molded piece as were specimens from teapots manufactured in Bethabara, North Carolina (South 1967: 46, Fig. 6). The only decorative elements present on the collection of cream-colored sherds are pearl gadrooning, on what appear to be vertical-walled vessels, and the feather edge motif molded in relief on plate edges. Both of these decorative elements have been found on cream-colored wares made in North Carolina and on those found previously at Camden (South 1971: 177).
