A Functional Study of the Kershaw House Site in Camden, South Carolina

*Kenneth E. Lewis
Research Manuscript Series, No. 110*

Prepared by the
INSTITUTE OF ARCHEOLOGY AND ANTHROPOLOGY
UNIVERSITY OF SOUTH CAROLINA
April, 1977

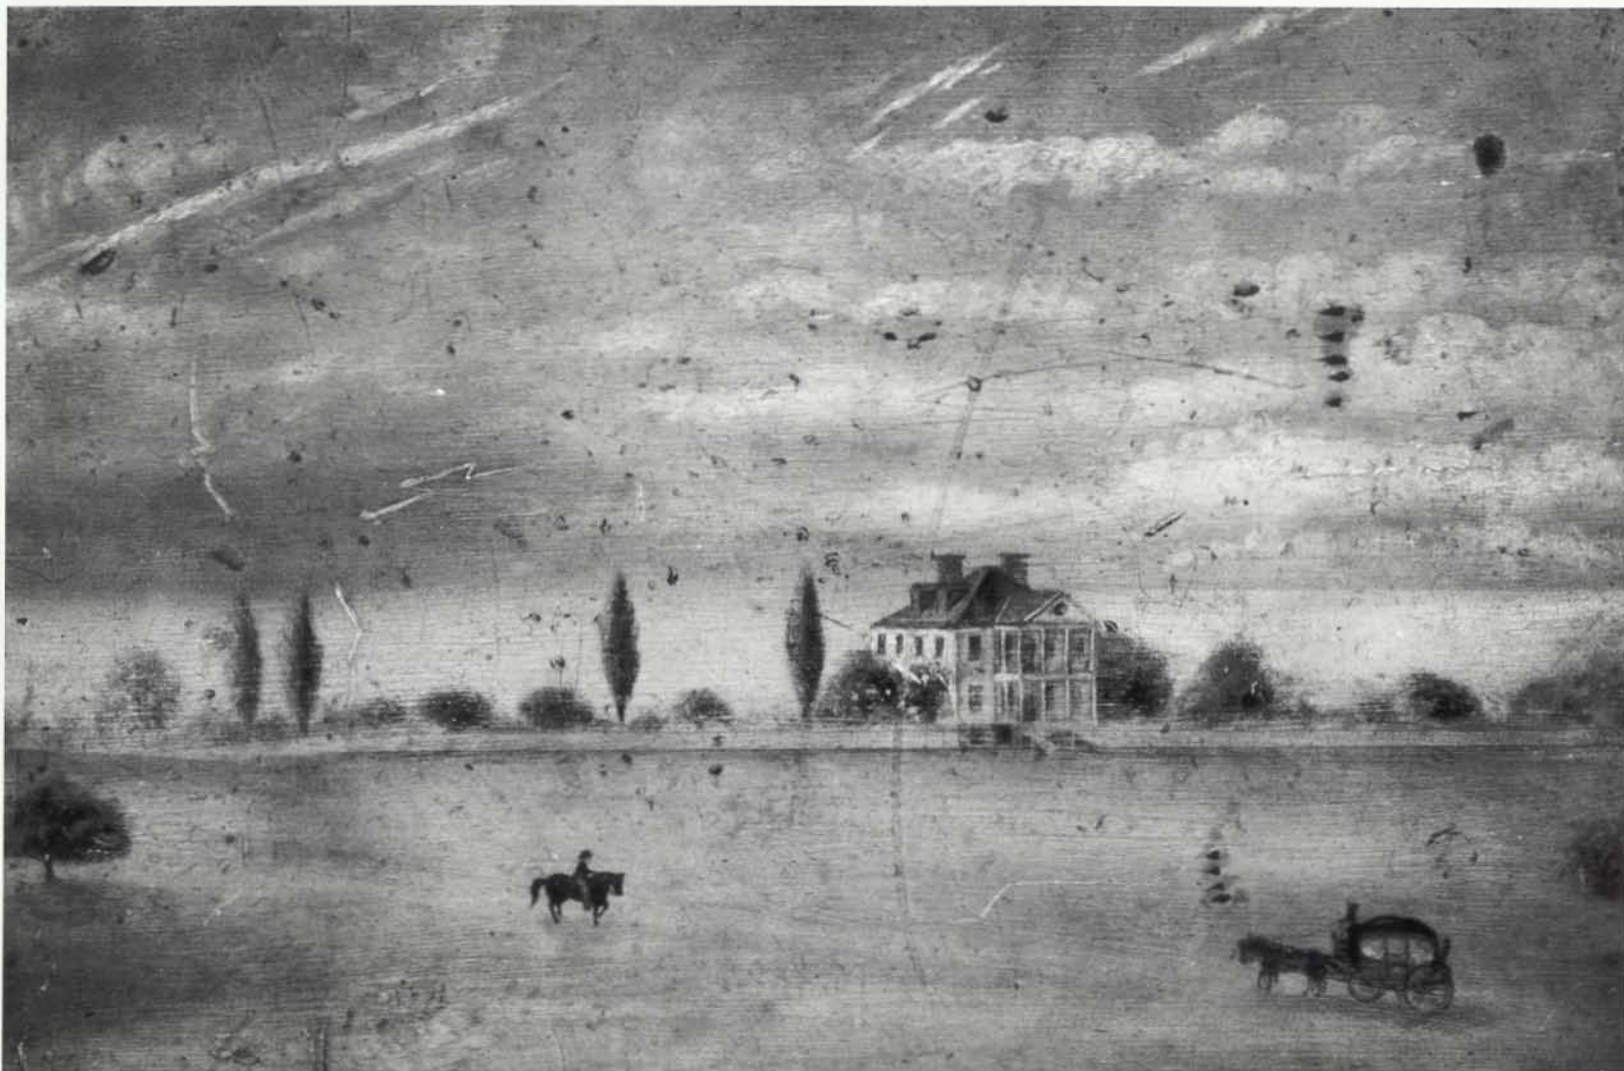
FIGURE 4: Early Nineteenth Century Painting of the Kershaw House. This Picture is the Work of I. B. Alexander and is Believed to Have Been Done in the 1830s. (Source: South Caroliniana Library, University of South Carolina.)

Kirkland and Kennedy (1905: 274) describe the house as "...a large, and, for the times, very elegant mansion of many rooms and passages, three stories high with spacious attics."* A painting made of the building in the early nineteenth century shows it to have been a square, five bay structure with a hipped roof. Its facade was set off by a two-stage pedimented portico (Fig. 4).

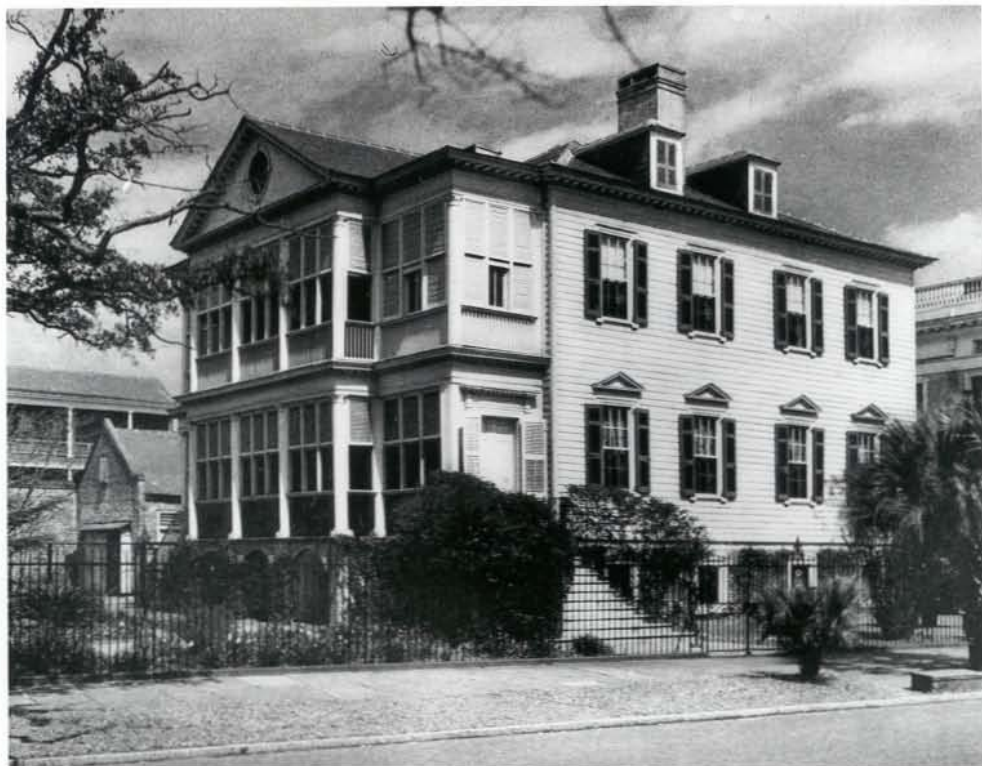
FIGURE 6: The William Washington House, Charleston, South Carolina. (Source: Simons and Lapham 1927.)

A comparison of the Kershaw house with contemporary structures reveals a strong similarity between it and the William Washington house (Fig. 6) situated on South Battery and Church Streets in Charleston (Henry Boykin, personal communication). This house was built by Thomas Savage about 1768, at least several years prior to the construction of Joseph Kershaw's house in Camden. The house takes its name from Colonel William Augustine Washington of Revolutionary War fame who purchased it in 1786. It is a large, square, "double" house of frame construction, with piazzas in front and rear, standing atop a brick basement (Huger Smith and Huger Smith 1917: 190). Another Charleston house of similar appearance is the Miles Brewton house at 27 King Street, built about 1765 (Fig. 7). It is nearly identical to the William Washington house in size and form, however, it is of brick rather than frame construction (Huger Smith and Huger Smith 1917: 93). Given the social and economic ties Kershaw maintained with Charleston together with the central cultural role that city played as entrepot to the frontier, it would not seem incongruous for him to have chosen a Charleston house as the prototype for his frontier mansion.

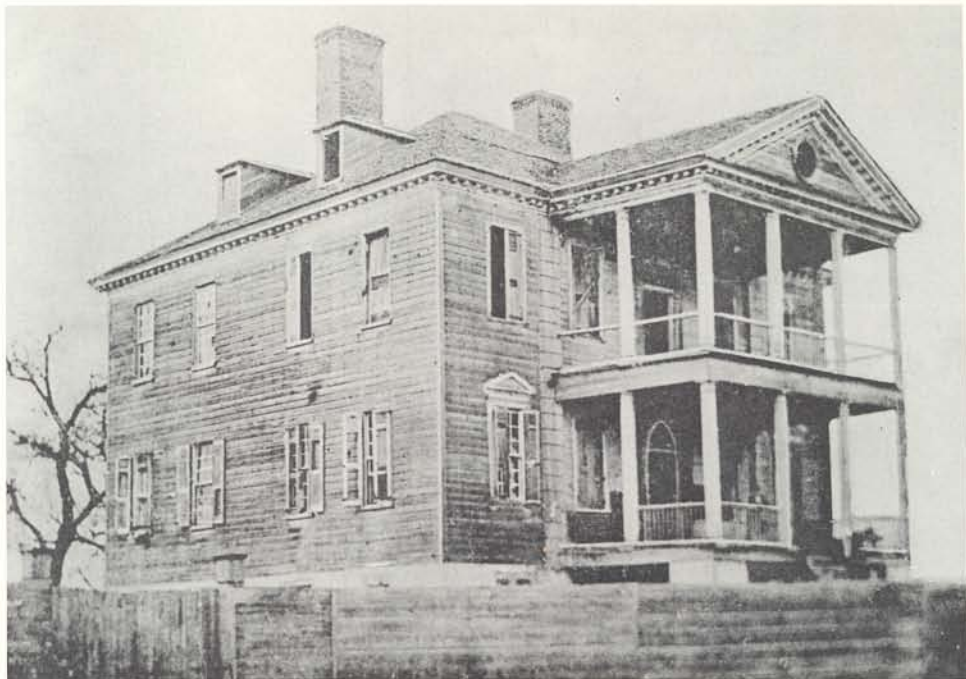
FIGURE 9: Photograph of the Kershaw House in the Decade Prior to the Civil War. (Source: South Caroliniana Library, University of South Carolina.)

Although the house itself was abandoned as a residence, another account of this period states that a man and his wife, presumably caretakers, lived in the backyard, probably in an outbuilding. The house is also described as having been surrounded by a fence at this time (Unnamed Newspaper 1912). Both the fence and the dilapidated condition of the house may be seen in Figure 9.

The remains of a row of brick piers were uncovered that paralleled the east wall of the house foundation at a distance of 8.0 feet. Three roughly square piers are arranged in a row to either side of a rectangular pier (Fig. 22). The placement of these supports indicates the presence of a rear porch that extended across the entire width of the house. A stairway is likely to have been supported by the rectangular center pier and presumably extended outward into the yard. Excavations to the rear of the house, however, uncovered no evidence of a stairway footing. Although archeological evidence indicates that a rear porch was at one time present on the Kershaw house, the absence of a porch in the photograph of that structure (Fig. 9) suggests that it was removed prior to the building's destruction.

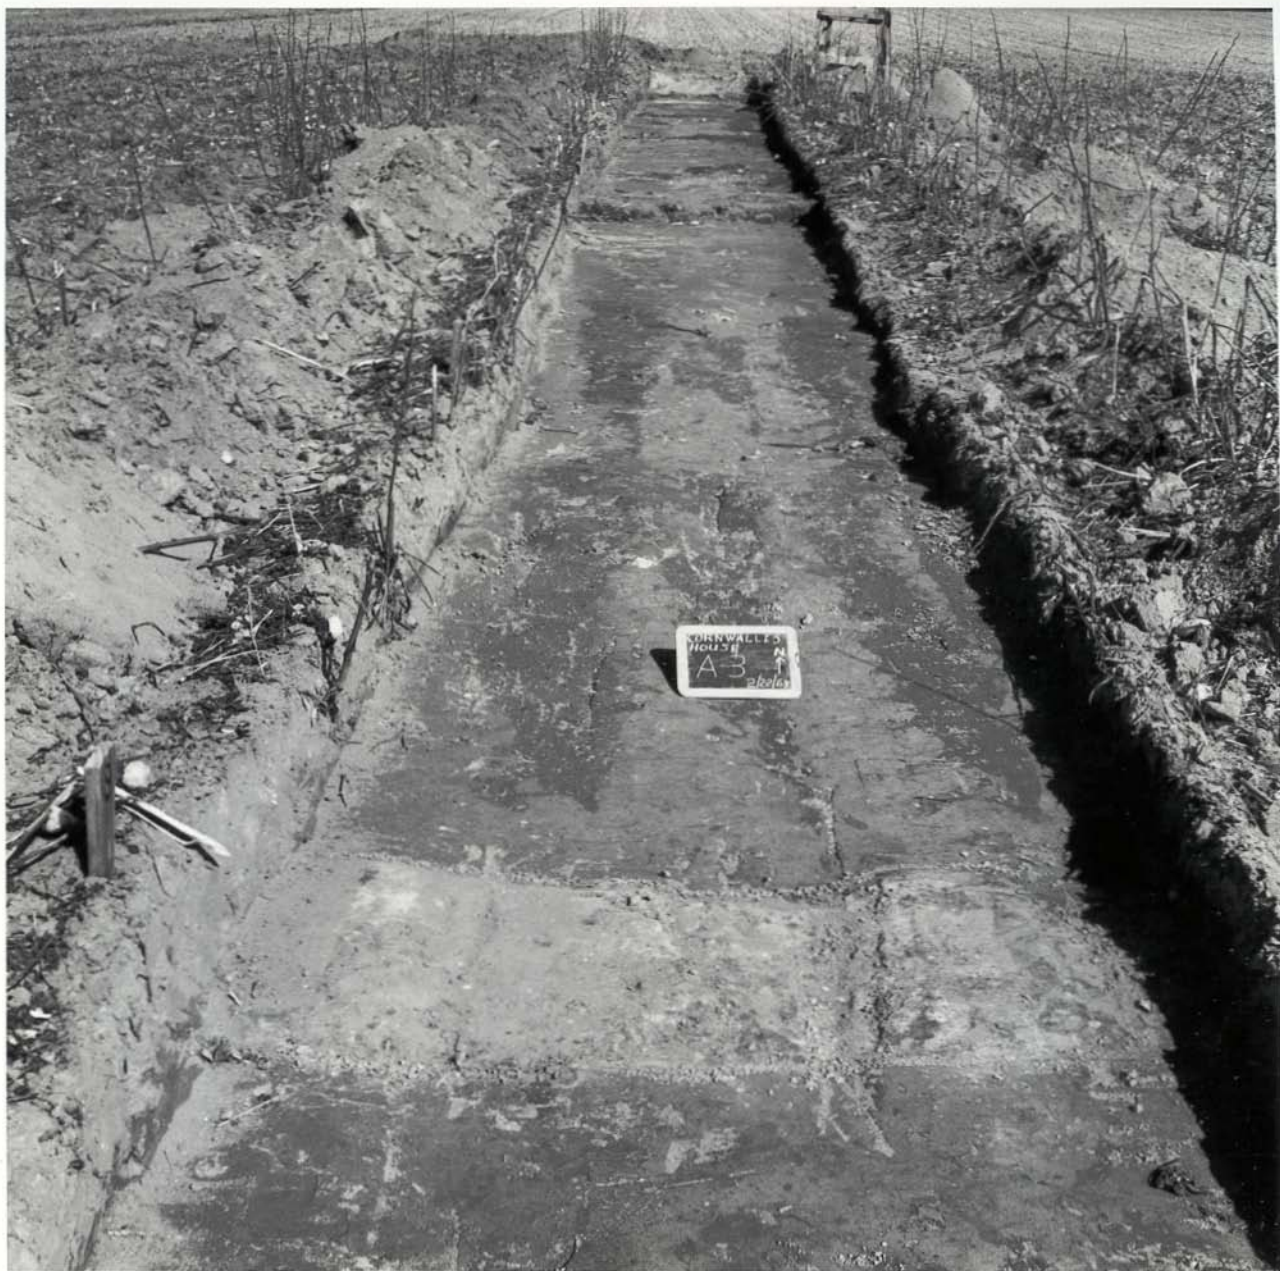
FIGURE 12: Calmes' North-South Trench Through the Kershaw House Structure.

Calmes excavated a 5.0 foot wide trench in a north-south direction hoping to intersect the walls of the house. This trench revealed a two layer soil profile consisting of "plow disturbed soil" about 0.75 foot in depth underlain by a "sterile soil" (Calmes 1968: 14).^{*} The foundations of the structure as well as other intact cultural features were visible at the base of the upper layer and extended into the sterile zone (Fig. 12). Architectural features uncovered in this initial excavation included foundation footing ditches filled with brick and mortar rubble to a depth of 1.0-1.5 feet and a section of trench, 1.5 feet wide and 2.5 feet deep, filled with a mixture of sand and clay. A second exploratory trench oriented perpendicular to the first, uncovered portions of footing trenches as well as a section of intact brick wall two brick lengths thick and extending five courses beneath the top of the sterile soil.

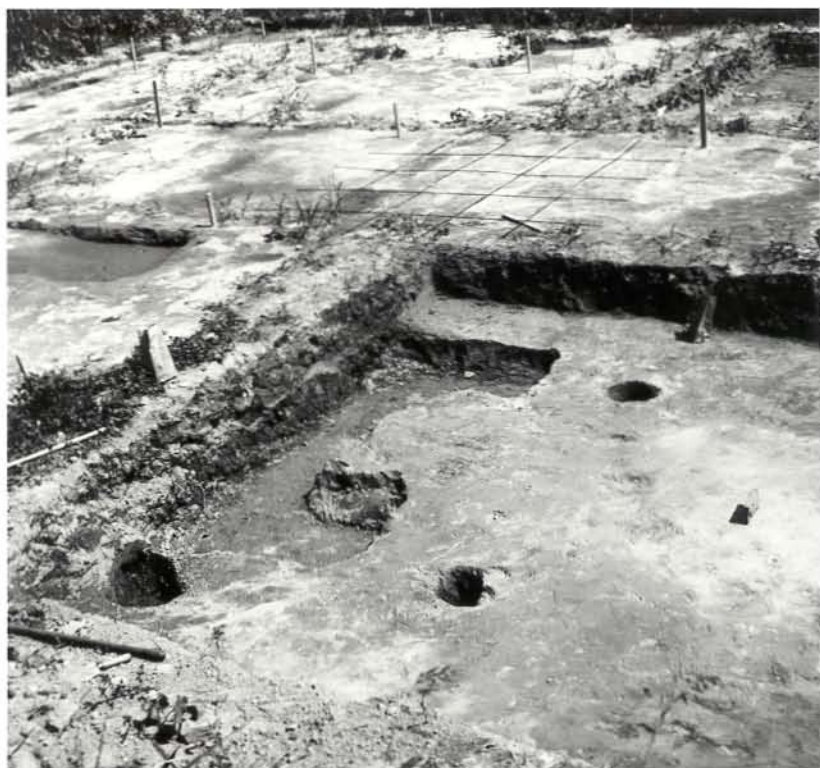
FIGURE 21: Fireplace Footings in the Kershaw House.

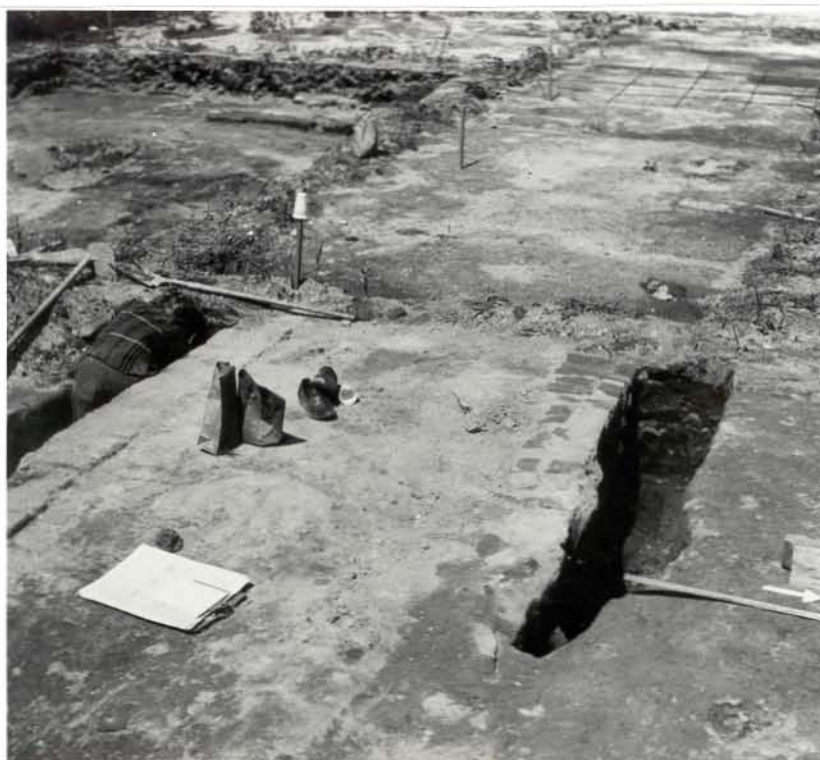
FIGURE 22: Brick Foundations Beneath the Kershaw House Porch.

The remains of two L-shaped piers located 14 feet west of the foundation and 25 feet apart provide evidence of a front porch facing Lyttleton Street. Portions of two brick porch support walls 1.0 foot thick extend outward from the foundation in line with the walls of the central hallway (Fig. 22).

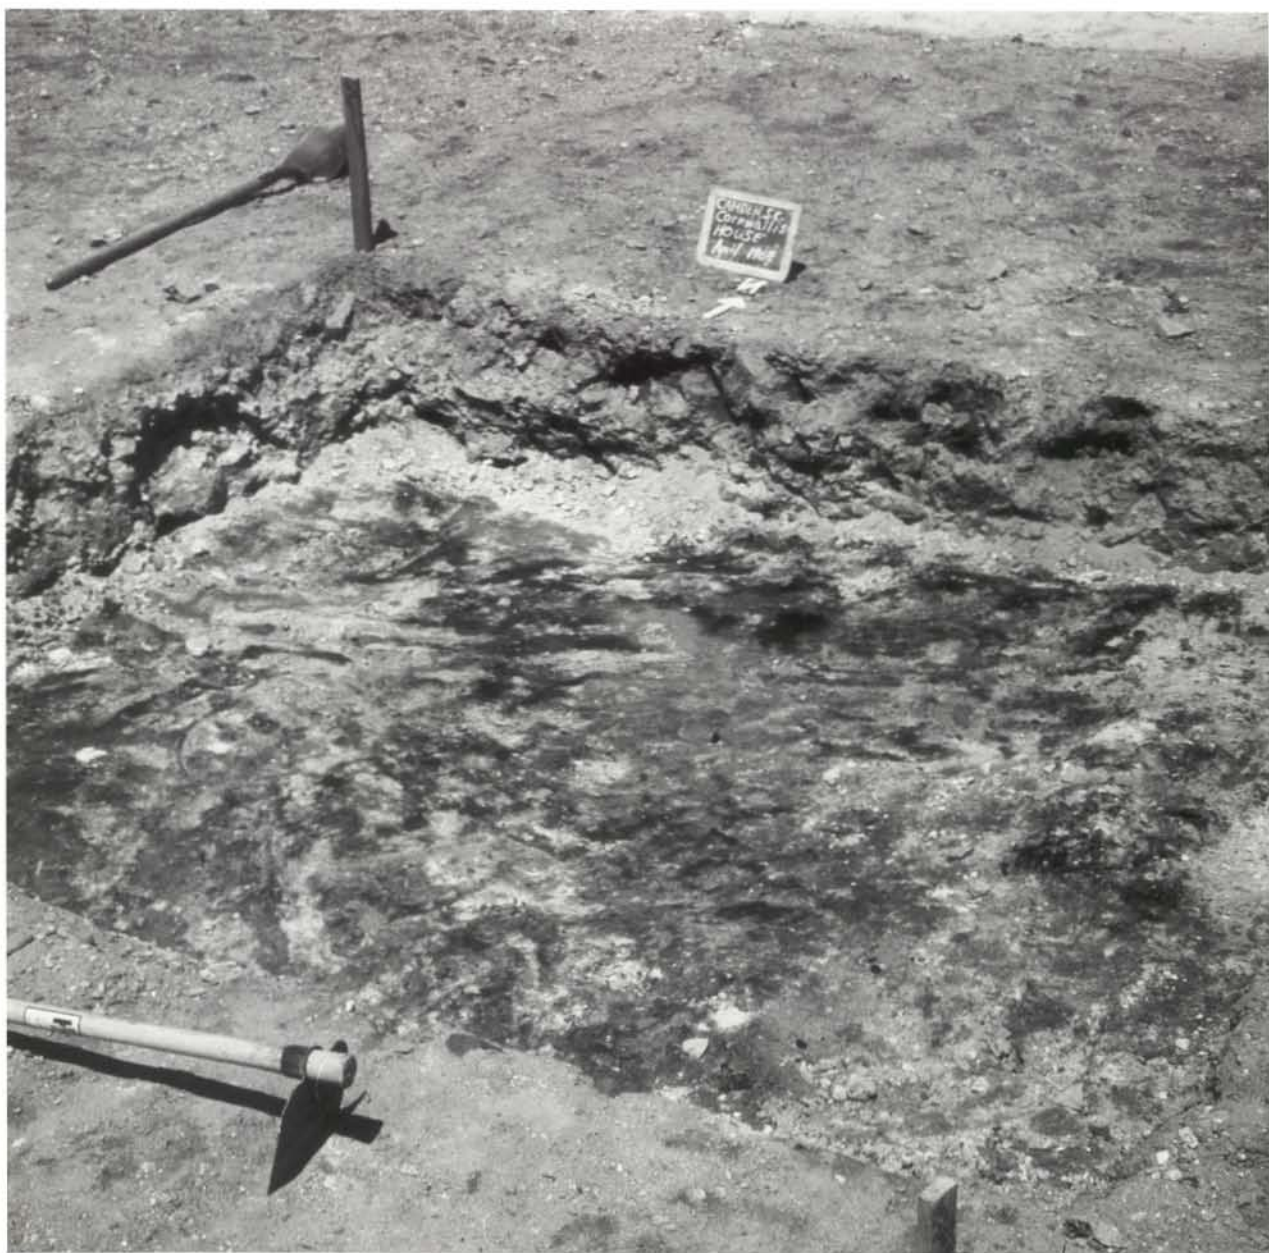
FIGURE 24: Photograph Showing Layers of Burned Debris in the Kershaw House.

Although it is uncertain who held the torch, documentary sources agree that the Kershaw house was destroyed by fire in February 1865, while serving as a storehouse for Confederate supplies. Archeological evidence of the building's destruction by fire will consist of the presence of materials that have been altered by burning. These should consist of the by-products of the destruction of flammables, mainly ash and charcoal. Other materials with melting points low enough to be deformed by heat, such as glass and metals, should be present in their distorted form. Many other substances, like ceramics, brick, and stone, normally unaltered by intense heat, may exhibit evidence of scorching, breakage, or discoloration due to their exposure to fire.

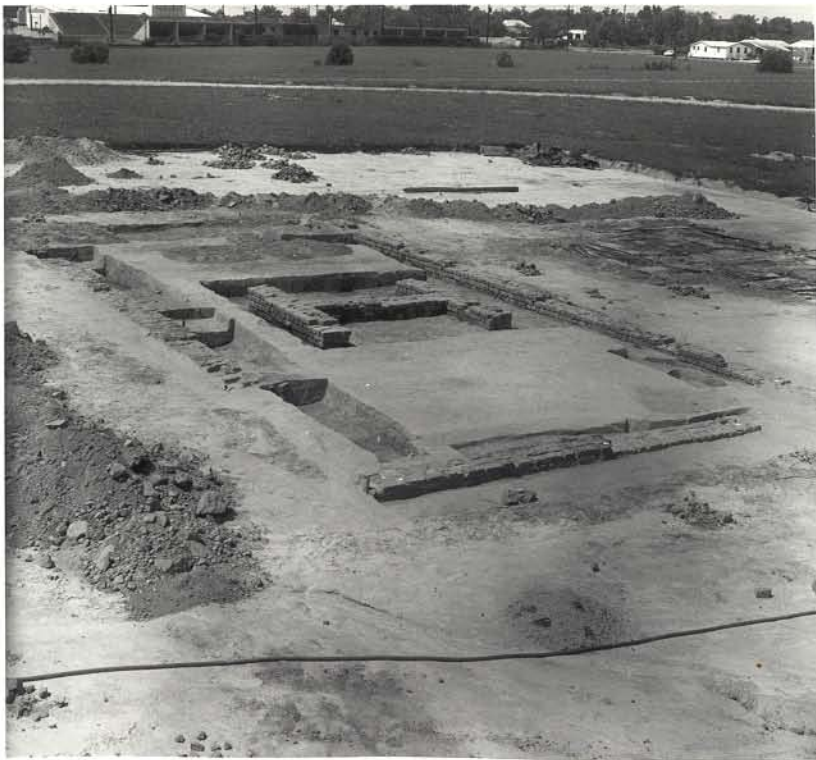
FIGURE 29: Excavated Foundations of the Saddlebag Structure Viewed From the Southeast.

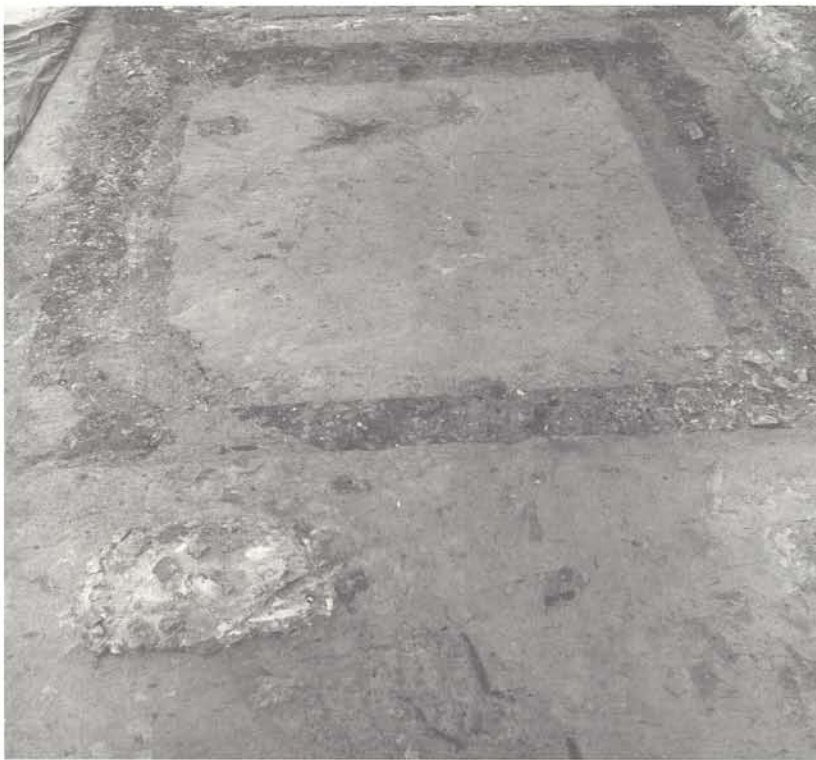
FIGURE 30: Archeological Remains of the Structure Intersecting the Palisade From the South.

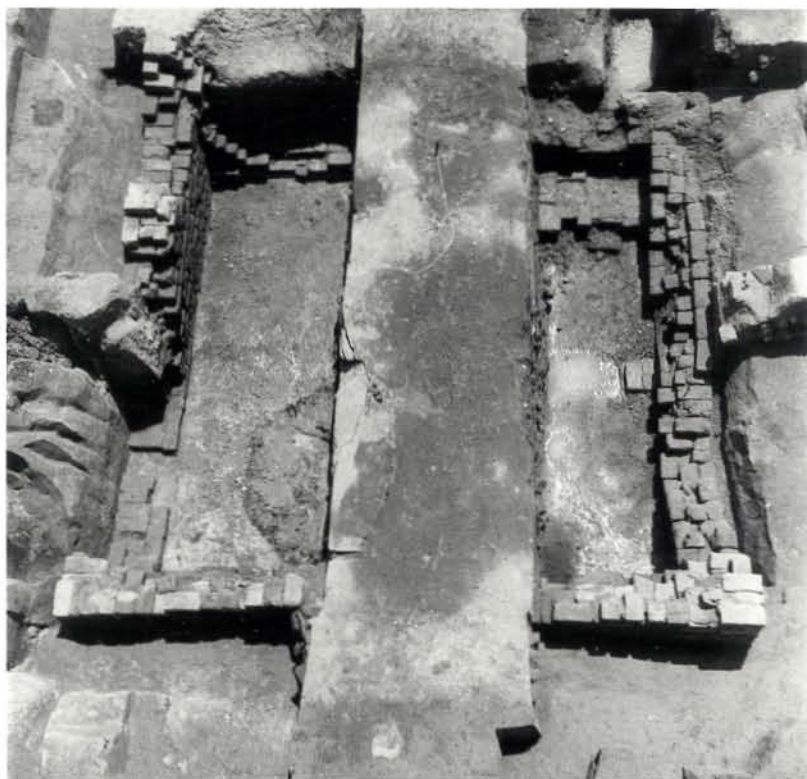
FIGURE 31: The Cellar Structure Viewed From the West. The Unexcavated Well is Visible in the Lower Left Corner Partially Obscured by the Central Balk.
