## Recent Advances in Piezoelectric Wafer Active Sensors for Structural Health Monitoring Applications

Published in *Sensors*, Volume 19, Issue 2, 2019, pages 1-21.

# Recent Advances in Piezoelectric Wafer Active Sensors for Structural Health Monitoring Applications

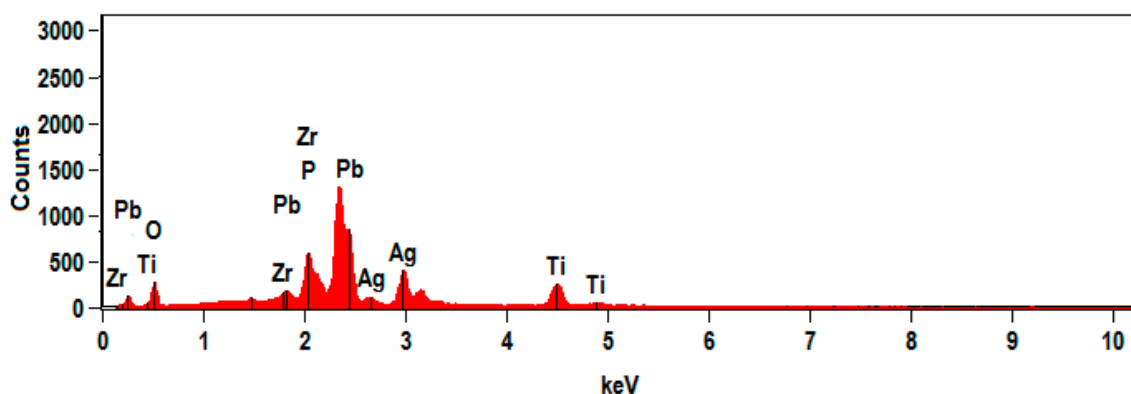
**Figure 1.** Energy-dispersive spectroscopy (EDS) spectrum of the lead zirconate titanate (PZT) piezoelectric wafer active sensors (PWAS).

In this section, PWAS transducers made with piezoelectric material lead zirconate titanate ( $\text{PbZrO}_3\text{TiO}_3$  or PZT) were investigated. PZT exhibits large electromechanical coupling coefficients and piezoelectric constants [65]. For PZT-PWAS, APC 850 type transducers [66] were used in this research. The PZT-PWAS transducer is circular in shape, and the diameter is 7 mm. The wafer has a PZT thin film with Ag electrodes on both sides. The thickness of the PZT-PWAS transducer is 0.2 mm. Energy-dispersive spectroscopy (EDS) was done on the PWAS transducer to obtain chemical compositions of the PWAS. Figure 1 shows the EDS spectrum of PZT-PWAS. The figure confirms that PZT-PWAS contains lead (Pb), zirconium (Zr), titanium (Ti), oxygen (O), and silver (Ag) electrode.

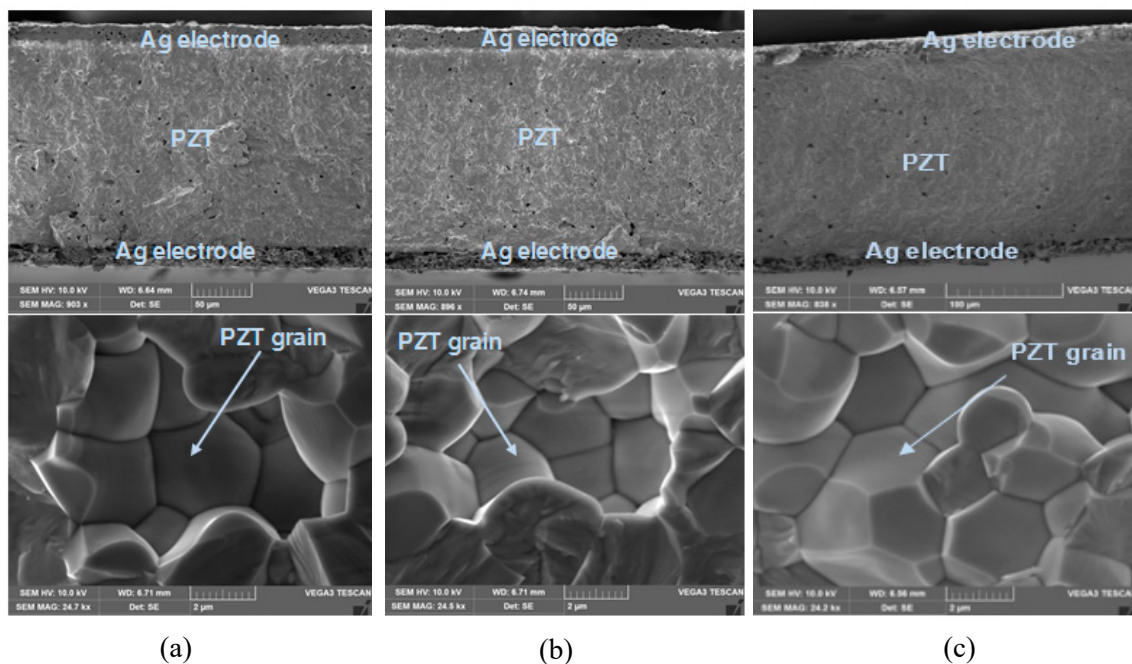
**Figure 2.** Scanning electron microscopy (SEM) image of the cross-section of PZT-PWAS: (a) at room temperature; (b) after exposure to 250 °C temperature; (c) after exposure to 225 kGy nuclear radiation.

and radiation. The PZT material used in a PWAS transducer is a ferroelectric material. For most ferroelectric materials, the existence of a domain structure or domain wall makes a significant influence on the material properties. In a PZT solid-solution system, the material properties may be changed, due to the change in the domain size and the domain wall motion [67–69]. In addition, the PWAS transducers are susceptible to damage after exposure to harsh environments. A scanning electron microscopy (SEM) was also done to visualize the microstructure of the PWAS. Figure 2 shows the cross-section of PZT-PWAS: (a) at room temperature; (b) after exposure to 250 °C temperature; and (c) after exposure to 225 kGy radiation. There are no significant changes in the microstructure or PZT grain after exposure to high temperature and radiation. Hence, PWAS can be integrated into the SHM system for successful damage detection.

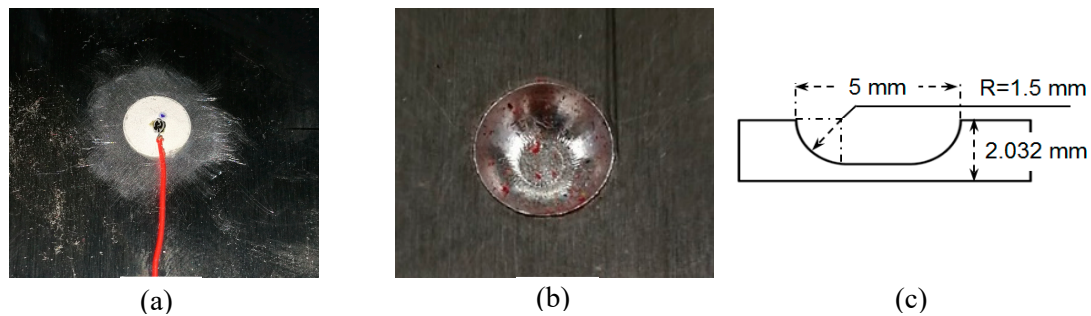
**Figure 3.** Experimental setup: (a) a circular PWAS; (b) corrosion damage; (c) schematic of the corrosion damage.

In this experiment, a 2.032 mm 2024-T3 aluminum plate was examined. The material properties are given in Table 1. A simulated corrosion damage was made on the 2024-T3 aluminum plate to study the damage detection by using the PWAS active sensing method, as shown in Figure 3.

To excite Lamb waves in the aluminum plate, a circular PWAS (APC 850, 7 mm in diameter and 0.2 mm thick) was bonded on the top surface as the excitation source. Figure 4 shows the schematic of the experimental setup. The function generator was used to generate a three-count Hanning window

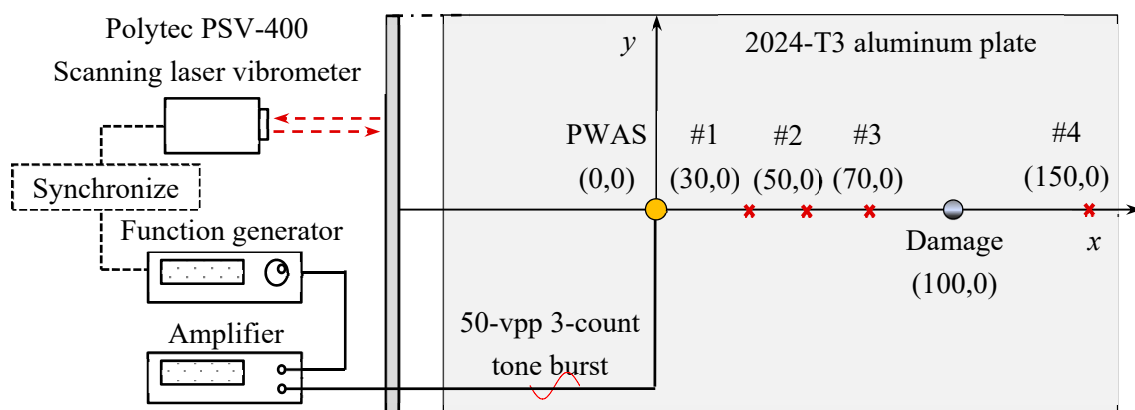
**Figure 4.** Schematic of an experimental setup using PWAS and scanning laser Doppler vibrometer (SLDV) for damage detection.

Under electrical excitation, the PWAS generates Lamb waves in the aluminum plate. Lamb waves propagate with an out-spreading pattern, interact with damage, undergo scattered and mode conversion, and are finally picked up by a Polytec PSV-400-M2 scanning laser Doppler vibrometer (SLDV). The quantity measured by the SLDV is the out-of-plane velocity of the bottom surface. Reflective tape was used to improve the signal quality. In the experiment, a line scan and an area scan on the specimen surface were carried out to detect the corrosion damage. The locations of the circular PWAS, corrosion damage, and special recording points are illustrated in Figure 4.

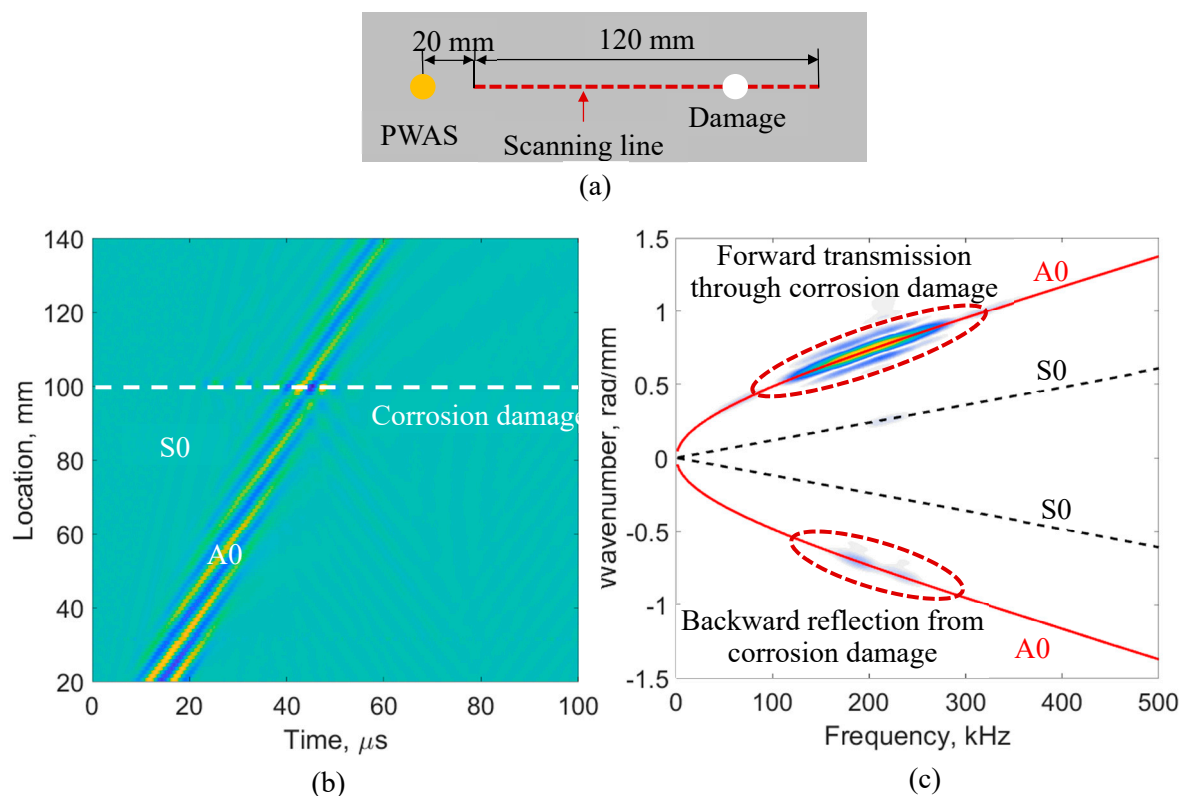
**Figure 5.** SLDV line scan for a 2.032-mm 2024-T3 aluminum plate: (a) schematic of the SLDV line scan; (b) time-space wavefield at 200 kHz; (c) frequency-wavenumber dispersion curves.

In the experiment, the time-space Lamb wave data was obtained from the SLDV line scan, as shown in Figure 5a. To obtain the experimental frequency–wavenumber dispersion curves, the measured time–space wavefield  $u(t, x)$  was transformed into the frequency–wavenumber domain by applying a two-dimensional (2D) fast Fourier transform (FFT). Figure 5b,c show the time–space wavefield and the corresponding frequency–wavenumber dispersion curves, the wave transmission and reflection due to the corrosion damage can be clearly observed. Hence, the damage can be easily detected by using the wavefield analysis.

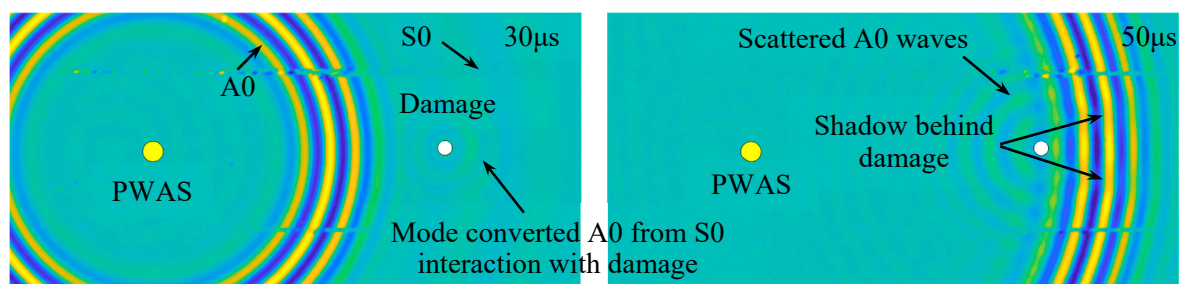
**Figure 6.** Spatial wavefield in the aluminum plate with simulated corrosion damage, showing S0 mode and A0 mode waves interacting with the corrosion damage.

In this section, an SLDV area scan was conducted to measure the wave interaction with the corrosion damage under PWAS excitation. Figure 6 shows a transient spatial wavefield in the plate. At 30  $\mu\text{s}$ , the fast propagating S0 mode with a long wavelength, and the slowly propagating A0 mode with a short wavelength could be identified. The mode-converted A0 waves could be noticed, propagating with a short wavelength from S0 interaction with the damage. At 50  $\mu\text{s}$ , after A0 waves interacted with damage, the scattered A0 waves could be observed, as well as the shadow behind the damage. Therefore, the damage could be visualized from the measured wavefield.

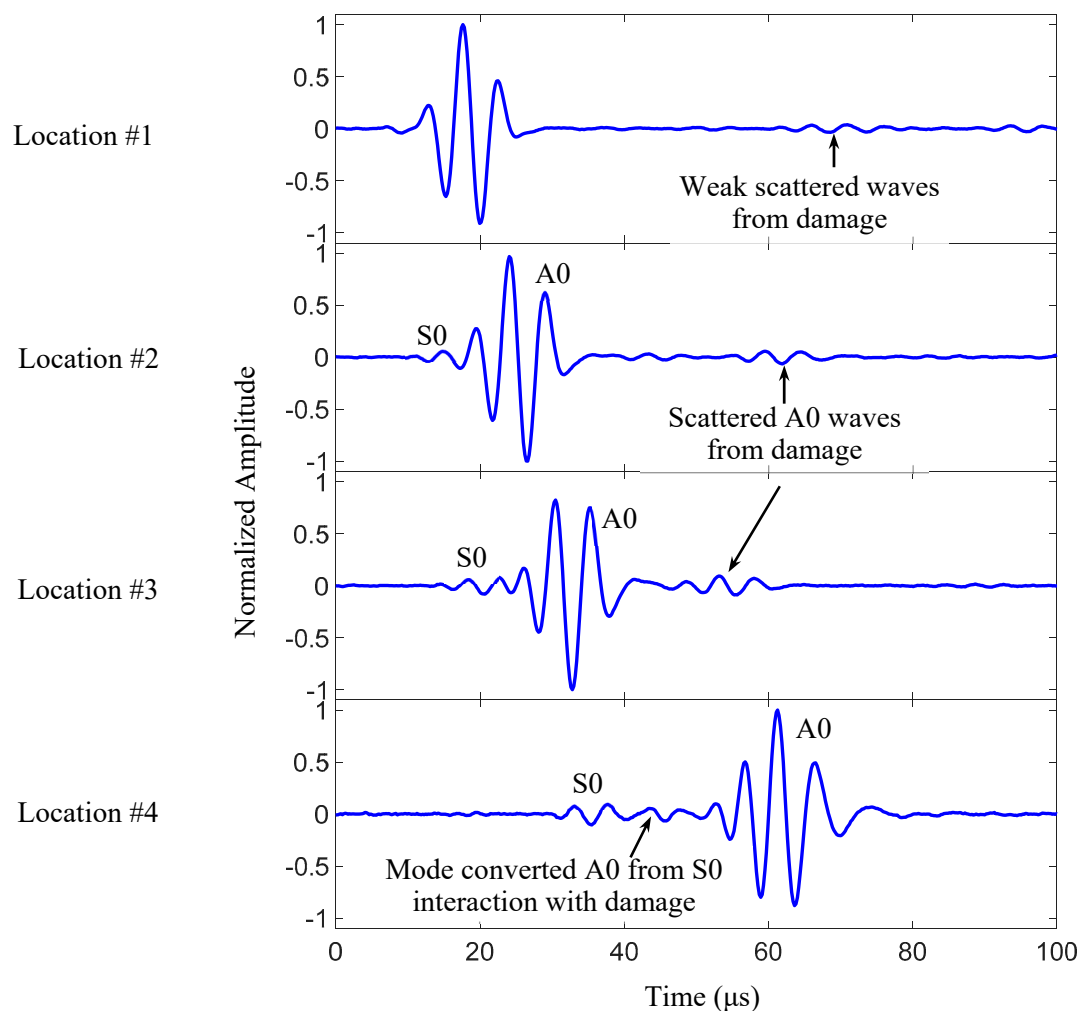
**Figure 7.** 200 kHz signals of the damaged plate at locations #1 through #4, shown in Figure 4.

Figure 7 shows the waveforms at various sensing locations for the 200 kHz excitation. The signals at location #1, #2, and #3 show that the scattered A0 wave amplitude increases when the sensing location moves closer to the damage. The signal at location #4 shows the mode-converted A0 wave packet from the S0 interaction with the damage.

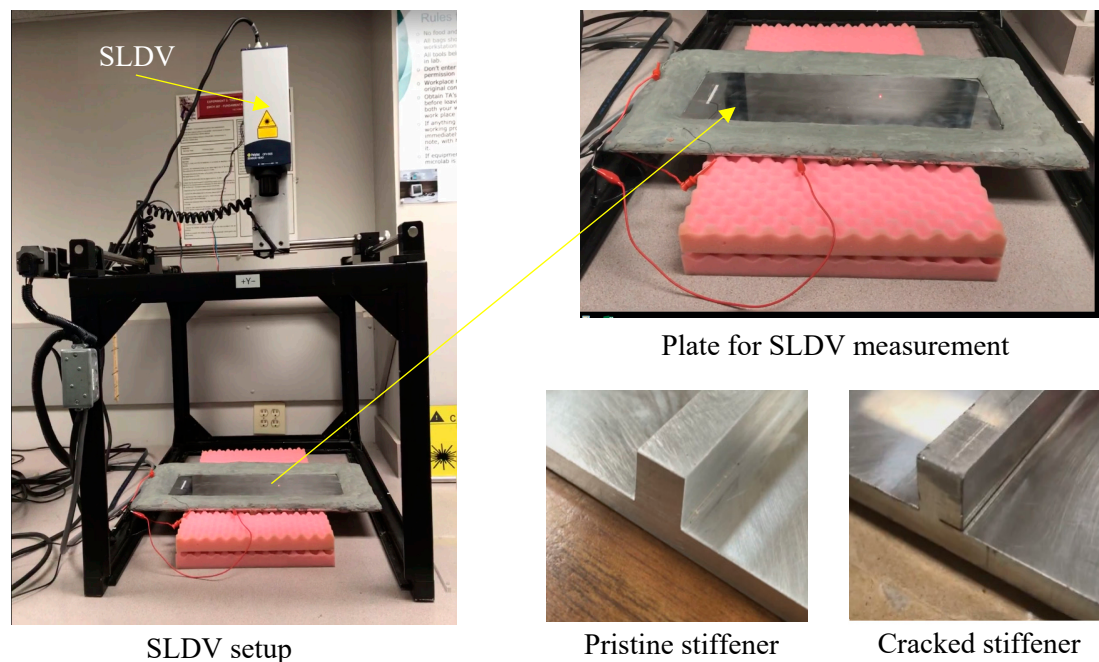
**Figure 8.** Experimental setup for the SLDV to measure the out-of-plane velocity of the scattered wavefields.

Two aluminum plates with a pristine stiffener and cracked stiffener were manufactured for the experimental study. Electrical discharge machining (EDM) method was used to create a crack along the entire length of the stiffener. The height and width of the stiffener is 8.47 mm. The thickness of the plate is 4.23 mm. For the crack stiffener, the crack width is half of the stiffener width, and the crack is present along the entire length of the stiffener (Figure 8). The experimental setup and the plates with pristine stiffener and cracked stiffener are shown in Figure 8. Two 60 mm × 5 mm × 0.2 mm PWAS transducers were bonded in a straight line on the top and bottom surfaces of the plate to create a line source. On both plates, the PWAS transducers were bonded 200 mm away from the stiffener. Two PWAS were excited simultaneously in opposite phase to generate A0 Lamb wave, selectively. The excitation signal is a three-count tone burst at 150 kHz generated by a Tektronix AFG3052C dual channel function generator. A power amplifier was used to amplify the excitation signal, which strengthens the reflected and transmitted signal from the discontinuity or damage. To create non-reflecting boundary condition, absorbing clay was applied all around the plate boundaries.

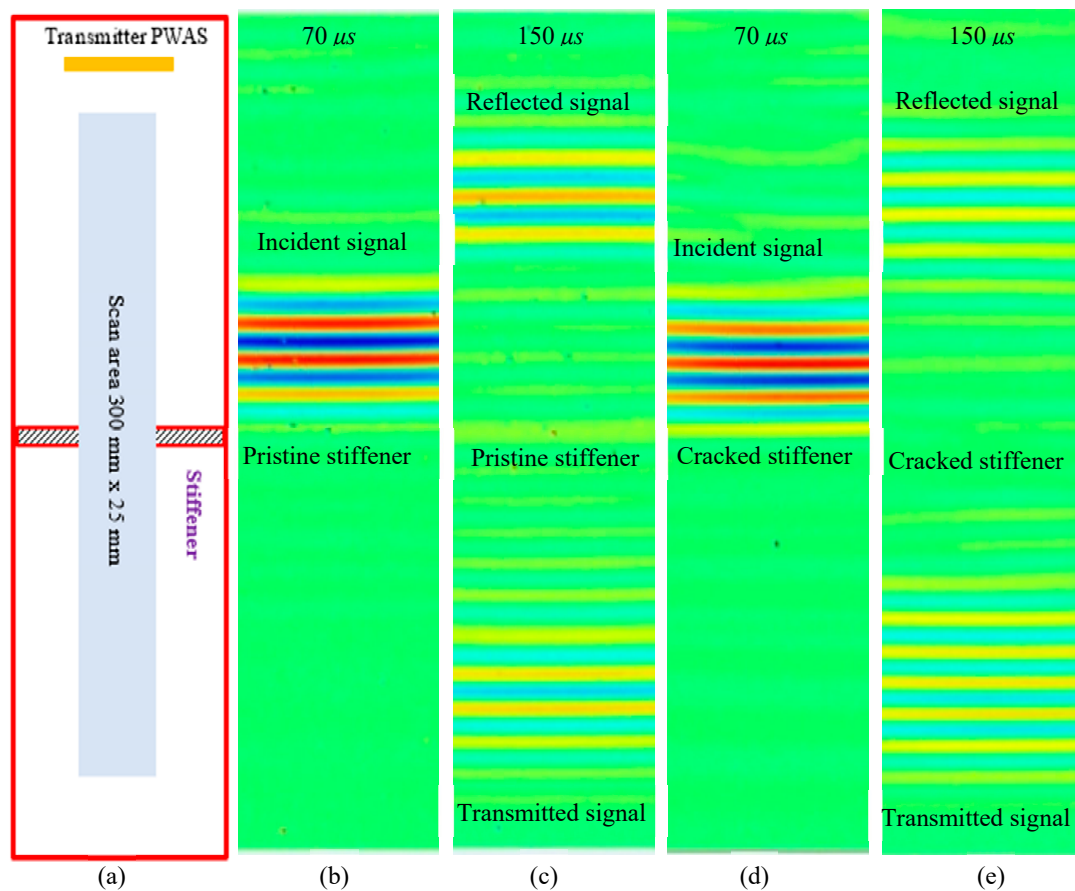
**Figure 9.** Experimentally measured scattered wavefields using SLDV: (a) scan schematic; (b) incident wave and (c) reflected and transmitted waves from pristine stiffener; (d) incident wave, and (e) reflected and transmitted waves from the cracked stiffener.

The wavefields were measured using SLDV. Figure 9a is the schematic of the SLDV measurement. Figure 9b–e show the reflected and transmitted wavefields for the pristine stiffener and cracked stiffener, respectively. It can be found that the long PWAS transducers can successfully generate the straight crested A0 mode Lamb wave. It also shows a minimal reflection from the plate edges, due to the use of absorbing clay. In addition, these figures show that the scattered wavefields are also straight crested waves after interacting with the discontinuity, as expected.

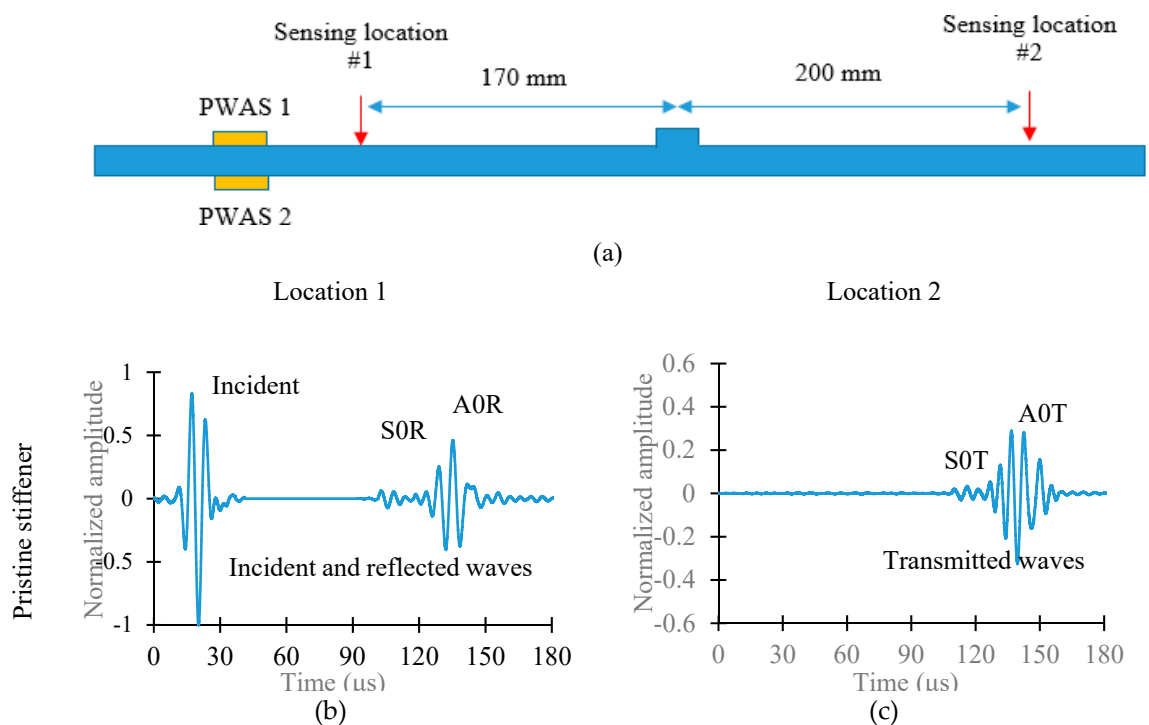
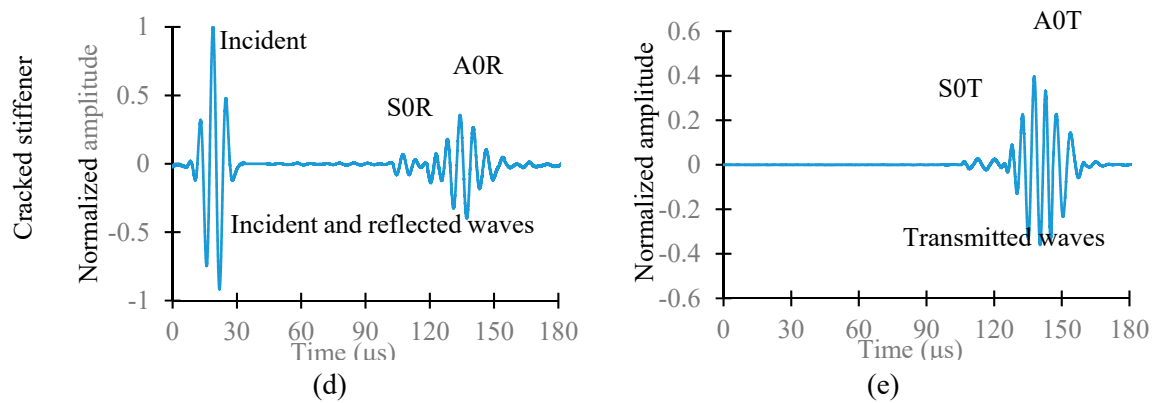
**Figure 10.** Cont.

**Figure 10.** (a) Schematic diagram of the sensing locations; (b) incident and reflected Lamb waves from pristine stiffener; (c) transmitted Lamb waves from the pristine stiffener; (d) incident and reflected Lamb waves from cracked stiffener; (e) transmitted Lamb waves from cracked stiffener.

Figure 10a shows the schematic diagram of the sensing locations. Sensing location 1 is 170 mm before the stiffener and the sensing location 2 is 200 mm after the stiffener. Figure 10b–e show the experimental scattered waveforms for the pristine and cracked stiffener, respectively. The corresponding fast Fourier transform (FFT) of the incident and scattered waves for the pristine and cracked stiffener are given in Figure 11.

The reflected and transmitted Lamb waves show a similar pattern in the time–domain signals for the pristine and cracked stiffener. However, the frequency response of the scattered signals shows a clear change in the amplitude of the scattered wavefields, due to the presence of the crack. Also, the shifting of the frequency spectrum due to the presence of the crack is an important phenomenon to note. The transmitted A0 Lamb wave has clear anti-resonance at 150 kHz for the cracked stiffener. Such information may be useful for crack detection in complex geometry.

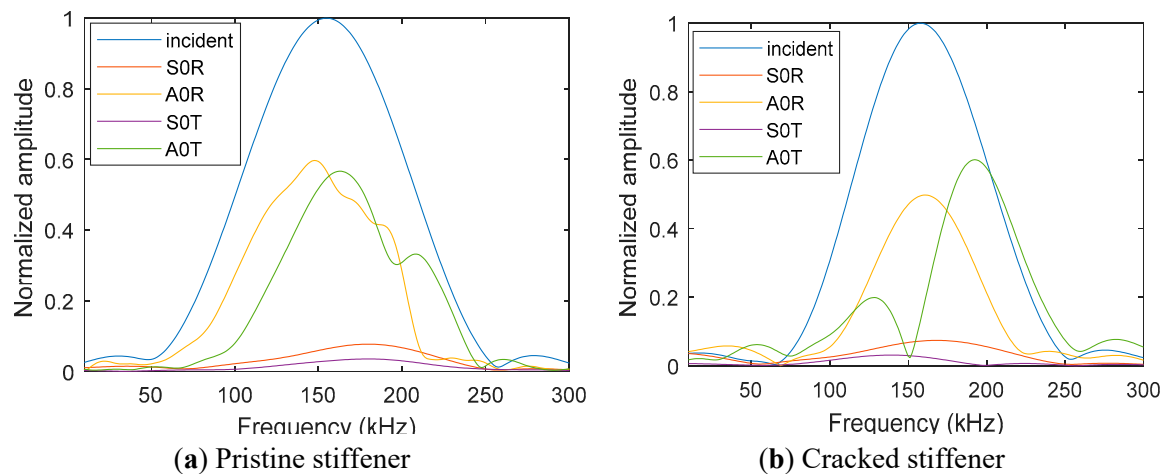
**Figure 11.** FFT of the incident and scattered Lamb waves: (a) pristine stiffener; (b) cracked stiffener.

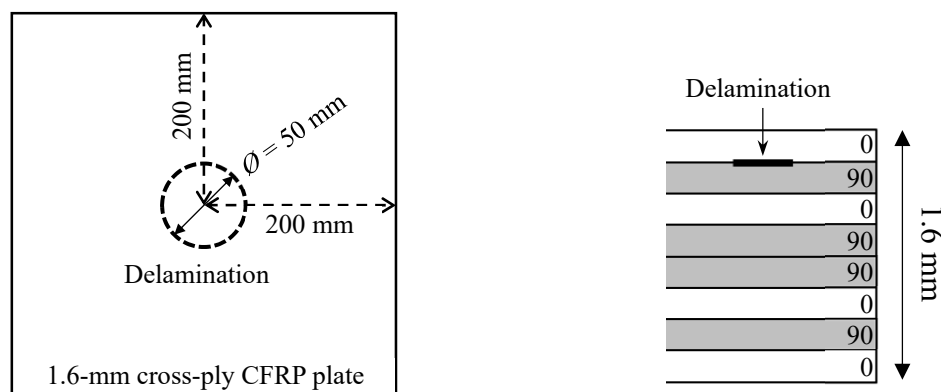
**Figure 12.** Schematic of a 1.6 mm cross-ply carbon fiber-reinforced polymer (CFRP) composite plate with circular delamination by inserting Teflon.

In this section, a 1.6 mm thick in-house cross-ply carbon fiber-reinforced polymer (CFRP) composite plate with a stacking sequence of  $[0/90]_{2s}$  was examined. The delamination is generated by inserting a 50 mm diameter Teflon film between the first ply and second ply during the ply lay-up process. Figure 12 shows the configuration of the composite plate. The engineering elastic properties of the unidirectional prepreg are given in Table 2.

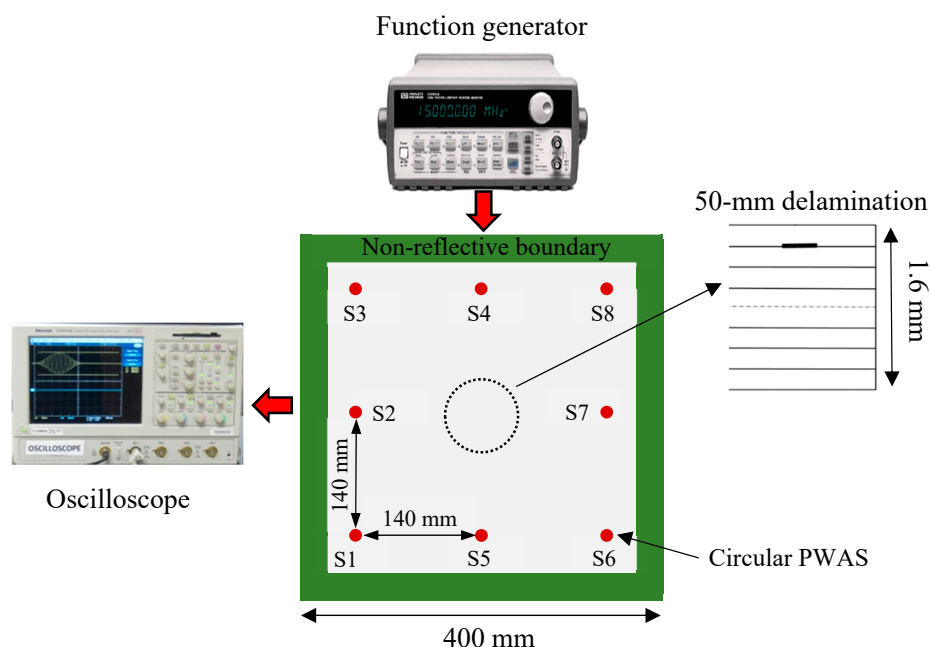
**Figure 13.** Experimental setup on the 1.6 mm cross-ply composite plate.

The experimental setup of using SHM techniques to detect the delamination in the composite plate is shown in Figure 13. Eight PWAS transducers were bonded onto the plate surface to form a sensor network. The diameter of each PWAS transducer is 7 mm, and the thickness is 0.2 mm. The clay was applied to the plate edges to absorb boundary reflections. An Agilent 33120A function generator was used to generate the excitation signal. The response signals were recorded by an oscilloscope.

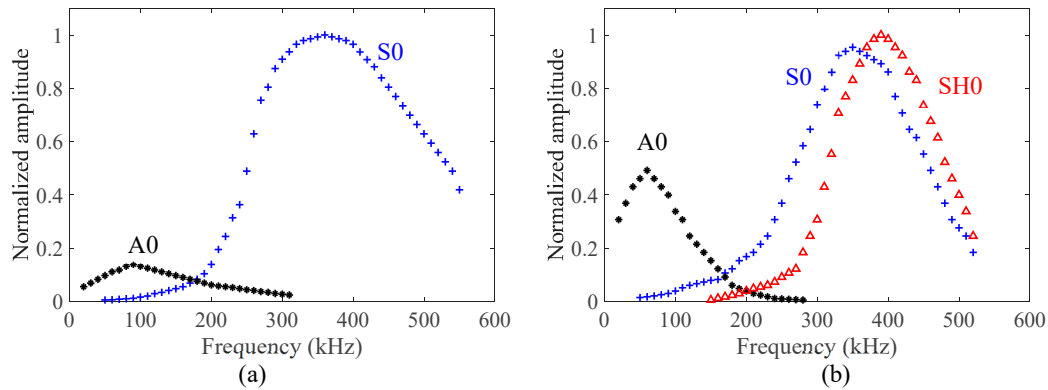
**Figure 14.** Experimental tuning curves of the cross-ply CFRP composite plate in the: (a) 0° directions; (b) 45° direction.

The excitation signal was a three-count tone burst signal at a center frequency of 330 kHz. This frequency was chosen based on the tuning curve. Experimental tuning curves of the cross-ply CFRP composite plate in the 0° and 45° directions are shown in Figure 14. It can be observed that only a

single mode (S0 mode) is dominant around the 330 kHz frequency in the 0° direction. However, SH0 mode was also observed as strong as S0 mode in the 45° direction. The excitation of the SH0 wave in the off-axis direction is due to the anisotropic behavior of the composite plate already reported by Giurgiutiu [73].

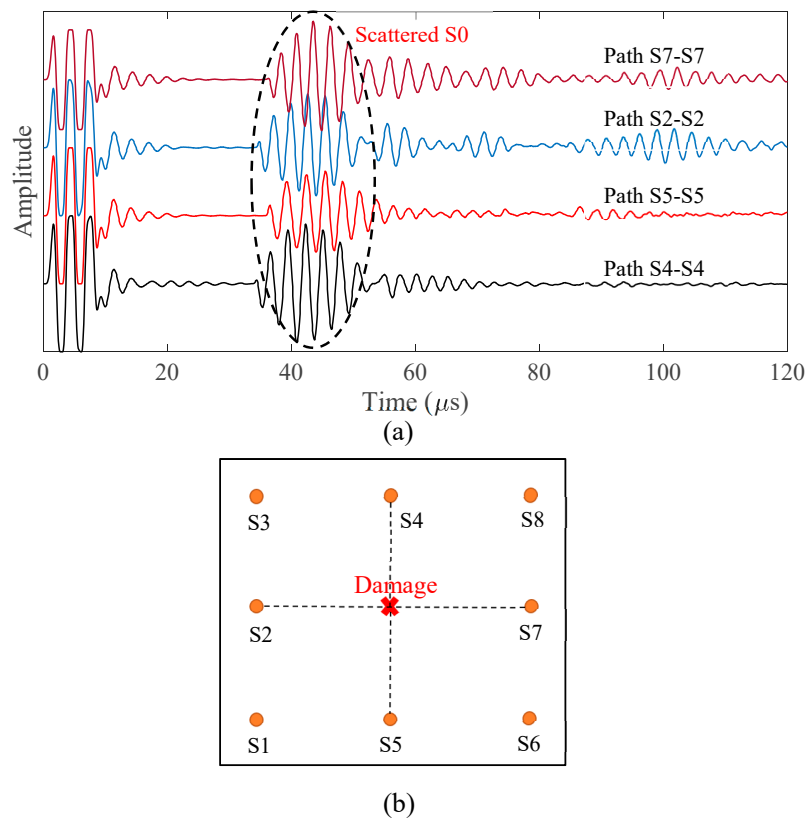
**Figure 15.** The new methodology for the localization of damage point: (a) pulse-echo signals of the sensing paths S2-S2, S4-S4, S5-S5, and S7-S7; (b) determining the location of damage.

The signals were collected by using pulse-echo and pitch-catch modes. First, the pulse-echo experiments were conducted for the PWAS S2, S4, S5, and S7 to detect and localize the damage using the proposed method in Section 4. Figure 15a shows the pulse-echo signals of the sensing paths S2-S2, S4-S4, S5-S5, and S7-S7. It can be noted that all of the signals have strong scattered S0 waves with the same TOF values. Hence, the damage is located at the center, as shown in Figure 15b.

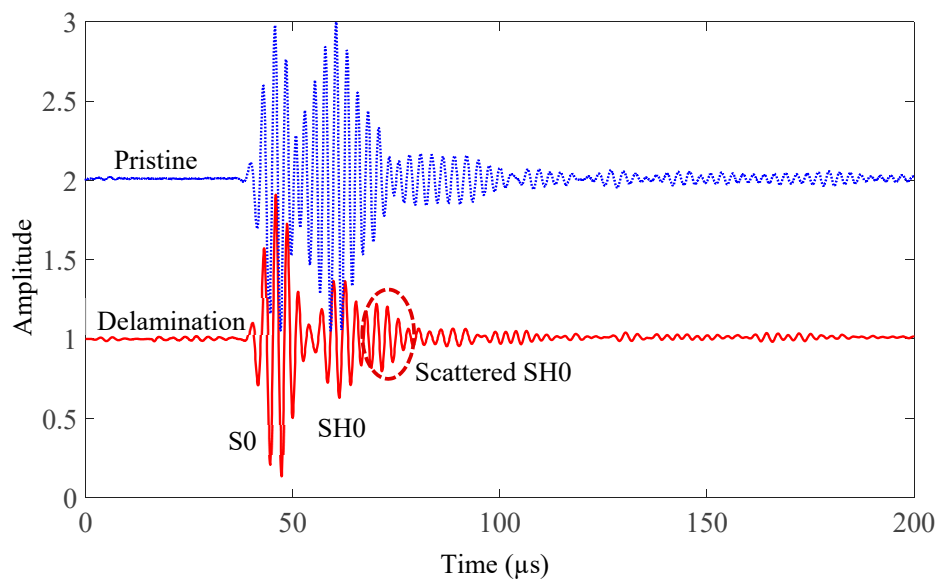
**Figure 16.** Comparison between the pristine signal and the delamination signal (Scattered S0 overlapped with incident waves).

In the pitch-catch mode, each PWAS transducer acted as a transmitter, whereas the rest of them in the network acted as receivers. For demonstration, only one set of signals is shown in Figure 16. In this set, PWAS S2 is the transmitter and PWAS S4 is the receiver. It can be observed that both S0 and SH0 are dominant in this sensing path (45° direction), which agrees with the experimental tuning curves in the 45° direction (Figure 14). The incident waves were determined as the S0 and SH0 modes, based on the group-velocity dispersion curve. Figure 17 shows the group-velocity directivity plot at 330 kHz. The curves indicate that Lamb waves propagate with various velocities in different directions. It can be observed that S0 mode has the highest group velocity, while A0 mode has the lowest group velocity. SH0 mode possesses a group velocity between A0 and S0, and it shows self-crossing behavior, as reported in Glushkov [74]. The scattered SH0 wave, due to the delamination, can be determined by calculating the TOF of incident path (PWAS S2 to damage) and damage path (damage to PWAS S4) using the corresponding group velocities and distances.

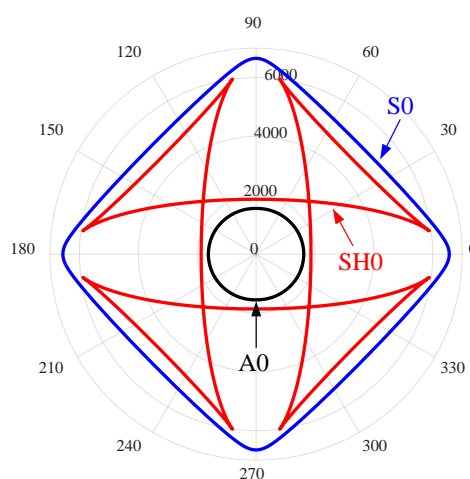
**Figure 17.** Group velocity directivity curves at 330 kHz in a 1.6 mm cross-ply CFRP plate.

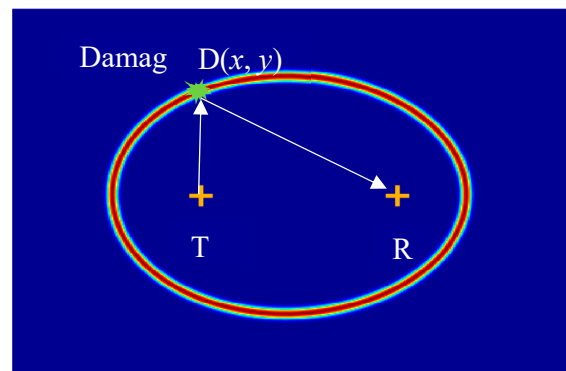
Figure 18. Damage orbit with the transmitter and receiver PWAS as foci.

Figure 18 gives the damage orbit for a certain sensing path. To determine the size of the delamination area, the sensing paths of multiple transmitters around the area of interest were used to get multiple intersection points that represent the damage edges. A new methodology was implemented to visualize the delamination without setting a threshold, using a combination of summation and multiplication algorithms. In this methodology, the summation algorithm [71] is used to extract the individual image of all the sensing paths for each PWAS transmitter. These images have strong intersection points, which represent the delamination edges, and the rest are undesirable orbits. The multiplication algorithm is used to fuse all of these individual images, to obtain the final image for the delamination, which does not require setting of a threshold. Figure 19 shows the final imaging result of the delamination. It can be found that the results of the imaging method match well with the real delamination. The edges of the 50 mm delamination can be observed.

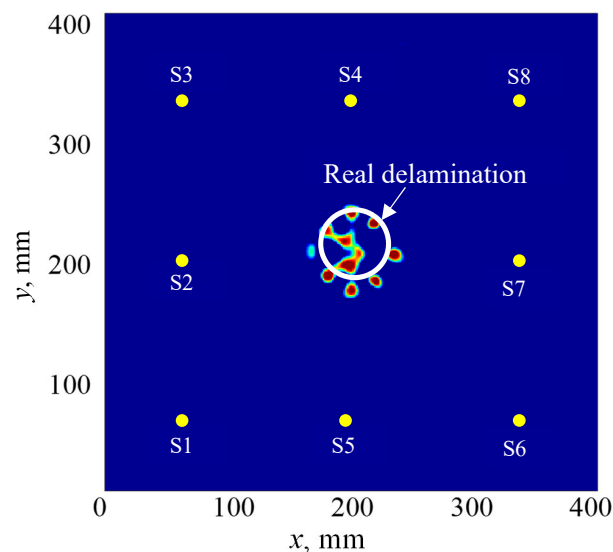
Figure 19. The imaging result of the 50 mm delamination in the cross-ply composite plate.

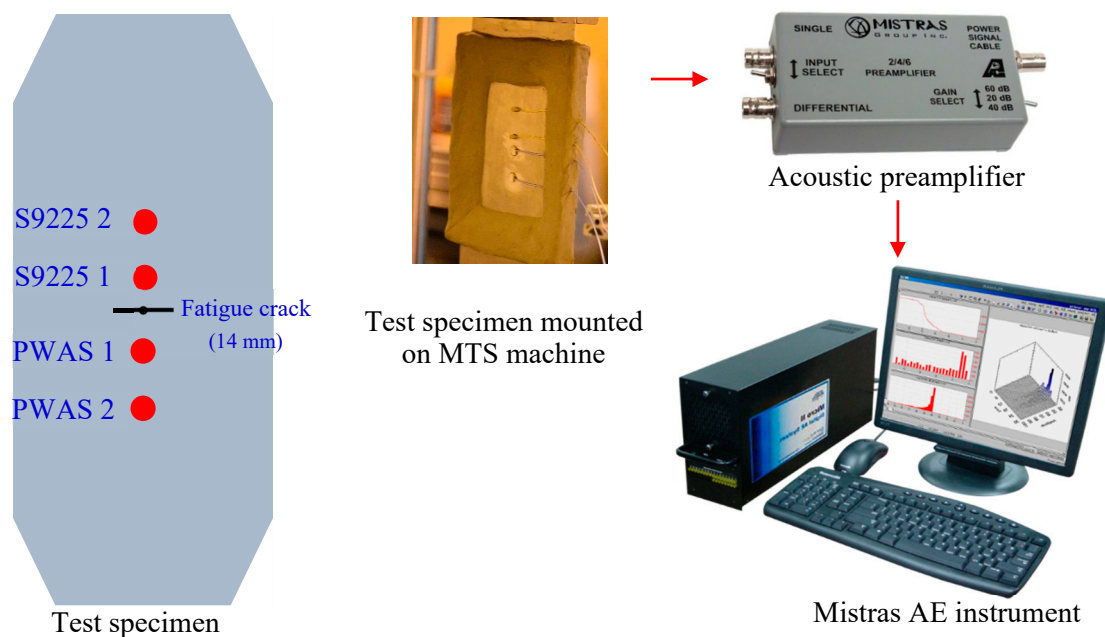
**Figure 20.** Experimental setup for capturing AE signals during the fatigue crack event.

To understand the sensing capability of PWAS to detect AE signals due to a crack growth event, PWAS transducers were used as an in situ sensor on a high-strength aluminum 2024-T3 specimen while undergoing fatigue crack growth. The aluminum specimen was 103 mm in width, 305 mm in, and 1 mm thick. A 1 mm hole was drilled at the geometric center of the specimen. Fatigue loading was applied on the specimen to generate a pre-crack of 14 mm tip-to-tip length. For the pre-crack generation, fatigue loading from 13.85 kN to 1.38 kN at a frequency of 10 Hz was applied. After initiating the crack approximately up to 14 mm tip to tip, two PWAS transducers at 6 mm and 25 mm from the hole, as well as two S9225 sensors at 6 mm and 25 mm from the hole were installed on the aluminum plate, as shown in Figure 20. S9225 is a commonly used and commercially available AE sensor. The S9225 sensor was used to make a comparison between PWAS and S9225 in this experiment. The test specimen installed with PWAS and S9225 transducers was mounted on the MTS machine. The fatigue loading was continued to vary between 13.85 kN and 1.38 kN with a loading rate of 2 Hz, and simultaneous AE measurements were performed. The experimental setup for capturing the AE signal from the fatigue crack growth is presented in Figure 20. AE signals during the crack growth were captured by using PWAS and S9225 sensors. The sensors are connected to the acoustic preamplifier. The acoustic preamplifier is a bandpass filter, which can filter out signals between 30 kHz to 700 kHz. The preamplifier is then connected to a four-channel Mistras AE system for processing the signals.

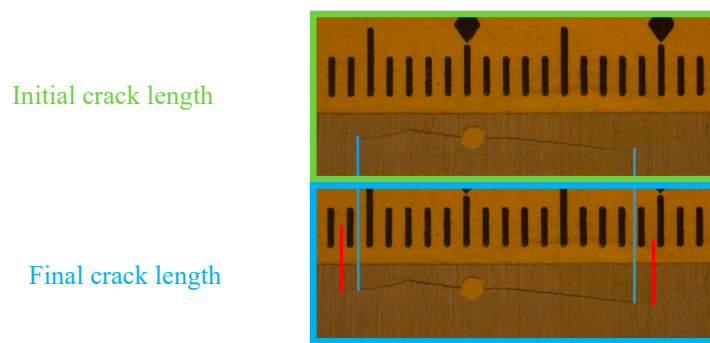
**Figure 21.** The initial tip-to-tip crack length was approximately 14 mm. After 2000 fatigue cycles, an advancement in the crack length of 2 mm was observed.

The crack growth on the specimen due to 2000 fatigue loading cycles from 14 mm to 16 mm is presented in Figure 21. The initial crack is presented in the green box, and the final crack in the blue box. The locations of the initial crack tips were marked using the blue lines, and the locations of the final crack tips were marked using red lines. The crack grew by approximately 2 mm. AE signals were captured simultaneously during the fatigue crack growth.

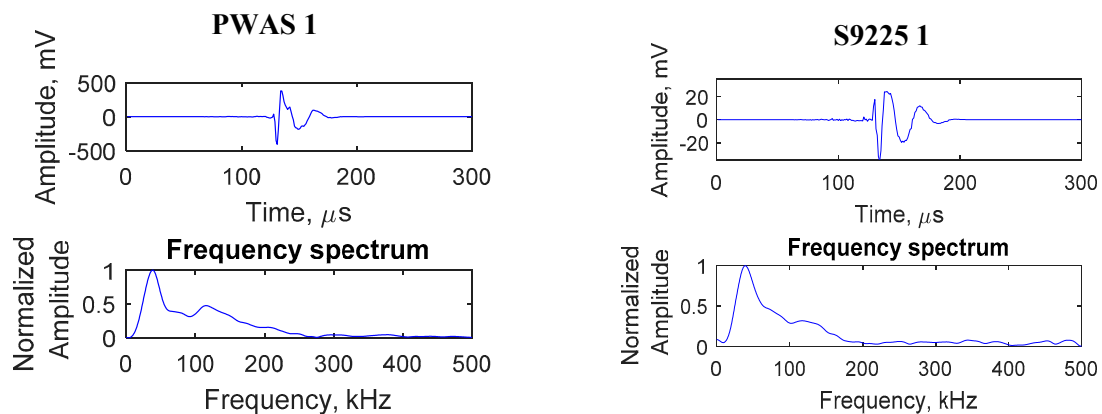
**Figure 22.** Signals captured by the PWAS 1 and S9225 1 sensors, due to a particular AE event at the crack.

A particular AE event captured by PWAS 1 and S9225 1 sensors is presented in Figure 22. The relative time of arrival of the signals at the PWAS 1 and S9225 1 sensors installed equidistant from the crack was obtained from the Mistras AE system. The time of arrival of signals at PWAS 1 and S9225 1 was found to be the same, which confirmed that the signals corresponded to an AE event happening that was equidistant from the sensors, which is the crack location. If the AE event was happening at a different location other than the crack, the time of arrival at the PWAS 1 and S9225 1 sensors would be different. In this way, it was confirmed that the AE signal captured was originating from the crack.

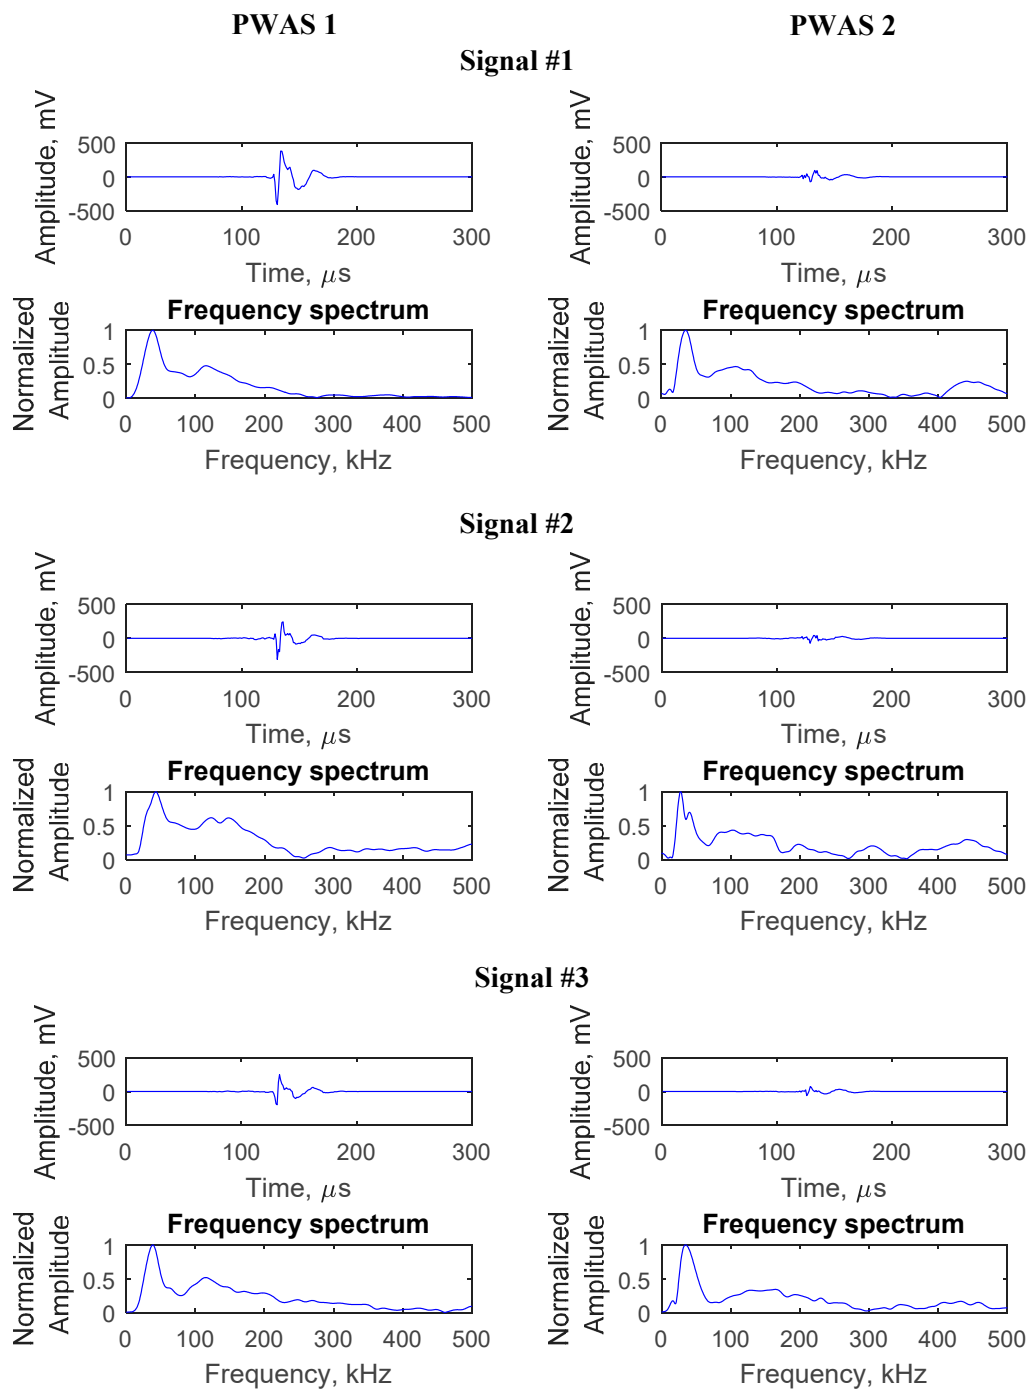
**Figure 23.** Typical AE signals captured during fatigue crack growth. Three sets of captured signals are presented. For each set, the signal at PWAS 1 and the corresponding signal at PWAS 2 are presented. The AE signals seem to maintain their signature at PWAS 1 and 2.

Several AE signals originating from the crack were captured during this crack growth event, as shown in Figure 23. From the time of arrival of the AE signals at PWAS 1 and PWAS 2, signals corresponding to the same AE event were identified. The sequence of arrival, as well as the amplitude of the AE signals, are presented in Table 3. The sequence of arrival confirms that the AE signals were originating from the crack. Geometric spreading caused the amplitude of AE signal to decay while propagating. This was also observed from the corresponding amplitude values of the signals at PWAS 1 and PWAS 2. The AE signals were found to have a similar signature by comparing the waveform, as well as the frequency spectrum of the signals. It can be observed that the frequency spectrum maintains its signature when reaching PWAS 2.
