Acousto-Ultrasonic SHM/NDE Methods Toward Field Application

ACOUSTO-ULTRASONIC SHM/NDE METHODS TOWARD FIELD APPLICATION

For the Degree of Master of Science in

Mechanical Engineering

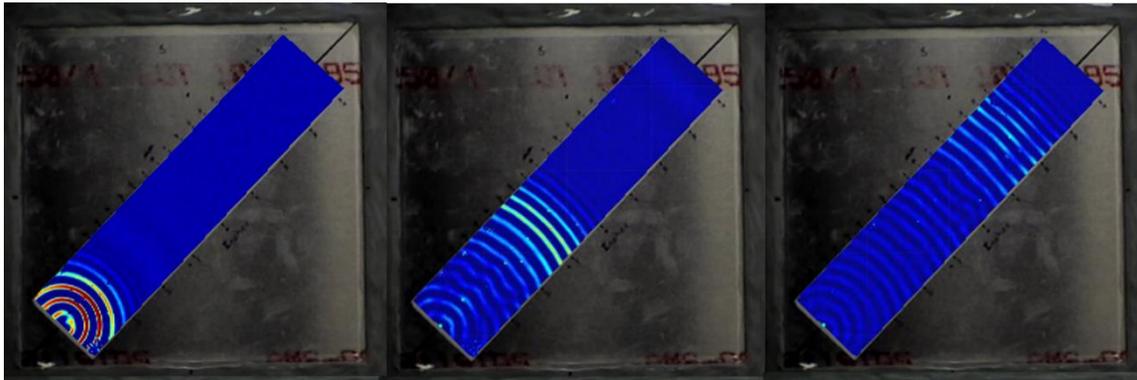
Figure 2.1: Waves propagating in aluminum plate

Similarly to dropping a rock in a pond and watching the ripples, waves will propagate within solid median (Figure 2.1). Like with ripples interacting with nearby rocks, once ultrasonic waves come across a dissimilar material or material discontinuity the propagating waves will be disrupted causing reflections, mode conversions, and more [3]. Ultrasonic testing is one of the most established nondestructive evaluation (NDE) methods used in practice due to its high sensitivity and abilities to detect both surface and internal defects [3]. There are often two basic configurations used in ultrasonic wave based SHM, pulse-echo and pitch-catch methods. The pulse-echo method uses a single side/location of excitation and sensing [3]. Ultrasonic waves propagate from one location and the echo/reflected waves are received at the same point or transducer. Pitch-catch method operates with a point of excitation and at a secondary location where the elastic waves are detected. These two different configurations are generally common with most types of transducers.

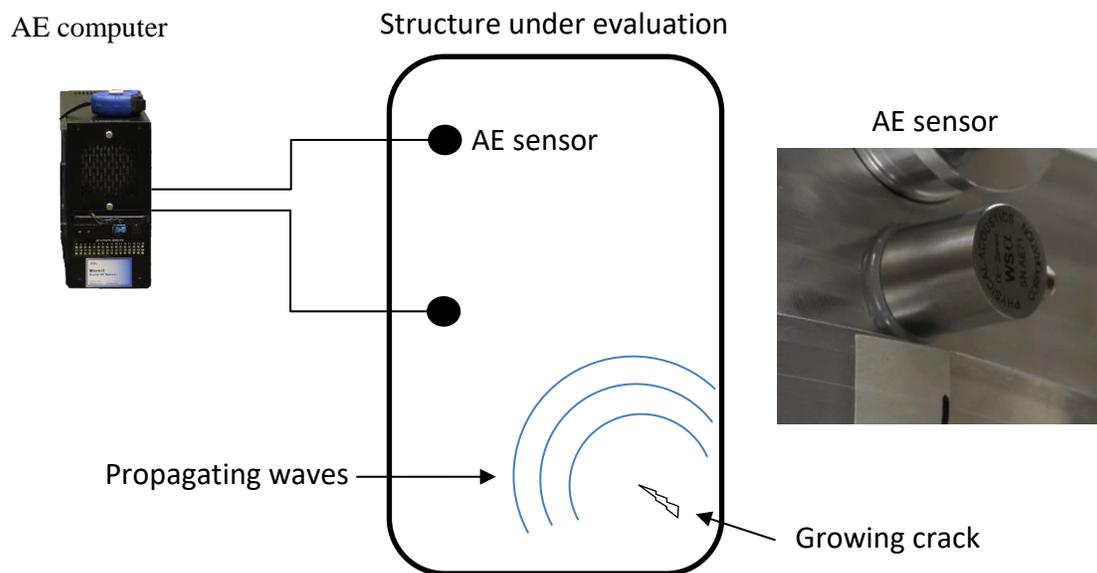
Figure 2.3: Overview of a typical passive AE system

Crack growth within a material causes a release of strain energy [8], known as acoustic emission (AE). The mechanism of which is described within fracture mechanics [9]. AE sensing relies on this mechanism of energy release to trigger acquisition (Figure 2.3), and therefore is a passive system [3, 9]. Sensors designed for detecting this release of energy are specifically manufactured for this task. Some are designed to have resonance at a select frequency, meaning that is a small periodic force, such as a passing wave, can drive large amplitude oscillations [10]. To aid in the acquisition, supporting computers and amplifiers are generally used.

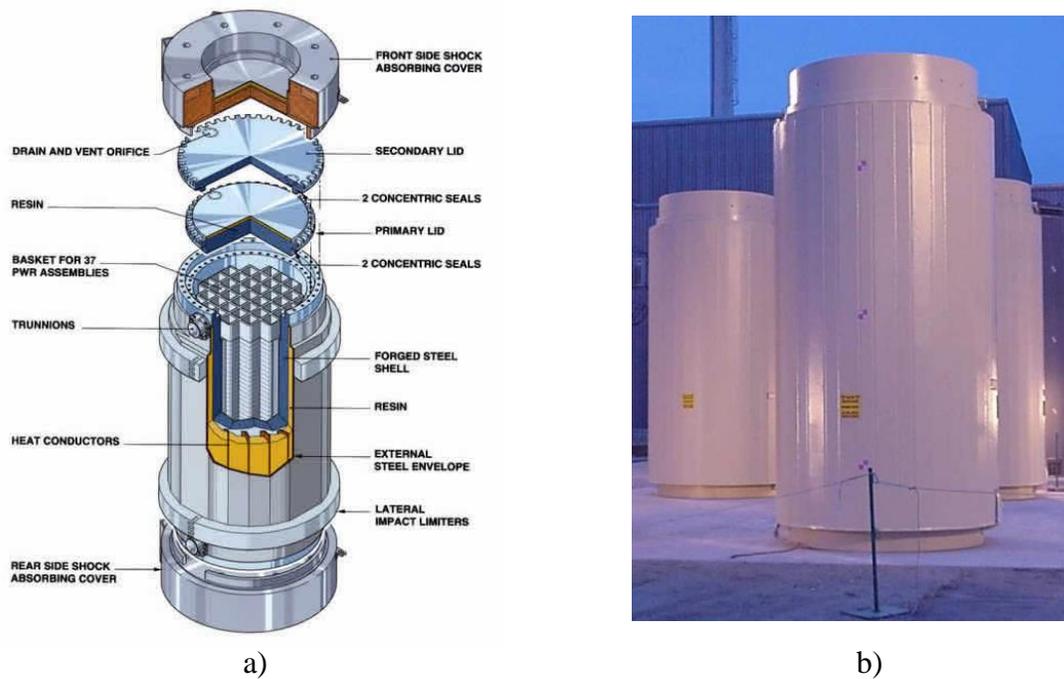
Figure 2.4: Holtec HI-STAR dry storage cask a) cross-section [13] and b) in vertical storage [14]

grow when pools at many nuclear reactors began to fill up with stored spent fuel. Utilities began looking at options such as dry storage cask for increasing spent fuel storage capacity [11]”. The purpose of these casks is to protect personnel and the environment by allowing the spent nuclear fuel (SNF) to cool during their decay without leakage and to provide radioactive shielding of the waste [12]. These dry storage casks are generally cylindrical structures where they are either bolted or welded closed after SNF is added. To prevent leakage of the hazardous waste there are multiple shell-like fixtures inside. For gamma radiation shielding, steel, concrete, and lead are generally used. Additional layers of polyethylene, boron-impregnated material or more concrete is used for neutron shielding [12]. A cross-section of one model of these devices is shown in Figure 2.4.

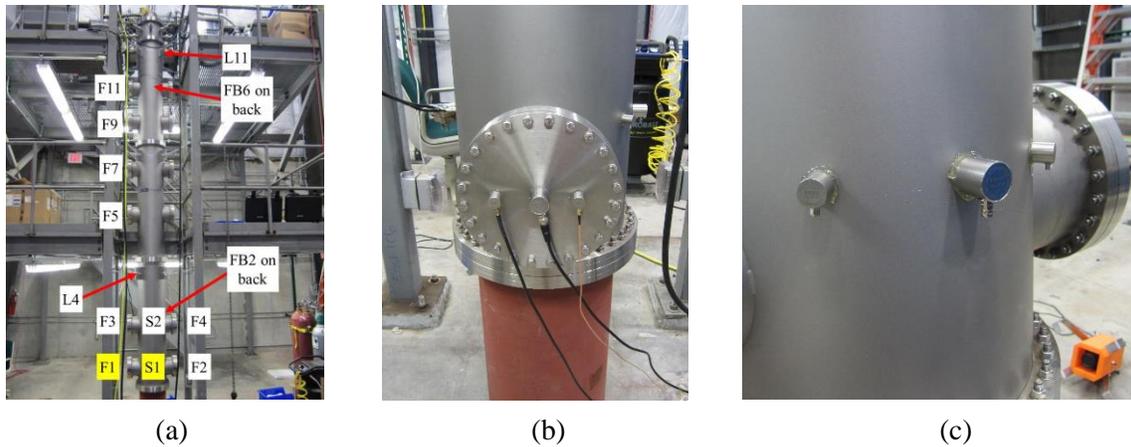
Figure 3.1: Nuclear vacuum chamber structure with a) labels and close-look of sensor sets on b) F1 and c) S1 [29]

The vacuum drying chamber was divided into sections and labeled where areas of sensing and excitation could be identified (Figure 3.1a) [30]. To monitor the AE events, six AE sensors in two sets of three were applied using hot glue (as it was easily removable and resulted in no damage) to the surface of the chamber. Each set contained one of each Physical Acoustics R15I, R15 α , and a WS α AE sensor¹ for Round 1. Later a R15 α and a WS α were used to measure the maximum range as they performed the best in

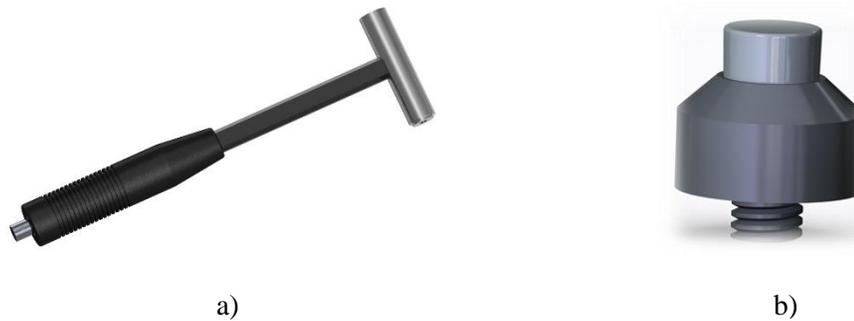
Figure 3.2: (a) Stainless steel impact hammer with (b) assembled tip [30] [29]

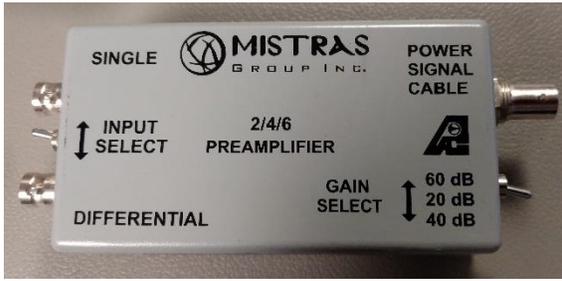
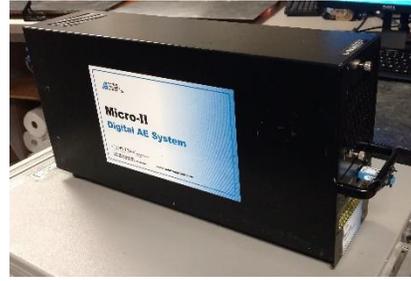
Figure 3.3: Pictures of an a) 2/4/6 preamplifier and the b) digital AE system

Round 2. All AE signals were collected using Physical Acoustics MICRO II Digital AE system (Figure 3.3b). A PCB model 086C04 impact hammer² with a built-in accelerometer and a PLB with 0.07mm lead were used to excite the AE signals. Two hammer tips were used for testing: a plastic PCB tip and a custom made 304 stainless steel tip (Figure 3.2). To boost the signals Physical Acoustics 2/4/6 preamplifiers³ (Figure 3.3a) operating at 40 dB were used on the AE sensors except for the R15i sensor which already has an integrated amplifier.

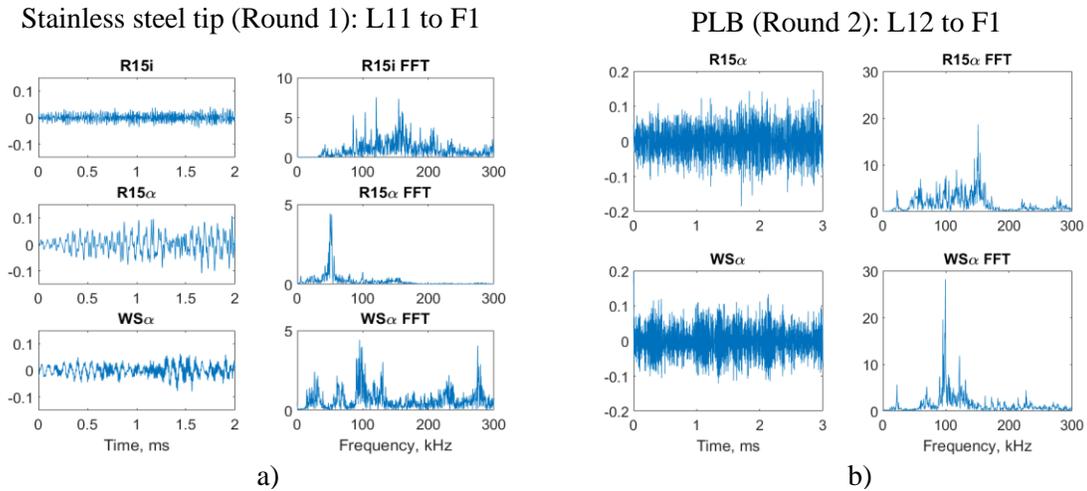
Figure 3.4: Sensing range of structure from the farthest points using stainless steel tipped banging and PLB excitation methods [29]

First examined was the AE maximum sensing distance (L11 or L12 to F1) in the complex structure. From the top of the structure, impacts from the stainless-steel tipped impact hammer banging was detected as well as the PLB with the WS α and R15 α sensors (Figure 3.4). The steel tip hammer excitation resulted in lower frequencies signals compared to those by the PLB excitation. Also, the PLB produced a much higher amplitudes and more defined frequency peaks.

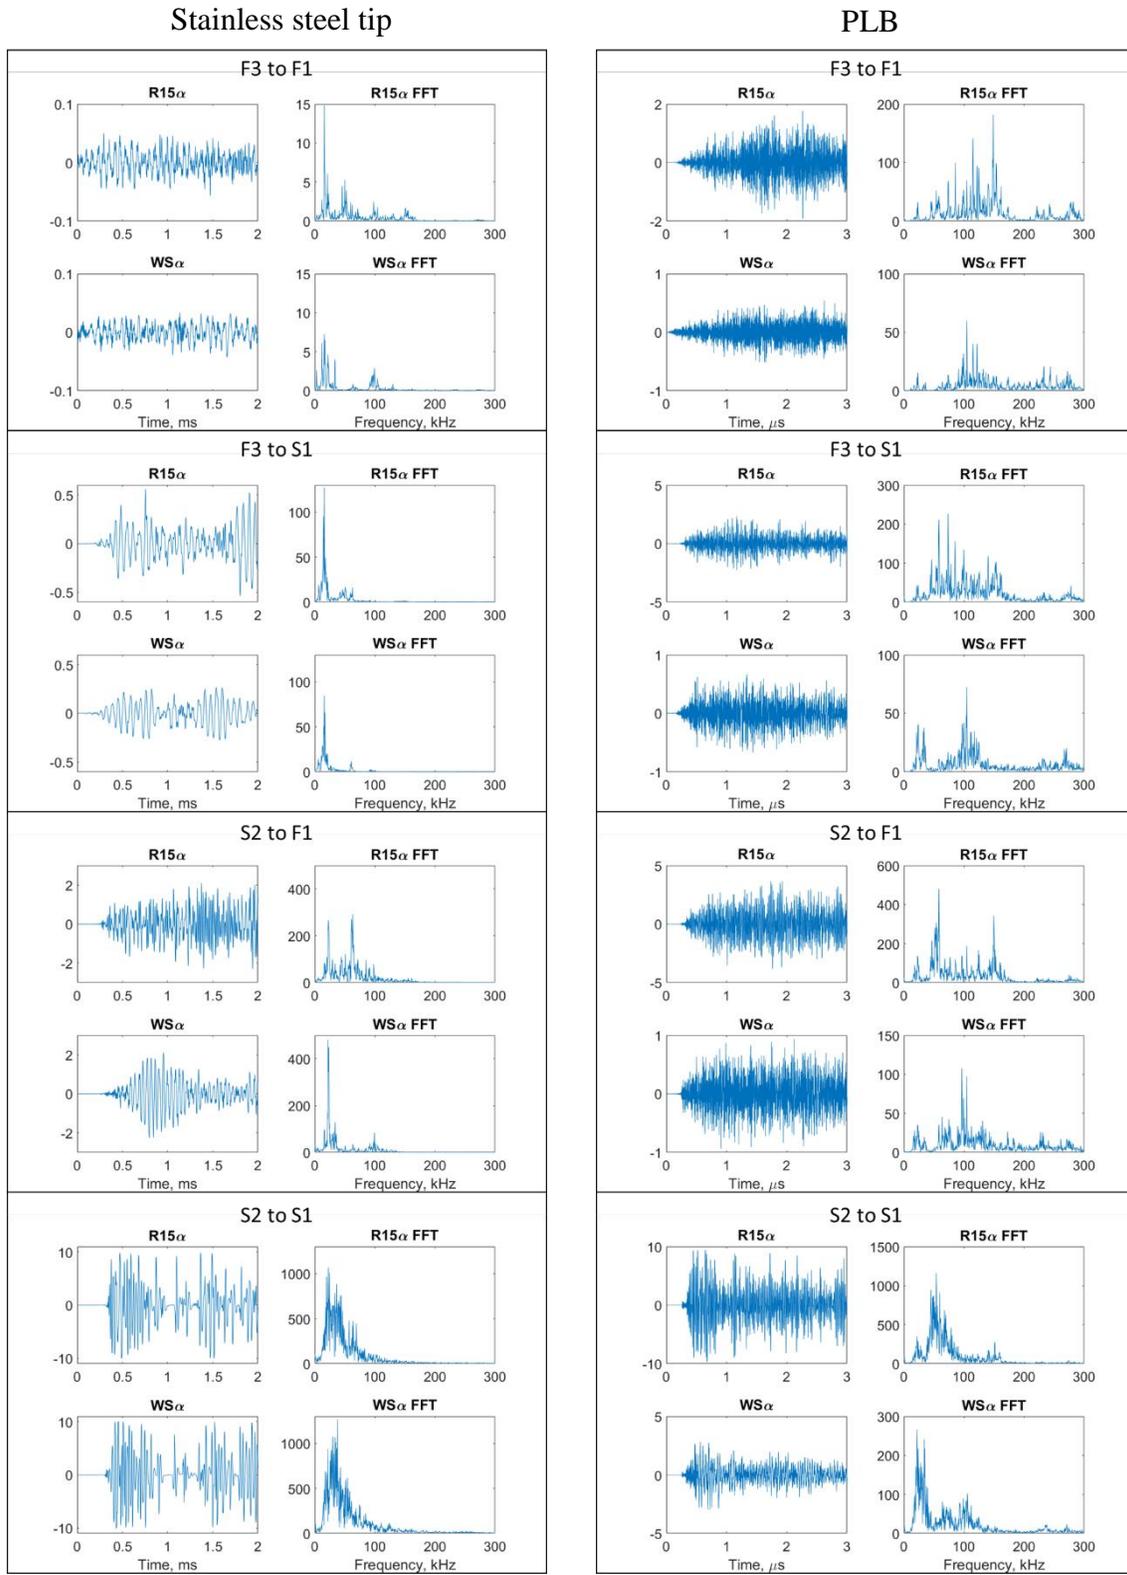
a) b)
 Figure 3.5: AE waveforms after passing through various structural conditions [29]

Next investigated was the structural influence on the signals. Examining the stainless-steel impacting and the PLB excitation methods showed changes that the flange and surface combinations produced (Figure 3.5). The structural complexity influence on the AE sensing for various cases of structural characteristics are as follows: surface to surface (S2 to S1), surface to flange (S2 to F1), flange to surface (F3 to S1), and flange to flange (F3 to F1). When examined, the stainless-steel impacting (Figure 3.5a) exhibited lower frequency components under 100 kHz. Closer observation of the frequency spectra showed changes in the locations of peaks. For the surface case the frequency plot (Figure 3.5, S2 to S1) showed a gradual increase to a single frequency for both WS α and R15 α sensors. However, when one or more flanges were introduced multiple and more defined peaks occurred. This was similar with the PLB excitation interaction with the flanges. In addition, examining the stainless-steel tip hammer impacting and the PLB excitation both methods showed changes that may be caused by the flange and surface combinations (Figure 3.5)

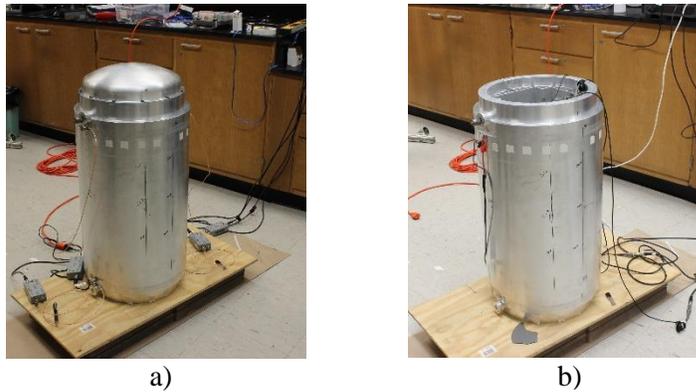
Figure 3.6: Small-scale dry storage cask with a) lid on and b) off

The next phase was to employ the AE sensing techniques used on a small-scale dry storage cask (Figure 3.6). Active sensing with the same set up AE sensors being used will also be study in order to evaluate the sensor's potential for dual passive-active (i.e. acousto-ultrasonic) integrated NDE/SHM. The procedures and methods tested in this small-scale structure will later be applied in a similarly manner to the full-scaled dry storage cask field test to be discussed in later sections.

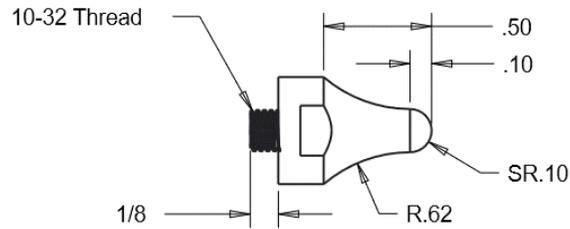
Figure 3.7: Custom tip to be fitted on hammer

The same PCB Model 086C04 impact hammer from the previous medium-scale testing was used for excitation in AE tests, but fitted with a custom made T304 stainless steel tip (Figure 3.7). This tip was made from a signal piece of steel to prevent foreign material falling into the casks during impacting and was used for all impact hammer

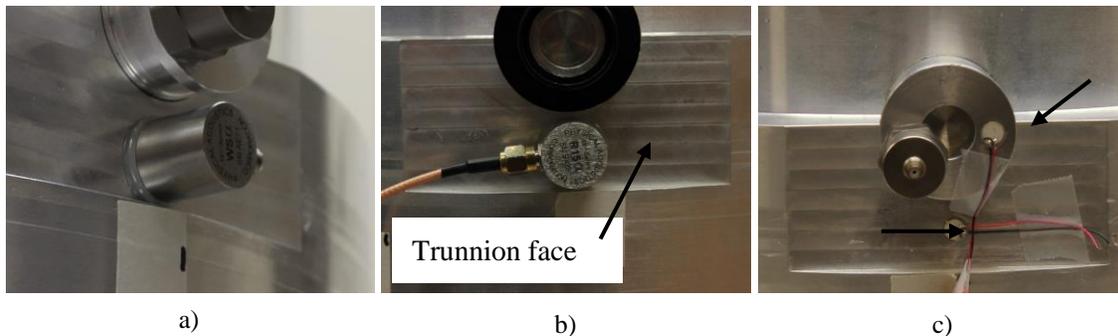
Figure 3.8: Sensors used experiments: a) WS α , b) R15 α , and c) PWAS wafers indicated with arrows

For the small-scale experiments three sensors were used: the PAC AE sensors WS α and R15 α , and PWAS wafers (Figure 3.8) made by Steminc with 7 mm diameter and 0.2 mm thickness. The wafers were bonded to the structure with M-Bond 200 strain gauge adhesive.

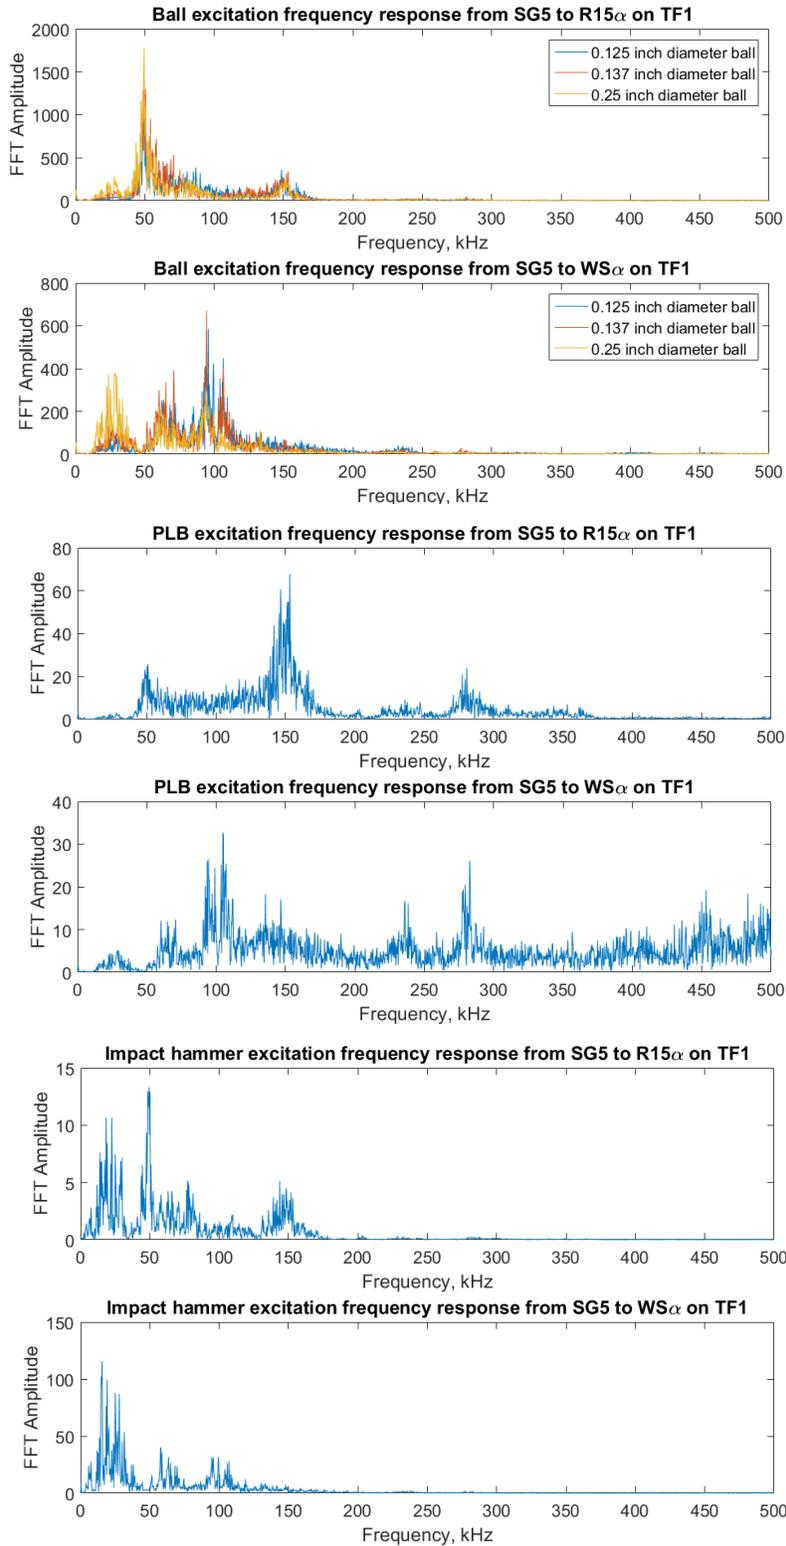
Figure 3.9: Shows the frequency domain of various excitation methods and sensor combinations

The impact hammer produced significantly lower frequency components than those of the other methods. Peaks for both AE sensors fell under 200 kHz with no higher harmonics (Figure 3.9). The R15 α and WS α maximum peaks occurred at approximately 50 kHz and 20 kHz respectively.

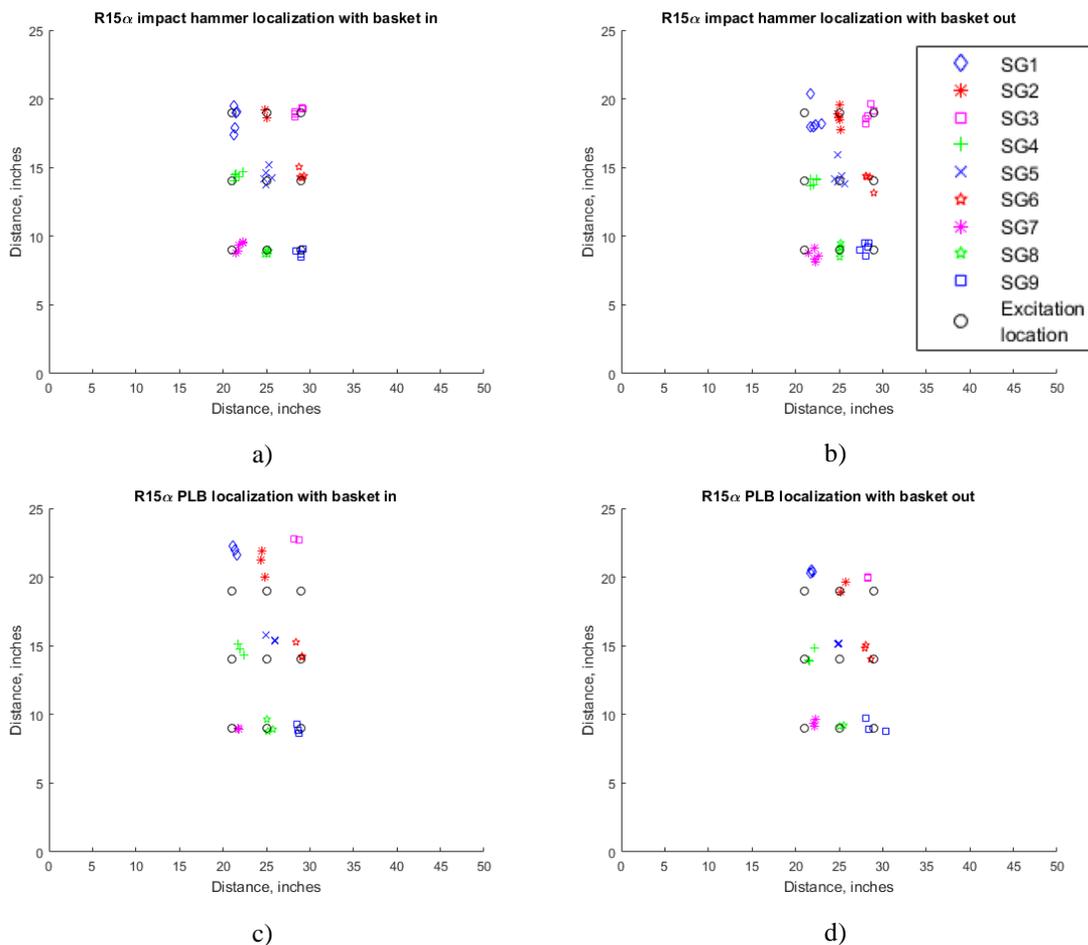
Figure 3.10: PLB and T304 tip impact hammer localizations of SG series using R15α

of the detected hits lay within an inch or two of the actual impact. The PLB with the basket out resulted in the least accurate calculated impact locations. The basket condition seemed to have negligible effect on the localization accuracy. Next the $WS\alpha$ wideband sensor data was analyzed (Figure 3.11).

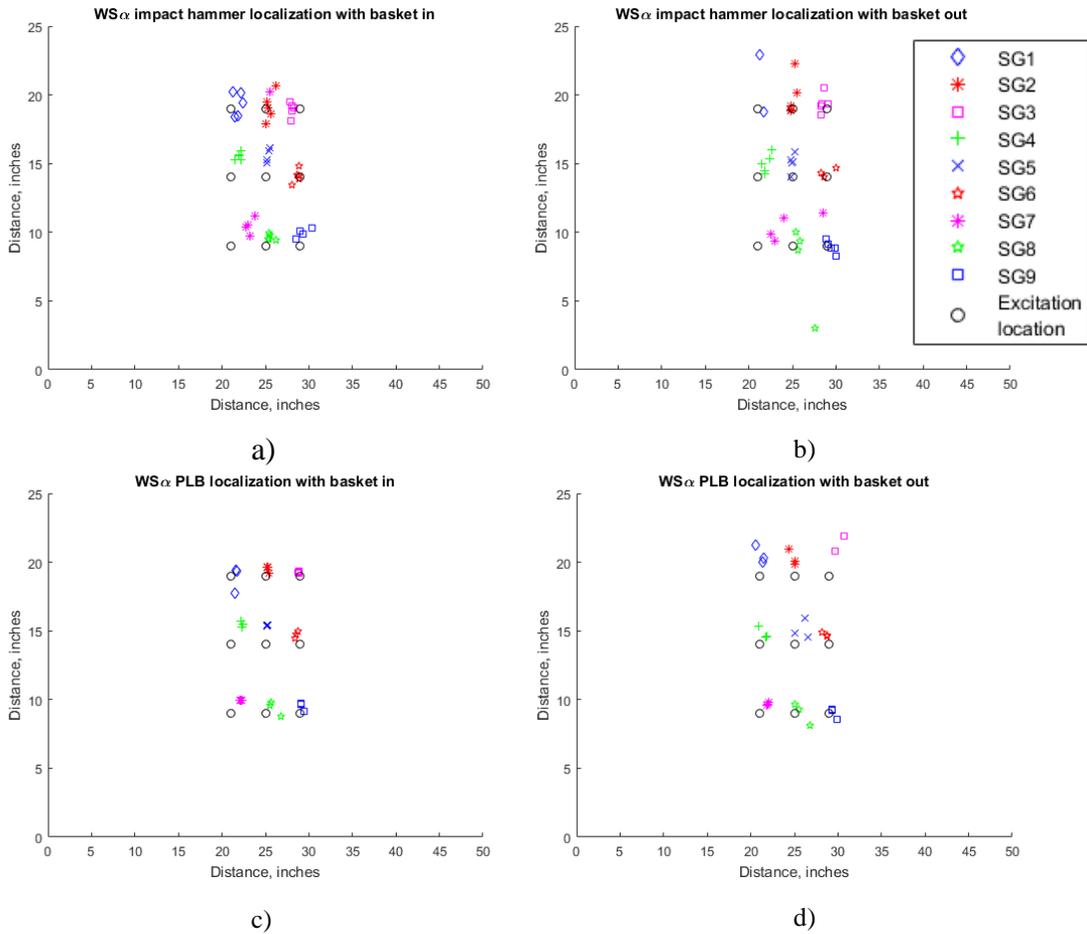
Figure 3.11: PLB and T304 tip impact hammer localizations of SG series using $WS\alpha$

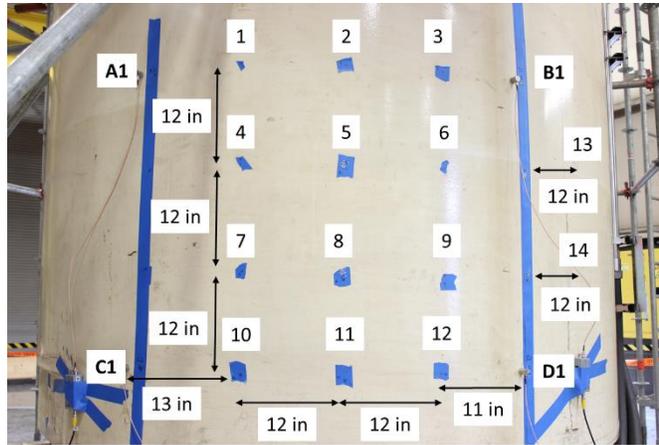
Figure 3.12: Impact locations on the front face consisting of the “a” series of excitation locations [30]

and the lower left corner was the origin. The one-inch shift within the “a” series grid was applied to avoid a welded seam.

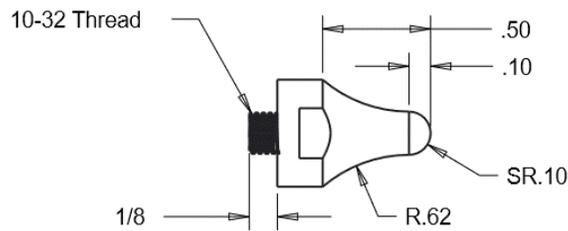
Figure 3.13: Impact hammer tip used for all experiments in inches [30]

Five AE events were created for each location using the custom stainless-steel tip impact hammer used in previous small-scale test (Figure 3.13). For proper source localization a few test hits were performed first to determine appropriate calculation parameters. The preamplifiers operated at 20 dB; and the acquisition settings within AEwin were given in Table 3.4. After testing, the sensor locations were added within the AEwin software and the saved data could be “replayed” with different localization settings to localize the events (Figure 3.14). The wave speed and other parameters for localization were eventually estimated by trial and error (Table 3.5). The software also interprets the surface as planar, therefore the top and lower portion of the cask was ignored. Also, the settings are set such:

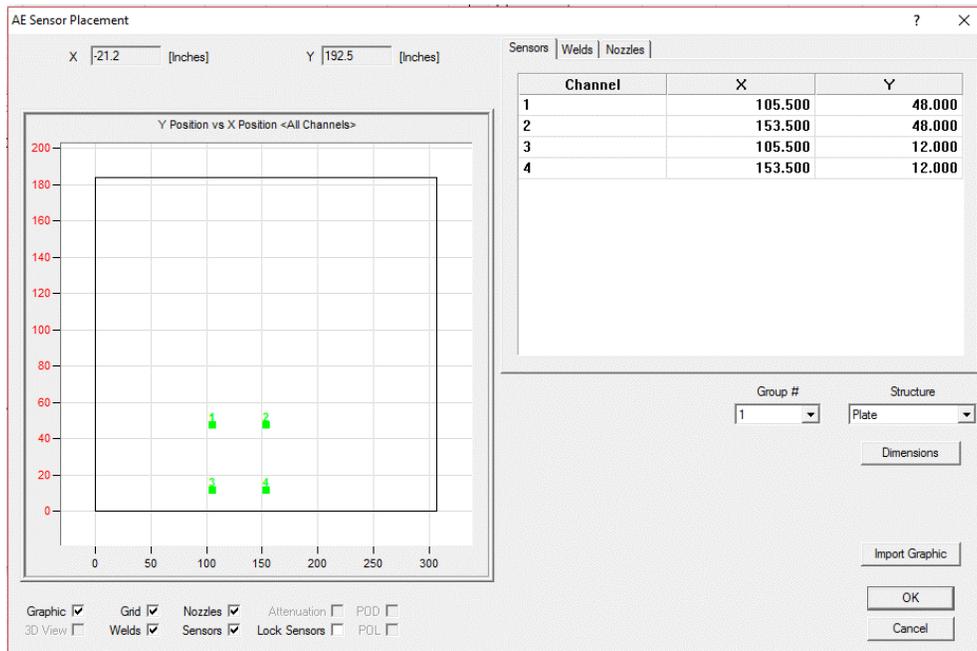
Figure 3.14: Sensor placement view for Experiment 1 [30]

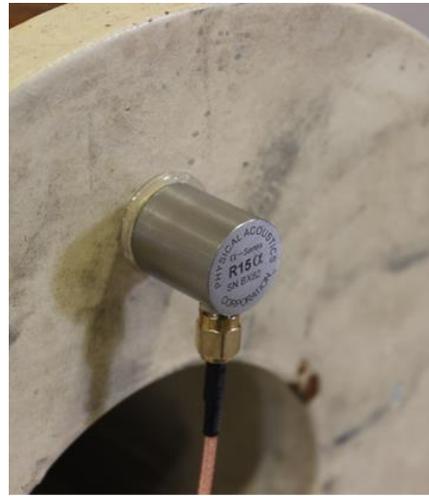
Figure 3.15: Sensors moved to a) trunnions A, B, C, D with b) a close-up image of a bonded sensor on trunnion C [30]

Following the first experiment the sensors were transferred and re-bonded to the trunnions. Each trunnion had a sensor and their locations labeled A2, B2, C2, and D2 (Figure 3.15a). The sensors were bonded halfway between the inner and outer portion of the trunnion (Figure 3.15b). Sensors were placed on the lower sections of trunnions A2 and B2, and the upper portion of C2 and D2.

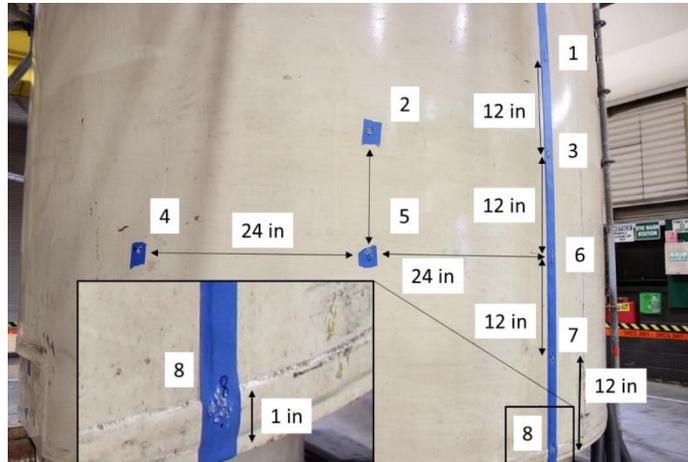
Figure 3.16: Layout of “b” series of excitation locations [30]

New impacting points were determined (Figure 3.16) and locations recorded. New painter's tape was applied and marked during the process. The new impacting area consisted of 8 impacting locations. The coordinates were that of the previous method.

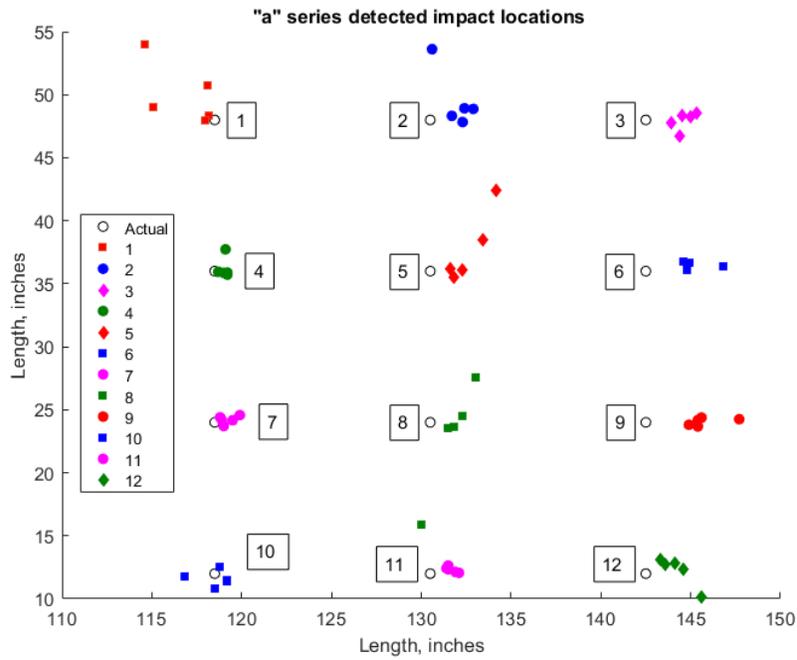
Figure 3.17: Series "a" detected impacts along with the actual locations [30]

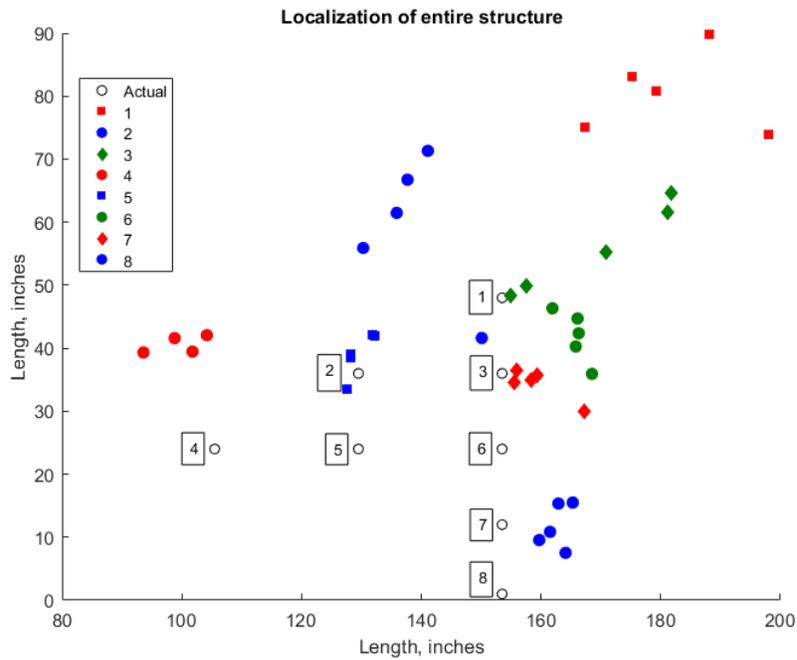
Figure 3.18: Series "b" of simulated AE locations and true locations [30]

Following each setup simulated AE events were created, and waveforms recorded. For each test, 5 AE events were made with each being separated by a few seconds. After the data was collected and processed by in the AEwin software, the localization results were plotted in MATLAB. It is seen that the small area localization provided the better results as the estimated AE events fell within a few inches of the actual points (Figure 3.17). The accuracy decreased the farther along the horizontal axis the excitation point was located at. This effect occurred again on the large-scale localization but with the detected locations being within a foot in the excitation points (Figure 3.18).

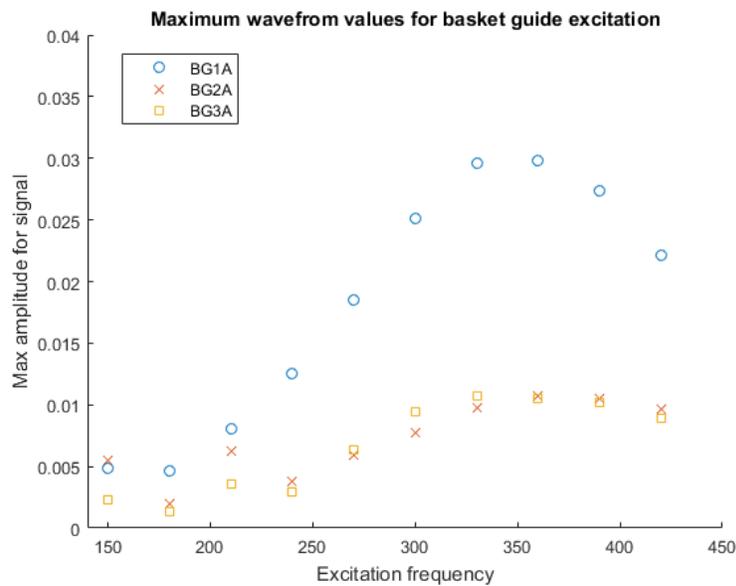
Figure 3.19: Small-scale max amplitude response measured from basket guides

Active sensing was carried out on the small- and full-scaled structures. However, when reviewing the data, it appeared that the bandpass filters used with the PWAS filtered out the structural response. Instead what was collected was more likely the PWAS and bonding response due to the thickness of the material. These higher frequency characteristics were both seen on the small- (Figure 3.19) and full-scale (Figure 3.20) frequency domain and amplitude plots. The plots exhibited a strong frequency component at 350 kHz which is uncharacteristic of large structures.

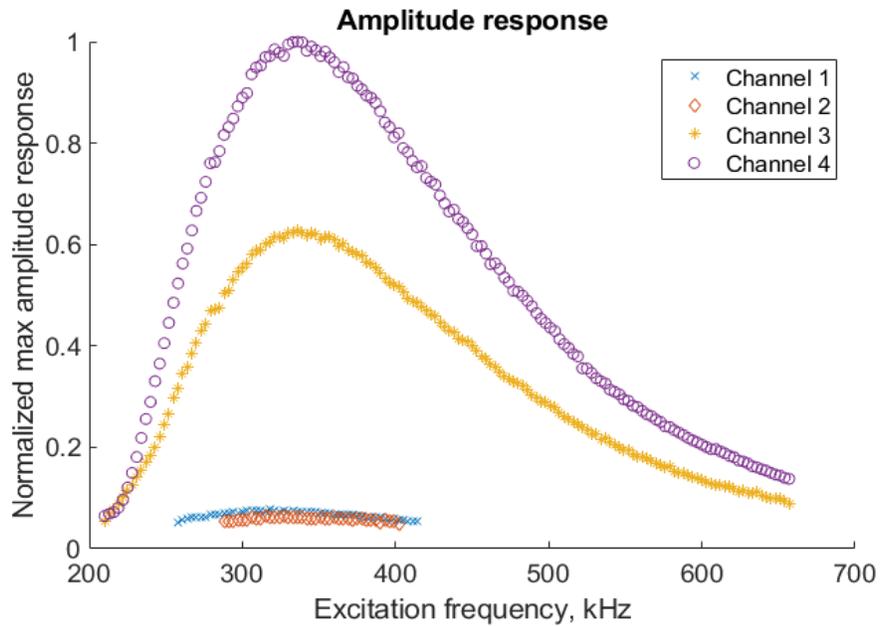
Figure 3.20: Full-scale max amplitude response with excitation frequency ± 6 kHz excitation error where the channels correspond with the trunnions [30]

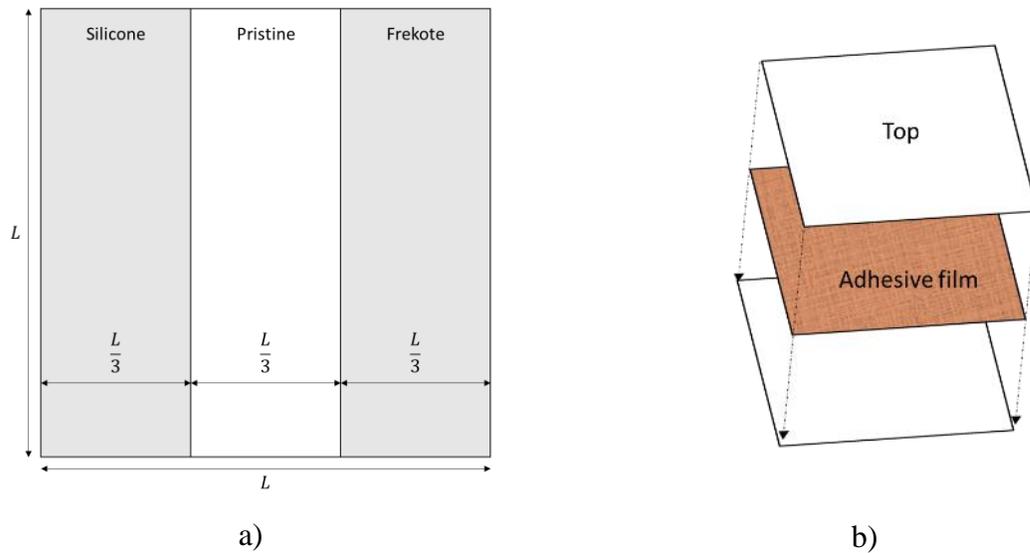
Figure 4.1: Plate damage layout from Specimens 1, 2, 4, and 5 from a) top down view and b) layup view

4.1). Two types of contaminations were used in this study: silicone oil and Frekote. Silicone oil and Frekote were chosen as both are present within industry and pose a potential risk of being introduced during bonding. Once within the adhesion layer NDE of the strength or properties of the bond has proven difficult to determine [31].

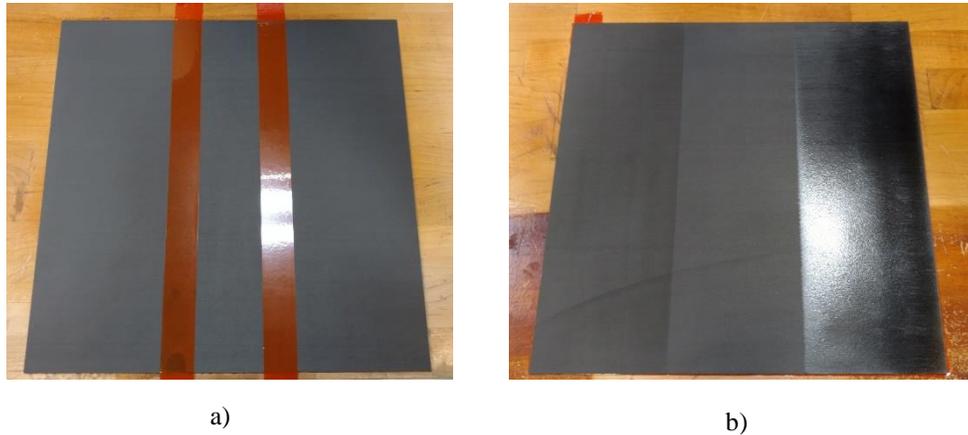
Figure 4.2: Process of weak bonding a) before application of contaminates and b) after drying for a composite specimen

Tape was used to make three distinctive different bonding regions (Figure 4.2a). Frekote was applied to a medical gauze and then wiped on the right portion of the plate. Silicone spray was applied to a clean gauze and wiped on the left portion of plate. After which the tape was removed and the plate was allowed to dry for approximately 5-10 minutes (Figure 4.2b).

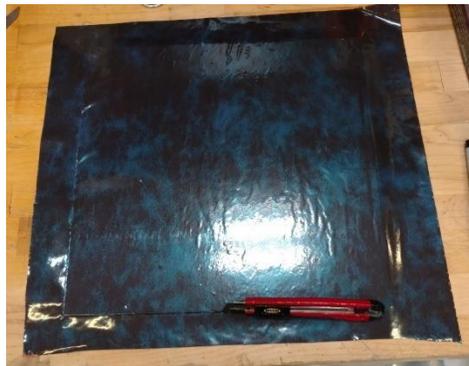
Figure 4.3: Adhesive film applied to non-contaminated side and being cut

On the mating surface of the other plate, the room temperature film adhesive had one side of protective film removed and was placed on the prepared surface. The air bubbles were removed, and excess material cut off (Figure 4.3).

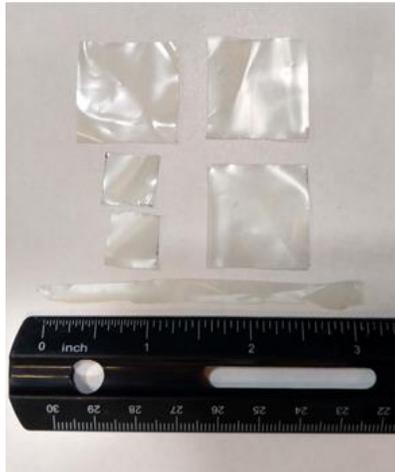
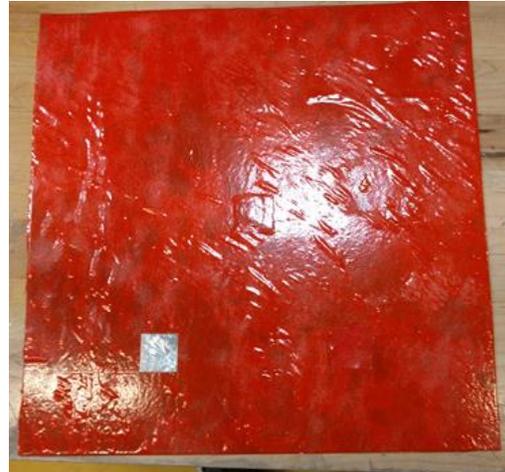
Figure 4.4: Damage preparation of Specimen 3 with a) prepared bagging tape sections to be inserted in and b) plate with adhesive applied where a section is removed to create a void

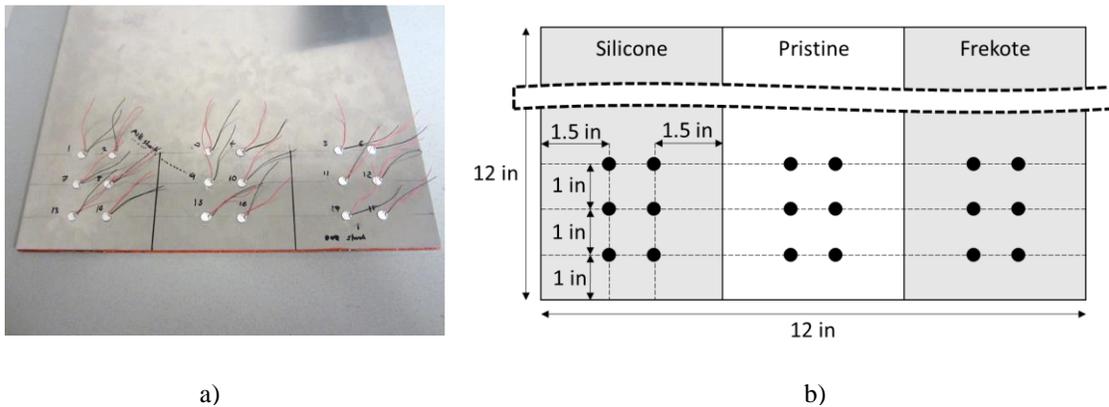
Figure 4.6: Plate 2 with a) sensors attached and b) layout of sensors

impedance of the structure was measured through its electro-mechanical coupling [4]. After cleaning and sanding surface preparation, 18 PWAS were bonded to front surface of the plate in three grids of six sensors to get the impedance at different locations of the bonded regions (Figure 4.6). The sensors were labeled from 1 to 18 starting from the top left most sensor, progressing to the right in a descending manner after each row.

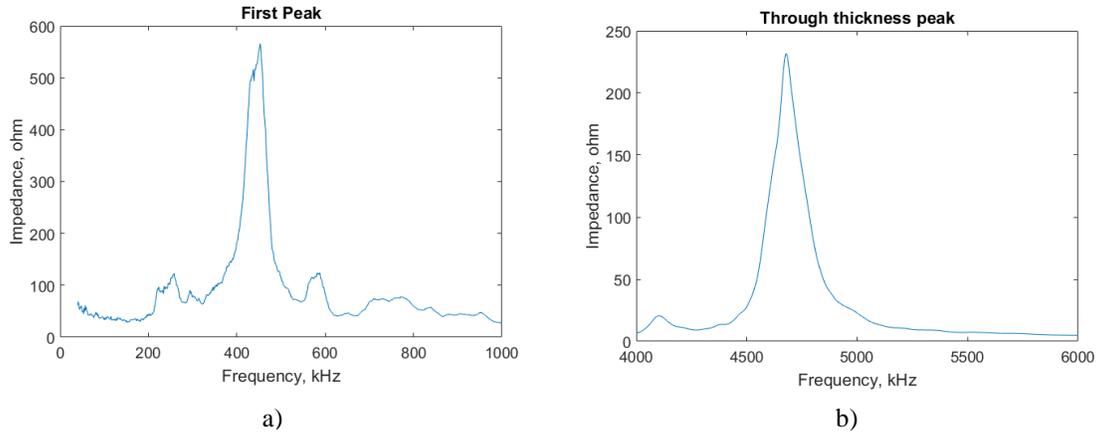
Figure 4.7: Sample data from Point 1 of a) first peak resonance and b) through thickness resonance

their first peaks occurred approximately 360 to 460 kHz while the through-thickness peaks fell within the 4.5 to 5 MHz range.

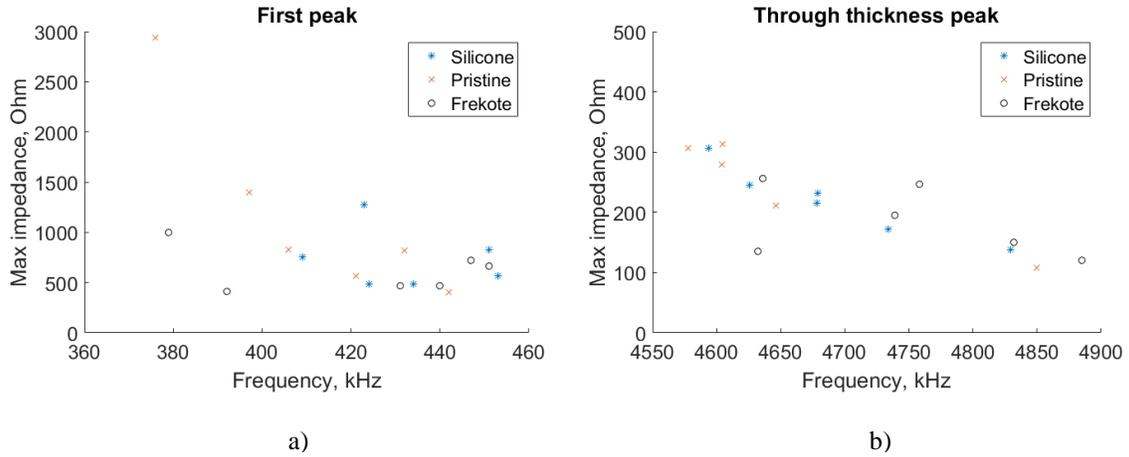
Figure 4.8: Max impedance resonance and their corresponding frequencies at a) first peak and b) through thickness peaks

The maximum values from the first peak and through thickness mode peaks along with their corresponding frequencies were then collected and plotted to observe any trends that could indicate any variation of bond quality for different cases (Figure 4.8). However, from the results that have been achieved in this study, no differences between the pristine areas and either contaminated regions can be observed. The peak values showed no indication of change within the bond layer. In addition, the pristine bonded results were significantly more scattered.

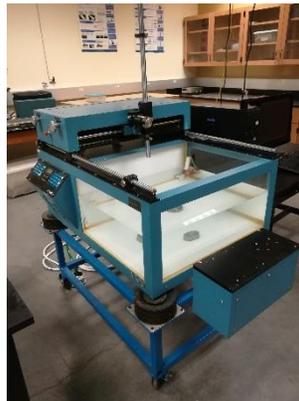
Figure 4.9: Immersion tank used for ultrasonic C-scan inspection

Ultrasonic C-scans using immersion tank is standardized NDE for defect evaluation. Hence an immersion tank test was also prepared for bond quality evaluation to see if any could be detected.

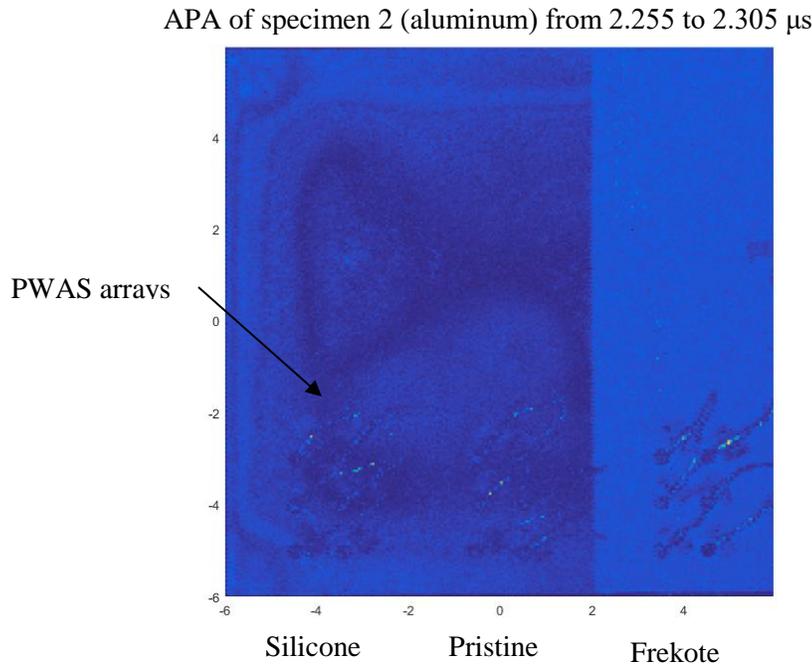
Figure 4.10: Immersion tank scan of Specimen 2 using a 10 MHz focused transducer using pulse echo single penetration displaying APA of signal between 1.235 to 1.285 μ s

After immersion tank scanning on all specimens was completed and it turned out that certain defects and contaminations could be identified. As expected the immersion tank easily detected all delamination and the adhesive voids and addition were identifiable (Specimen 3). Also observed was the interesting adhesive bonding pattern along the edges of the plate, likely due to changes of heat and pressure during bonding. Some bond layer contamination could also be seen on the aluminum specimens (specimens 1 and 2). When examining various time settings for the C-scan, the Frekote contamination appeared through most of the absolute peak amplitude (APA) windowed signal. However, the silicone contamination seemed to be undetectable on the aluminum plates (Figure 4.10).

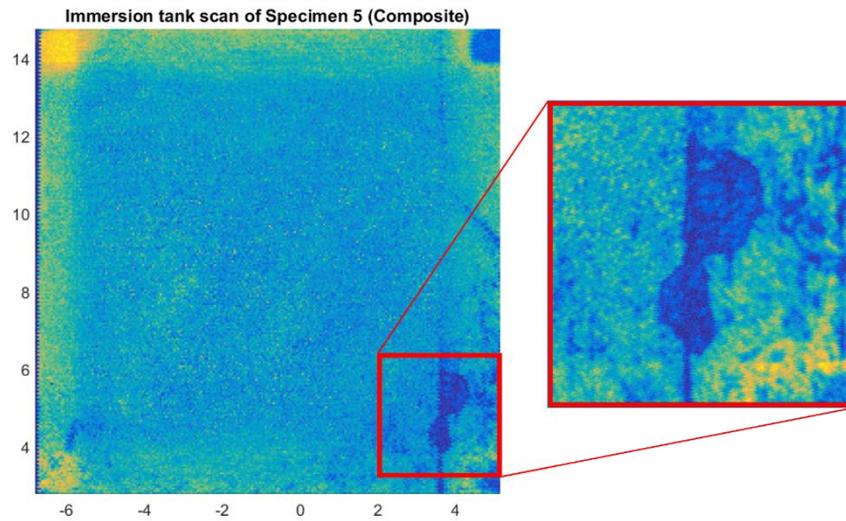
Figure 4.11: Immersion tank scan of Specimen 5 using a 10 MHz focused transducer pulse echo single penetration displaying APA of signal between 1.73 to 1.78 μ s with closeup of 3 \times 3 inch area of selected damaged area

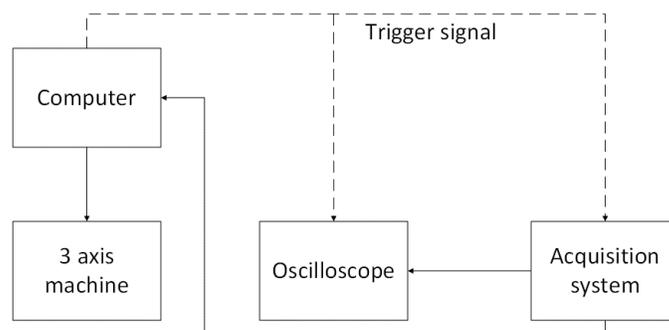
Figure 4.12: Simple block diagram of the system

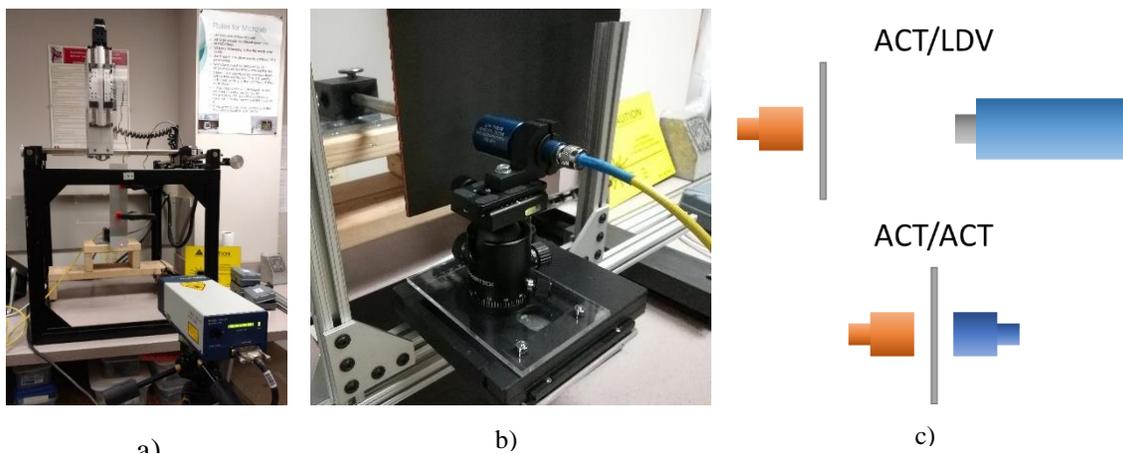
Figure 4.13: The scanning system a) equipped with ACT-LDV, b) ACT-ACT and c) diagram of sensor alignment

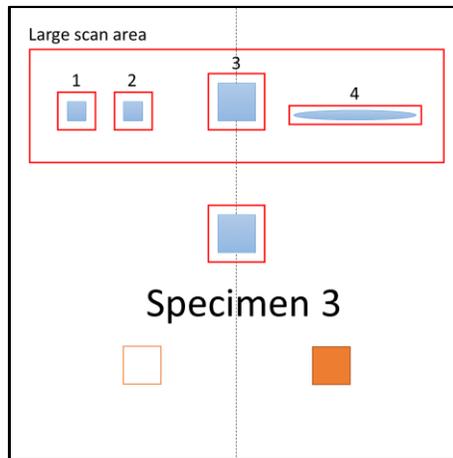
Figure 4.14: Scan areas on Specimen 3
