Acousto-Ultrasonic SHM/NDE Methods Toward Field Application

ACOUSTO-ULTRASONIC SHM/NDE METHODS TOWARD FIELD APPLICATION

For the Degree of Master of Science in

Mechanical Engineering

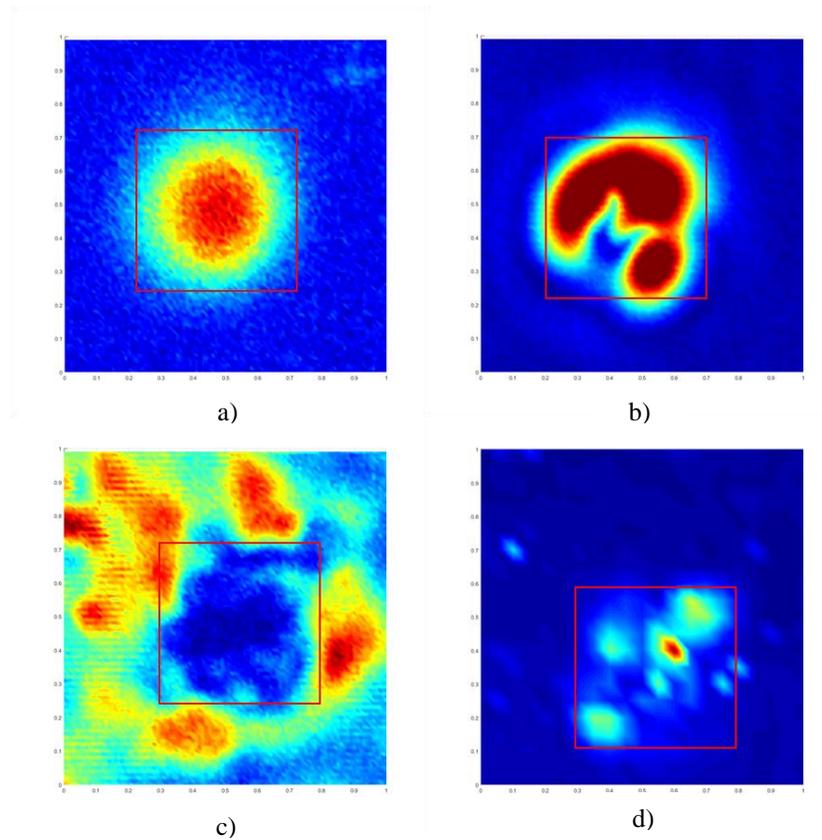
Figure 4.15: Location 1 APA scan area detecting a 0.5 by 0.5 inch bagging film using a) ACT-ACT at 120 kHz Settings 1 b) ACT-ACT at 225 kHz c) ACT-ACT at 400 kHz d) ACT-LDV at 225 kHz where the red box indicates the disbond size and location

seems to miss the rest of the bagging film. The 400 kHz scan resulted in the full damage being seen. The film was nearly undetected with the 120 kHz transducers.

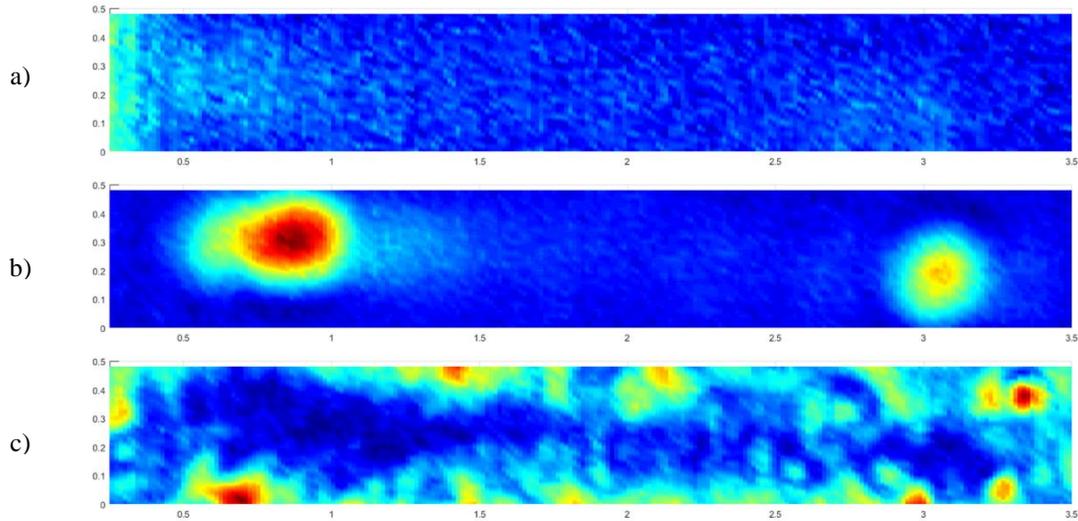
Figure 4.16: Location 4 APA scan area detecting a roughly 3.25 by 0.25 inch section of bagging film using a) ACT-ACT at 120 kHz b) ACT-ACT at 225 kHz c) ACT-ACT at 400 kHz

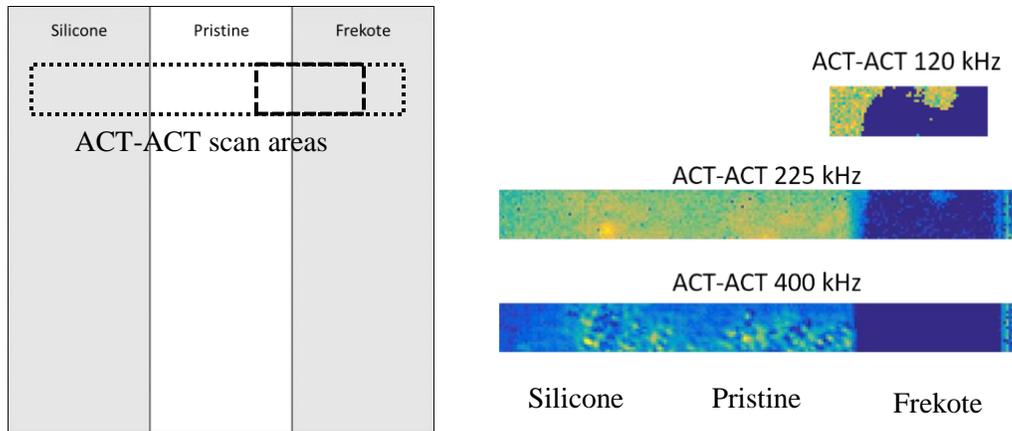
Figure 4.17: ACT-ACT 120, 225, and 400 kHz 2× APA a) scan areas and b) scans

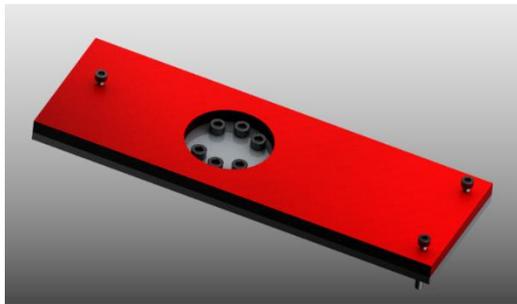
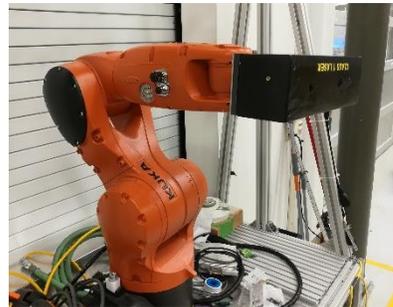
Figure 4.18: Dummy pulse laser a) flange and b) mounted on a KUKA KR6

The PL dummy was built from a wooden block and fitted with an iron core to simulate the weight. The block was supplied with a Class 1 laser and external leads to power it. Once mounted using the adaptor plate (Figure 4.18), procedures could be practiced for future experiments.

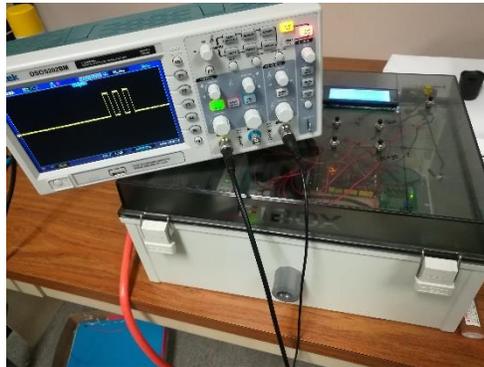
Figure 4.19: Function box with oscilloscope resting on top showing the output signal
This function box receives the 24 volt signal from the KUKA computer, indicating that the robot has positioned and through a microcontroller exports the desired averages and excitation rate trigger signal at 5 volts. These settings are displayed on a liquid crystal LCD.

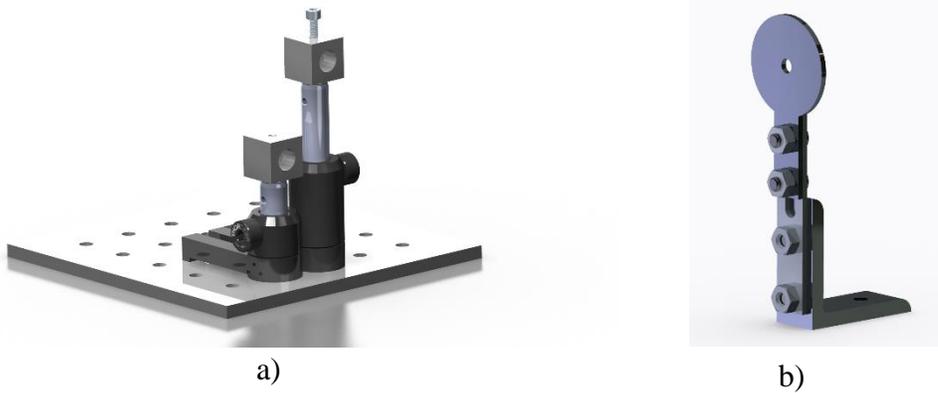
Figure 4.20: Alignment tools with a) line laser housings and b) target for calibration

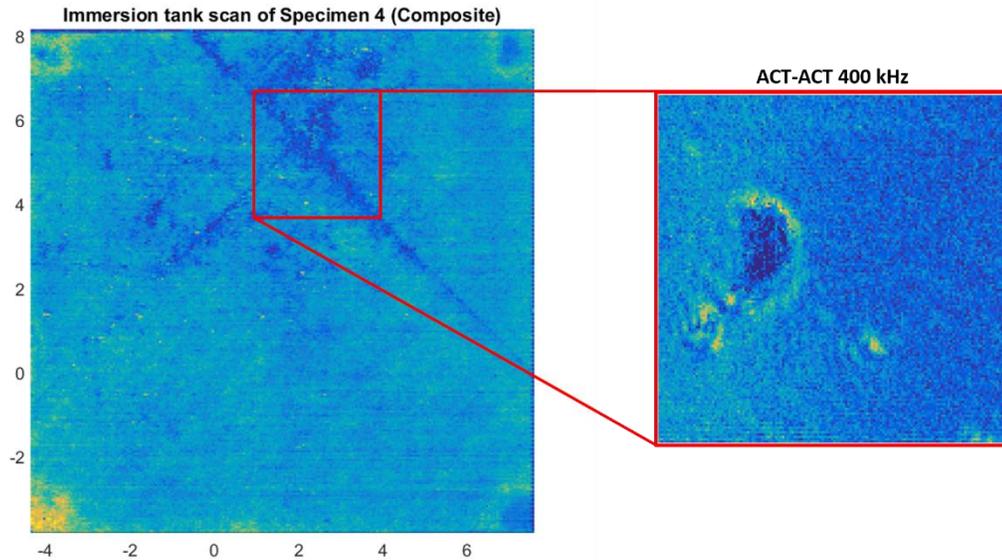
Figure 4.21: Immersion tank scan of Specimen 4 APA between 1.575 and 1.625 μ s at with closeup of ACT-ACT 400 kHz scan APA between 300 and 301 μ s

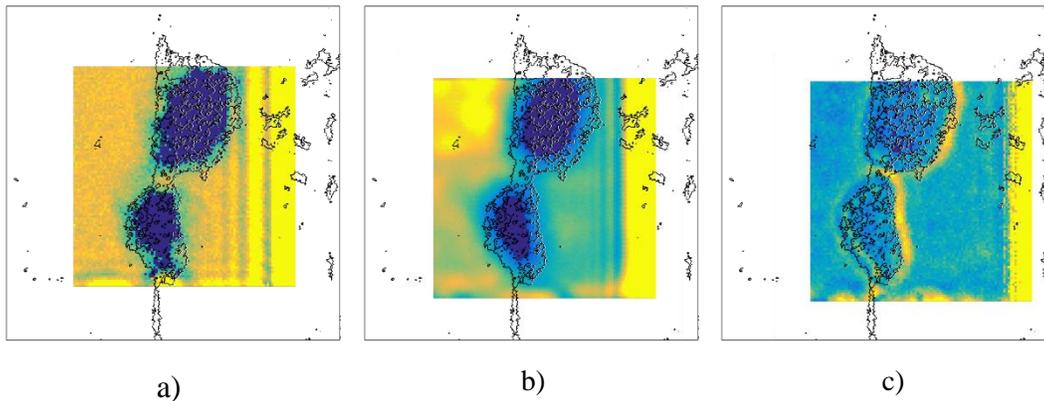
Figure 4.22: ACT-ACT 2x2 inch through transmission APA 50 to 100 μ s C-Scan of damage on Specimen 4 of damaged region with 3x3 inch immersion scan contour overlap using a) 120 kHz b) 225 kHz and c) 400 kHz transducers
