Mechanical Characterization and Non-Destructive Evaluation of SiC_f/SiC_m Composites for Nuclear Applications

MECHANICAL CHARACTERIZATION AND NON-DESTRUCTIVE EVALUATION OF
SiC_F/SiC_M COMPOSITES FOR NUCLEAR APPLICATIONS

For the Degree of Master of Science in

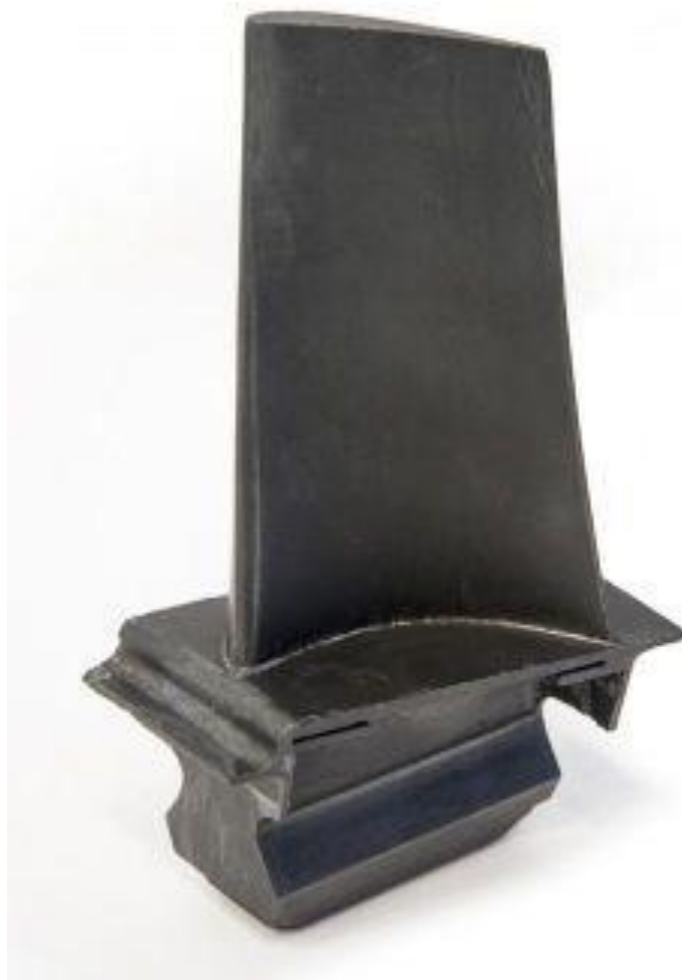
Figure 1.3: $\text{SiC}_f/\text{SiC}_m$ composite turbine blade [17]

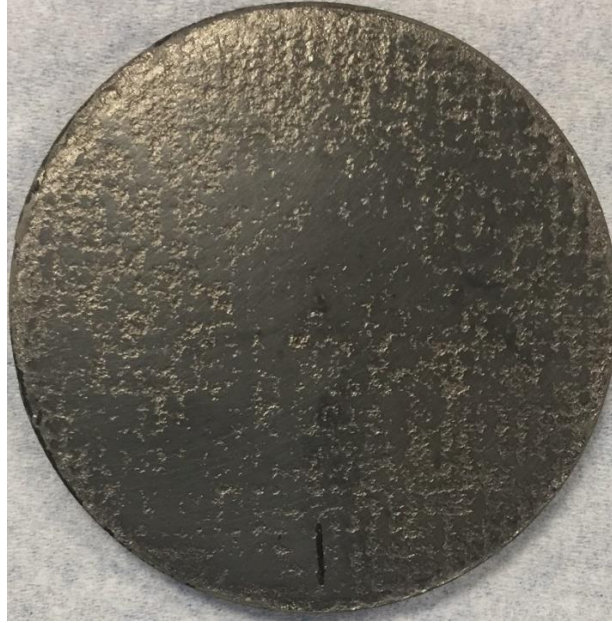
Figure 2.1: Pristine SiC_f/SiC_m Disk (Disk 1), mark on bottom added to indicate orientation and impact side.

Three samples, here labelled disks 1, 2 and 3, were provided by General Atomics for testing. Each were of similar flat disk design, measuring approximately 50mm in diameter by 3mm in thickness. These disks were made up of a β -phase monolithic SiC matrix sandwiched around multiple laminae of woven SiC fibers and were manufactured using transient eutectic phase (TEP) processing via hot pressing. It is important to note that the TEP process is noticeably different than the CVI process in that a hot press is used for powder compaction. Each sample was lightly polished by the manufacturer to remove surface roughness.
