Evaluating the Efficacy of Sand Fences on Dunes Impacted by Hurricanes

EVALUATING THE EFFICACY OF SAND FENCES ON DUNES IMPACTED BY
HURRICANES

For the Degree of Master of Science in

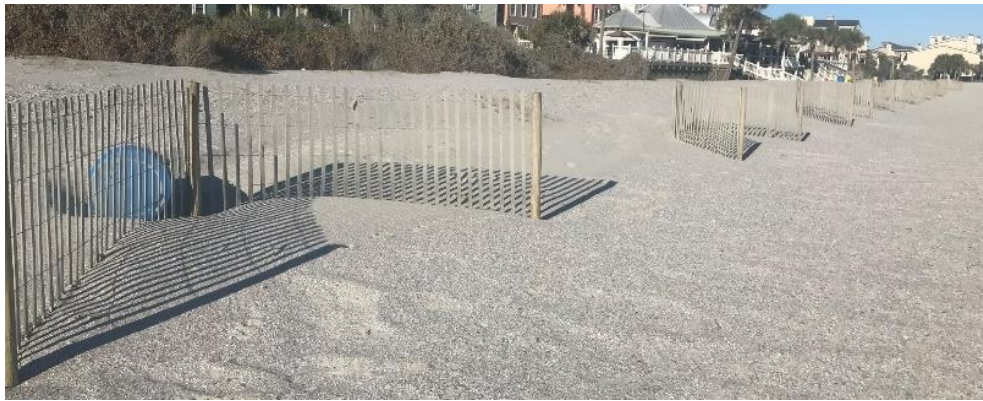
Figure 1.1 Sand fences installed in a V-shaped formation along a South Carolina beach. The apex of the “V” is pointing towards the dune crest.

Sand fences are placed to stabilize existing dune systems or to encourage incipient dune formation. They provide a porous barrier and are installed in a wide array of positions, including shore parallel, perpendicular, or in V-shaped formations with a landward apex (Figure 1.1). Installations seek to regulate the rate of aeolian transport to reduce erosion and/or to cause sand deposition (Li and Sherman, 2015). Sand may be transported in conditions where shear velocity (u^*) exceeds threshold shear velocity (u_{*t}). As wind-blown sand is

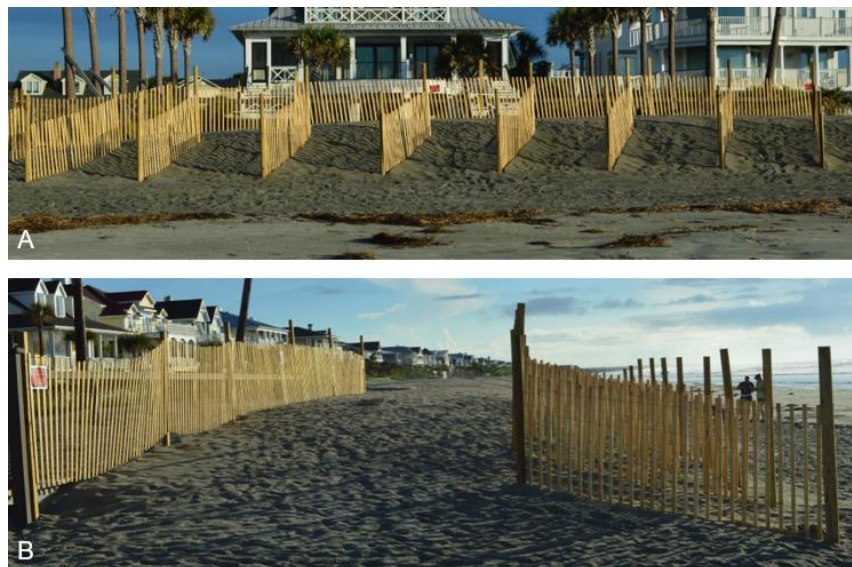
Figure 3.2. Photos of the fenced site taken on 9/11/18, where the wrack represented the high tide line from the recent king tide on 09/09/2018. A) View looking landward. B) View of site from southwestern extent, including the shore parallel fence (left side of image).

The fenced site has a linear distance of approximately 22 m. It contained ten oblique sand fences installed on a mechanical dune (Figure 3.2A) and a shore parallel fence installed landward (Figure 3.2B). The fences were oriented from the southwest to the northeast and numbered 1 through 10 (Figure 3.3). The fences were located approximately 2.3 m apart, and their average length was 3.1 m (Figure 3.3). The control site was located 18.5 m northeast of the

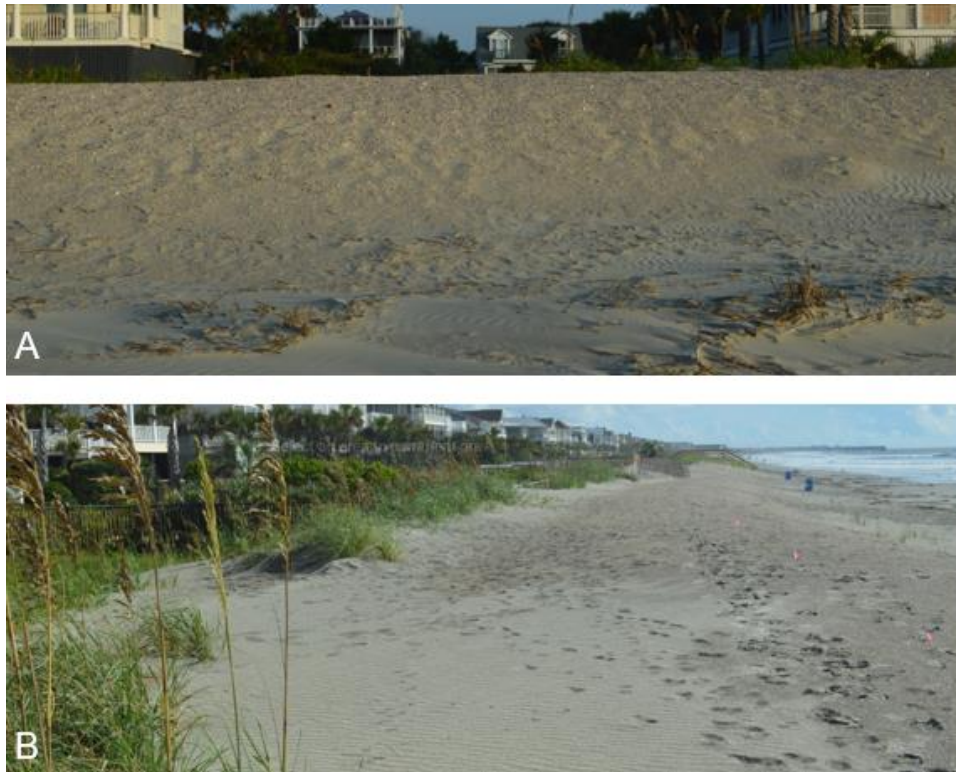
Figure 3.4. Photos taken of the control site on 09/11/18. A) View looking landward. B) Landward extent of control site (vegetation line).

fenced site and had a linear distance of 22 m. We segmented the site and generated five transects that were 5.5 m apart (Figure 3.4A). This site was also on the mechanical dune, but unlike the fenced site, there was no landward development. The landward extent of the site was delineated by the vegetation line (Figure 3.4B).

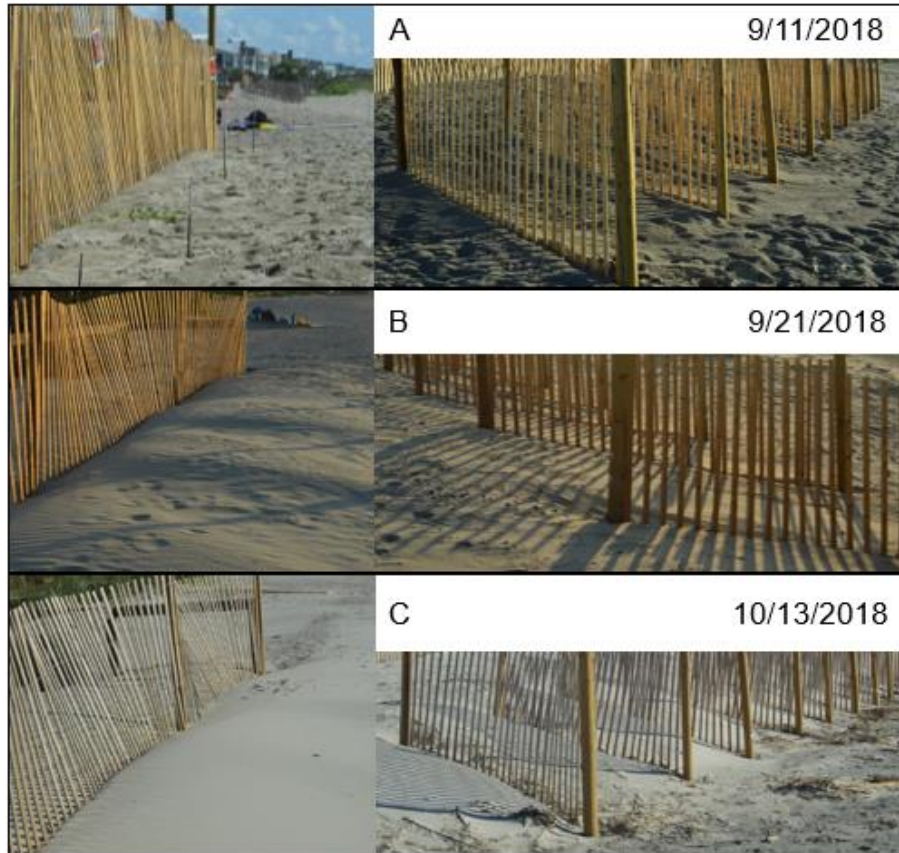
Figure 5.1. Photos of the fenced site on the three collection dates, featuring the shore parallel and oblique fences. A) Pre-Florence; B) Post-Florence/Pre-Michael; C) Post-Michael

Data suggested that the greatest morphologic change occurred during time period one. This result was supported by field measurements (Figure 4.2 A; B, Figure 4.3 A; B). However, the inclusion of field photographs (Figure 5.1 A; B; C) indicated that fine-scale depositional patterns were not thoroughly detected by the field measurements and as such, the results should be carefully considered when assessing volumetric change during period two when depositional patterns were most observed. At the conclusion of time period two (Figure 5.1C) results indicated that under maximum wind conditions, greater incipient dune growth was observed in the fenced site while erosion occurred concurrently in the control site (Figure 4.2 C; D). The exception to this occurred along the back dune (section a) where native plants aided in trapping sediment to stabilize and increase dune volume. This role was mimicked at the fenced site by the presence of the shore parallel fence. Field photos and in situ data within section a supported this depositional trend and landward migration witnessed at both field sites. The fenced dune site was largely unvegetated, with a stabilizing species appearing between fences 4-5 during time period one, which promoted an increase in volume. This observance supported the previous suggestion that sand fences and vegetation promote dune growth and recovery (Mendelssohn et al., 1991). Deposition was predominantly located around the native vegetation, between the oblique fences, and along the shore parallel fence. These depositional patterns support the functionality of sand fences for dune building and recovery (Miller, Thetford, and Yager, 2001; Khalil, 2008) in environments susceptible to aeolian transport. The depositional patterns and orientation follow

the dominant wind direction observed during Hurricane Michael's path during time period two, supporting that the storm largely influenced the geomorphic change observed at the site.
