Load Rating Evaluation of Deteriorated Prestressed Channel Girders

LOAD RATING EVALUATION OF DETERIORATED PRESTRESSED
CHANNEL GIRDERS

For the Degree of Master of Science in

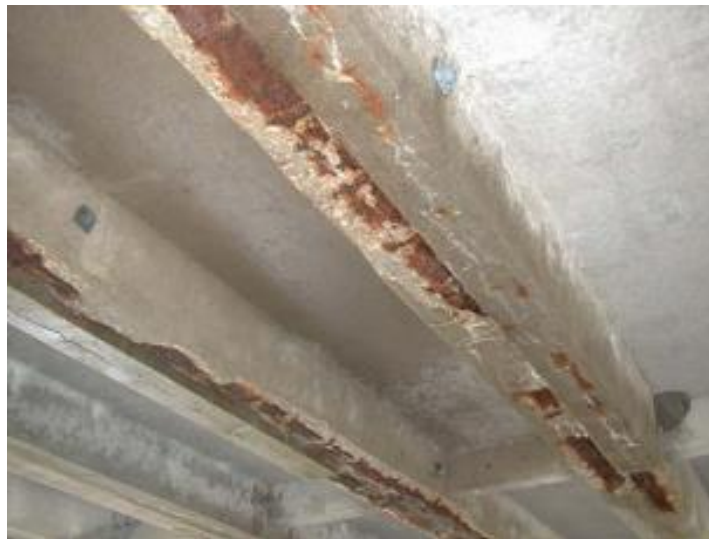
Figure 2.1 Typical PCB deterioration (Klaiber et al. 2003).

Klaiber et al. (2003) investigated precast channel bridges girders from secondary road Iowa bridges built some 40-50 years ago. Many of these bridges (600) show signs of deterioration. Typical deterioration consists of reinforcement corrosion resulting in spalling or missing concrete cover, cracking, and rust stains on the bottom of the soffit. This type of deterioration leads to loss of cross-sectional area in the reinforcement and ineffective reinforcement-concrete bond. Four channel bridges were instrumented in the field with deflection transducers and strain gauges to track midspan vertical deflections and strains during truck loading. Twelve laboratory tested girders were loaded to failure in a four-point bend test set-up and were instrumented similar to the four field tests. The overall goal of Klaiber et al. (2003) was to assess the structural sufficiency of the girders' deteriorated state through field and laboratory testing.

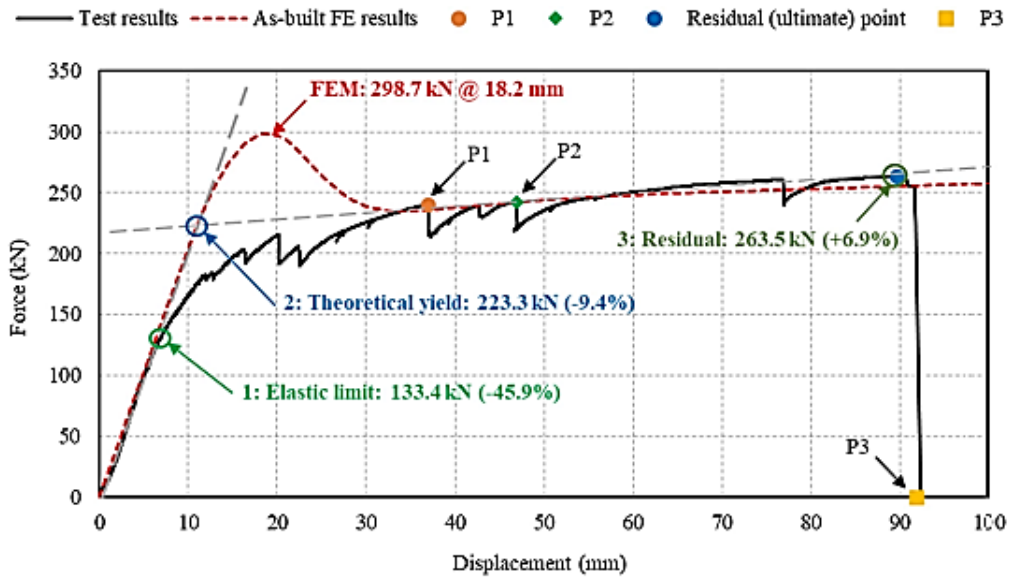
Figure 2.3 Load-deflection behavior of the tested damaged girder versus the numerical as-built behavior of the girder (Gunasekaran et al. 2022).

Results of the test can be seen in the load-displacement curve shown in Figure 2.3. The girder demonstrated linear behavior up until a load of 30 kips and 0.25 in. midspan displacement. Crack C6 then propagated beyond the soffit of the girder, and once the behavior became non-linear crack C6 began to open and multiple new cracks

formed. All the dips in the load-deflection curve in Figure 2.3 are attributed to the opening of a new crack or propagation of an existing crack. Load increased up to 59.2 kips and 3.7 in. of displacement was reached, where ultimate capacity was achieved and complete failure occurred. The failure mode consisted of concrete crushing followed by strand rupture. The noticeable difference between the experimental and FEM load-displacement response were thought to be due to existing cracks and concentration of stresses in the prestressed strands at these crack locations.

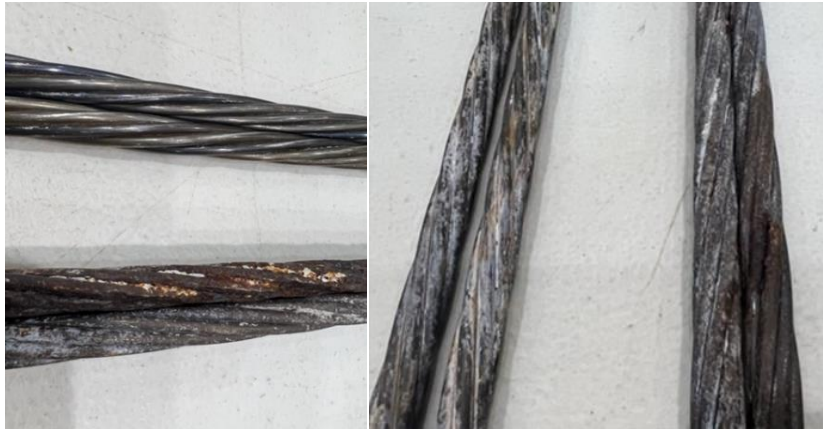
Figure 4.1 Various levels of strand corrosion.

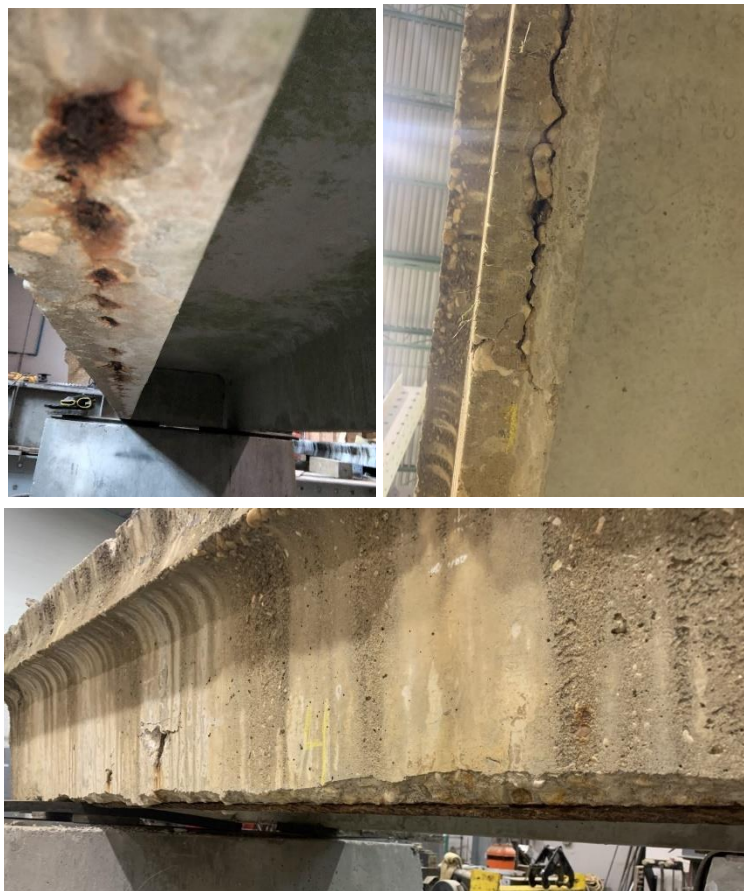
Figure 4.2 Examples of channel deterioration.

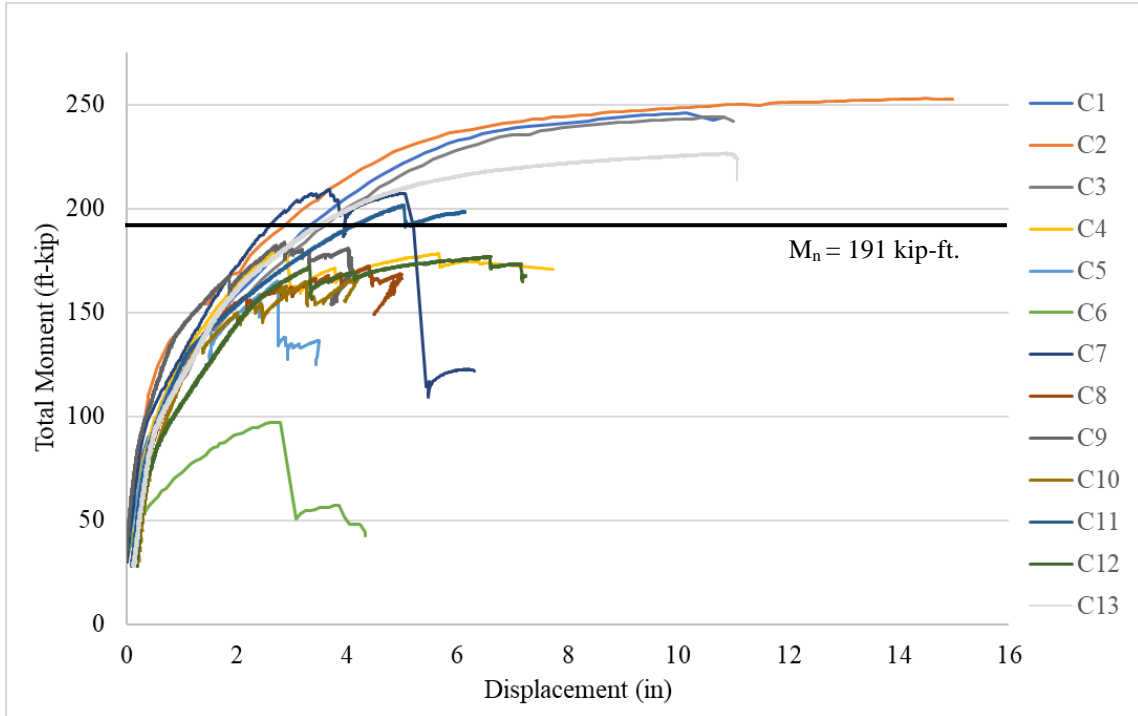
Figure 4.3 Moment vs. displacement.

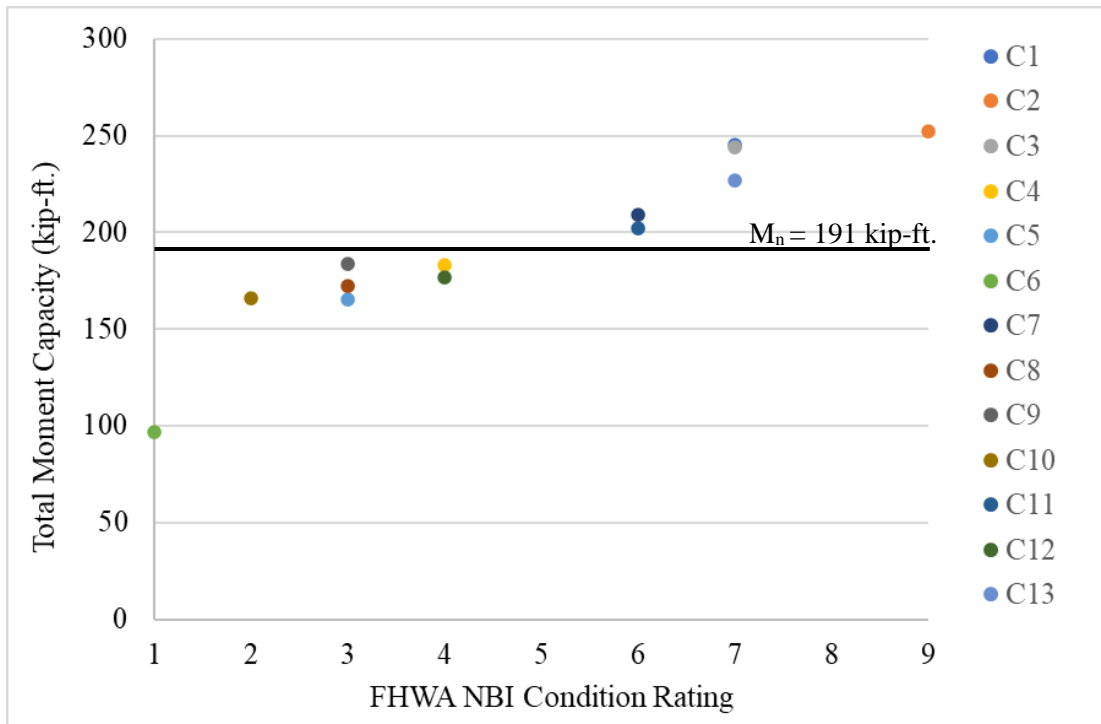
Figure 4.5 Total moment capacity and corresponding condition rating.

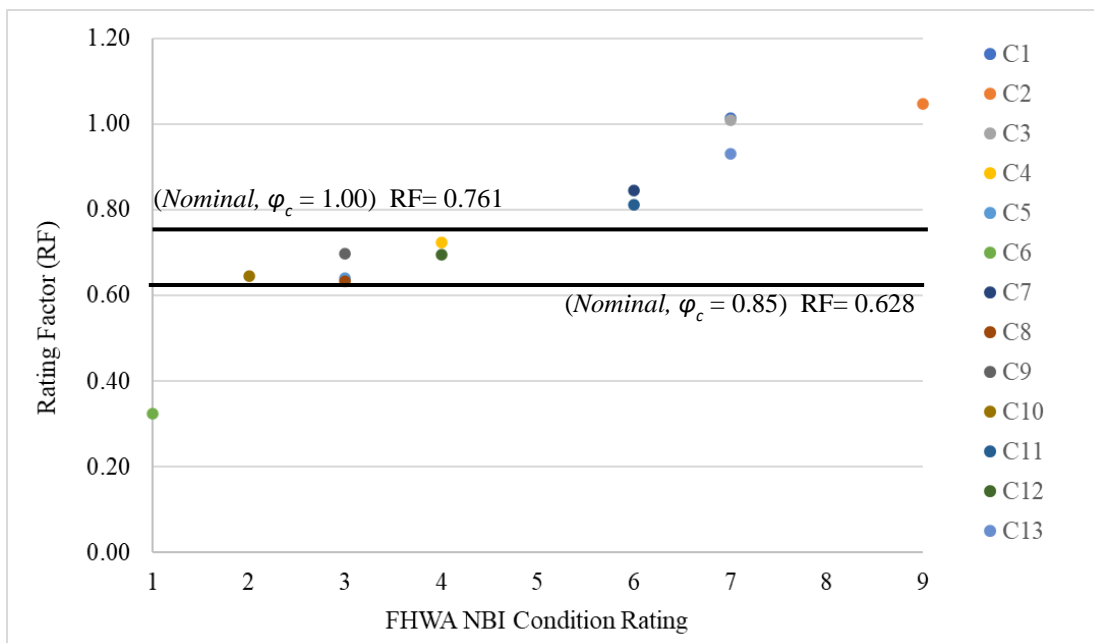
Figure 4.6 LRFR Strength I (inventory) rating factor and corresponding condition rating.

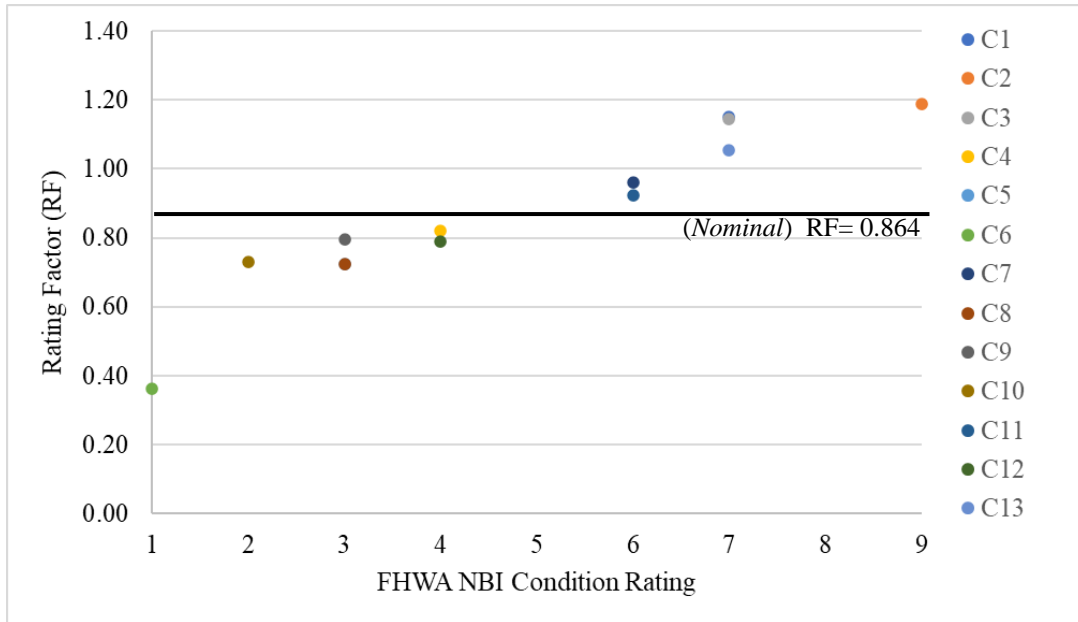
Figure 4.7 LFR Strength (inventory) rating factor and corresponding condition rating.

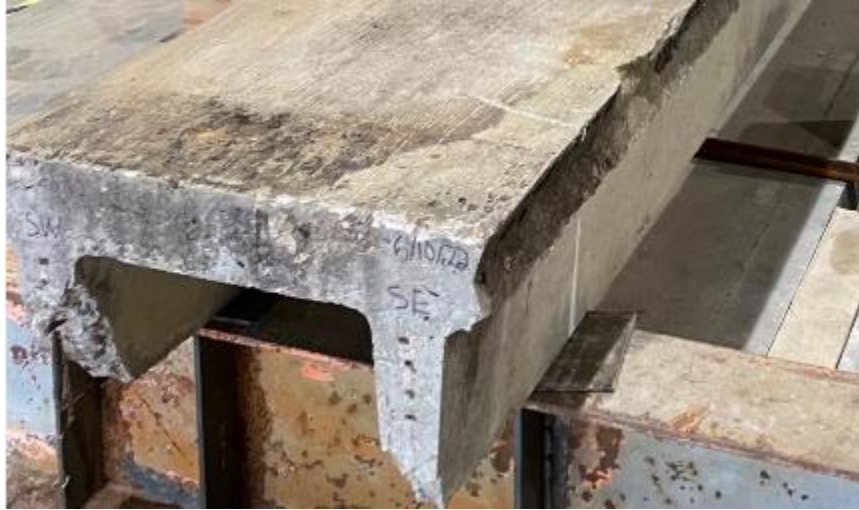
Figure A.4 C1 (NBI 7) end spalling, minor defect.

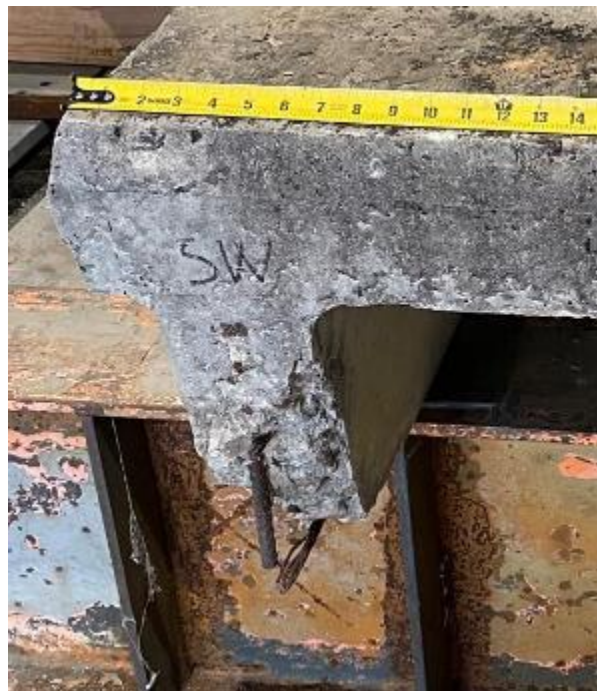
Figure A.5 C1 (NBI 7) exposed strand.

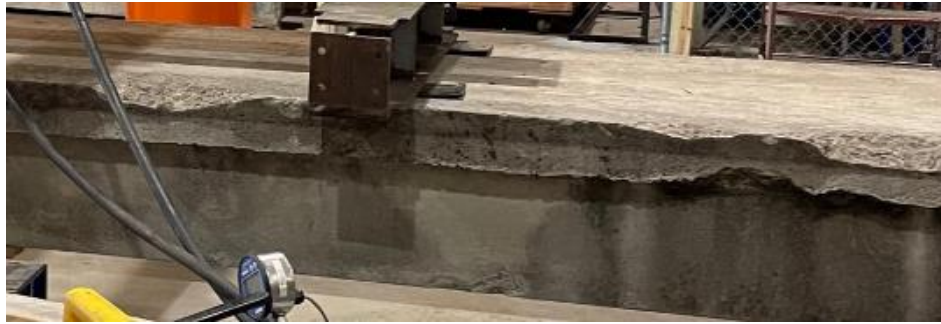
Figure A.6 C1(NBI 7) flange spalling, minor defect.

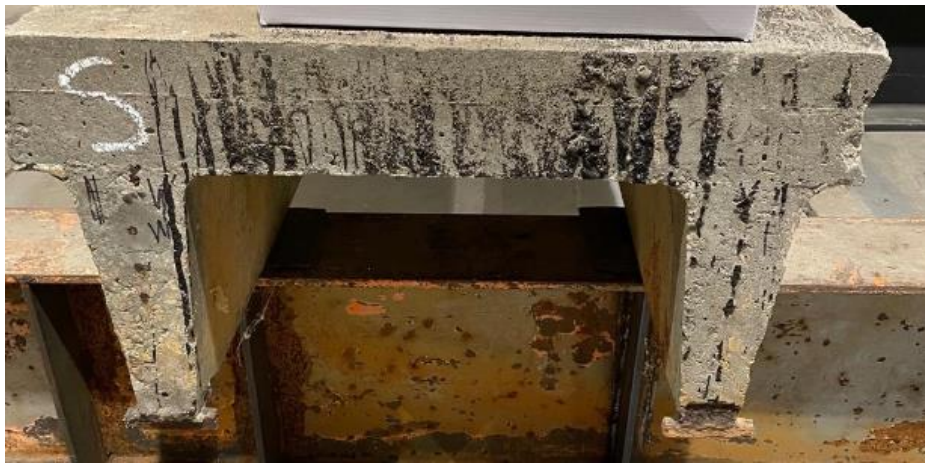
Figure A.7 C2 (NBI 9) end deterioration.

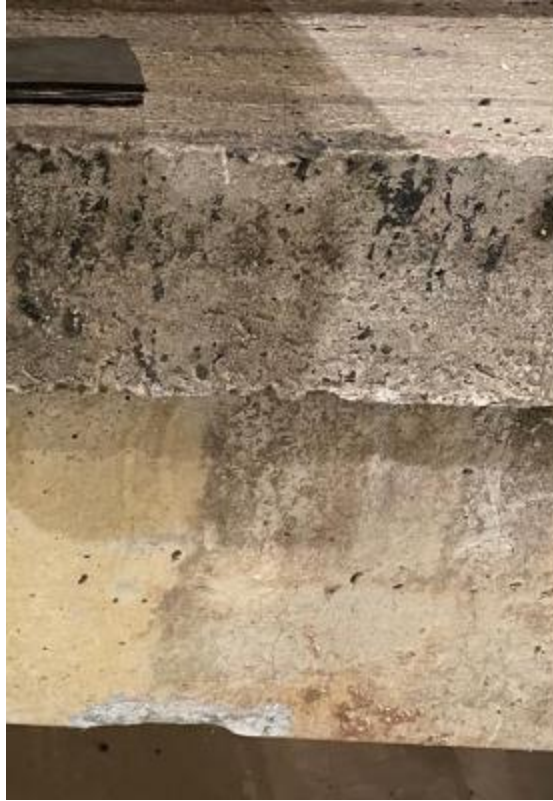
Figure **Error! Use the Home tab to apply 0 to the text that you want to appear here.**A.8 C2 (NBI 9) inherent defect.

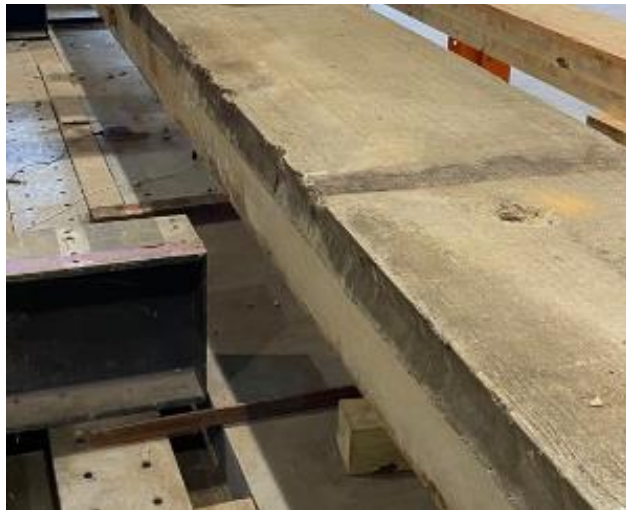
Figure A.9 C3 (NBI 7) flange spalling.

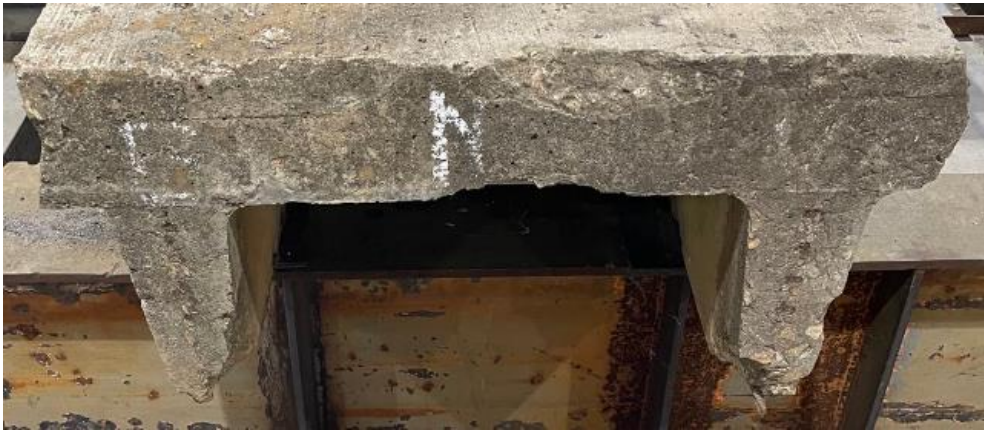
Figure A.10 C3 (NBI 7) end spalling.

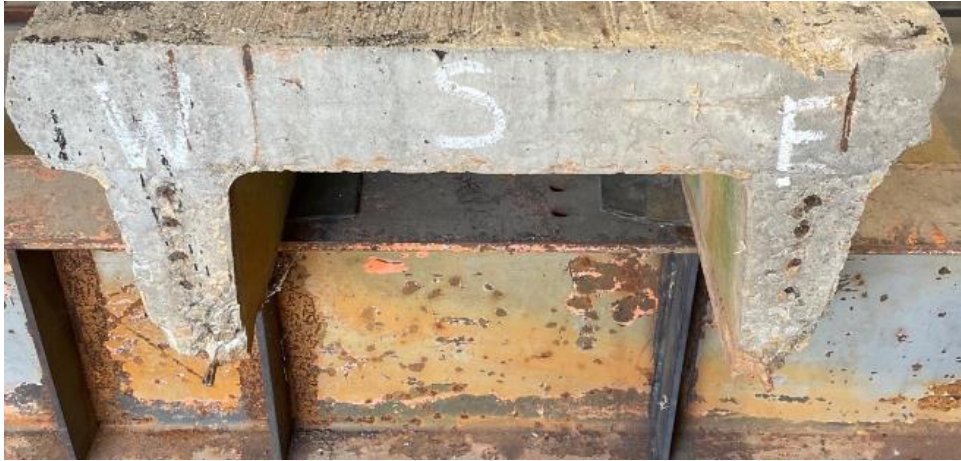
Figure A.11 C3 (NBI 7) exposed strands.

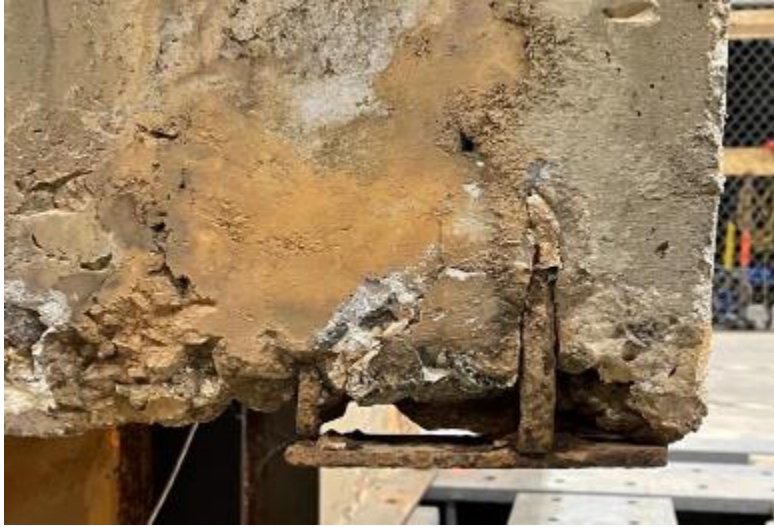
Figure A.12 C4 (NBI 4) moderate spall.

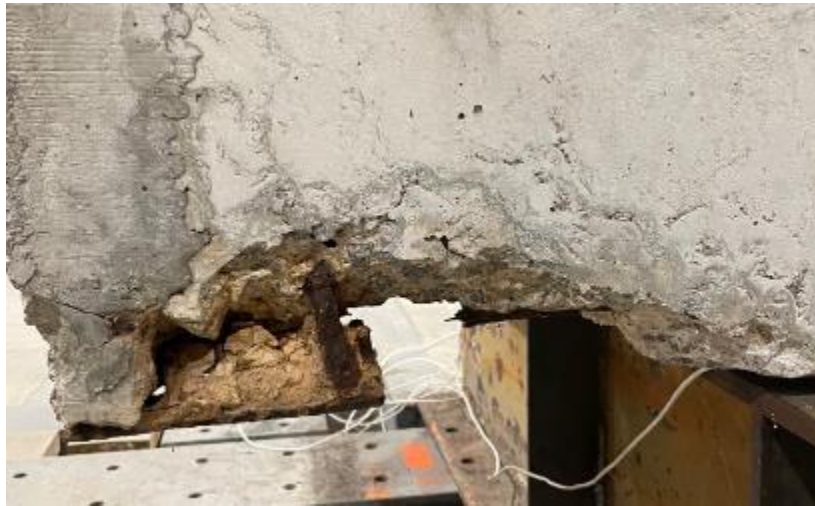
Figure A.13 C4 (NBI 4) moderate spall and corrosion.

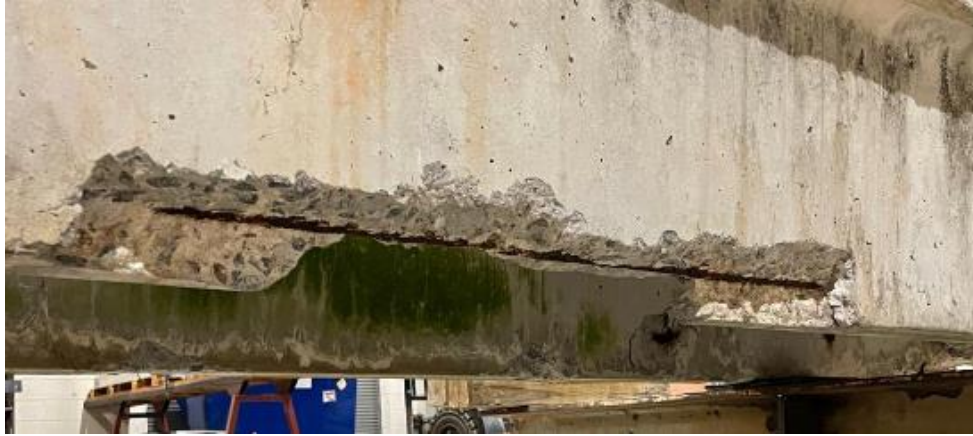
Figure Error! Use the Home tab to apply 0 to the text that you want to appear here.A.14 C4 (NBI 4) major defect near quarter span.

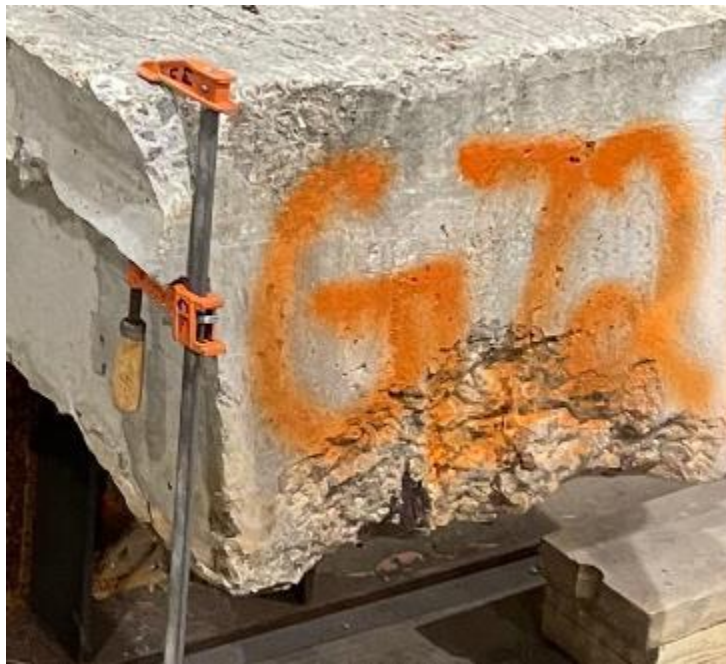
Figure A.15 C5 (NBI 3) large spalling, moderate defect.

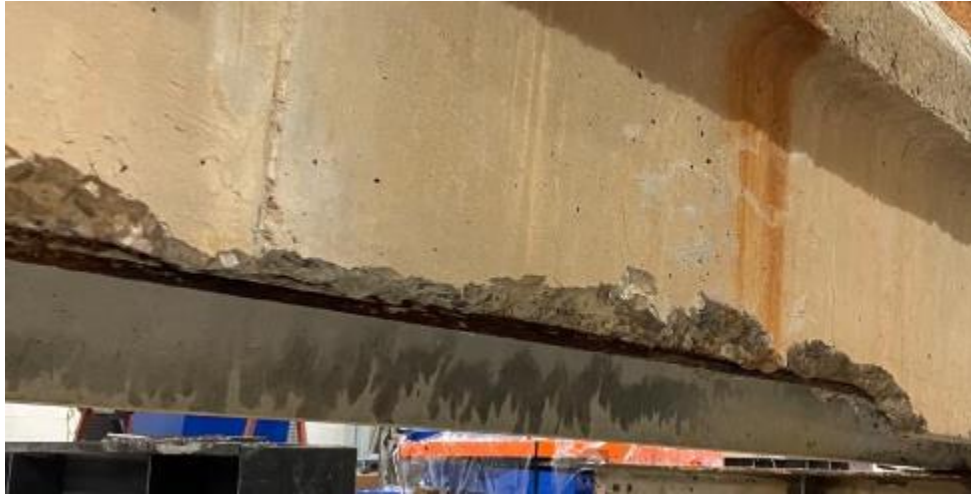
Figure A.16 C5 (NBI 3) major defect near load point.

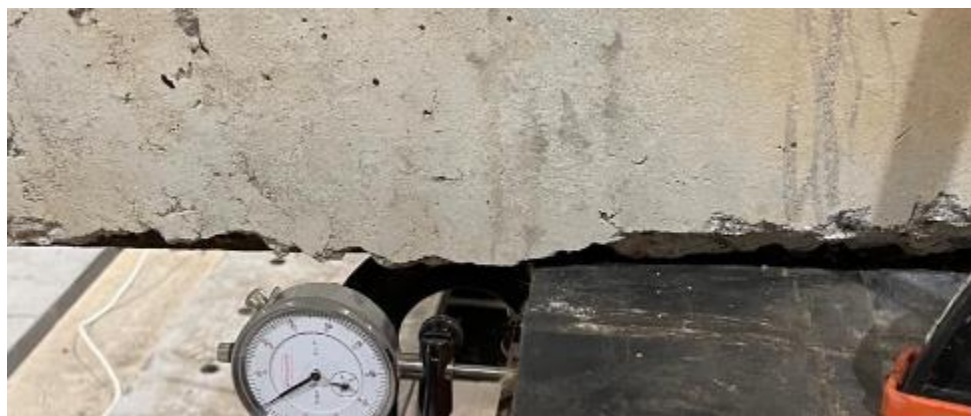
Figure A.17 C5 (NBI 3) major defect.

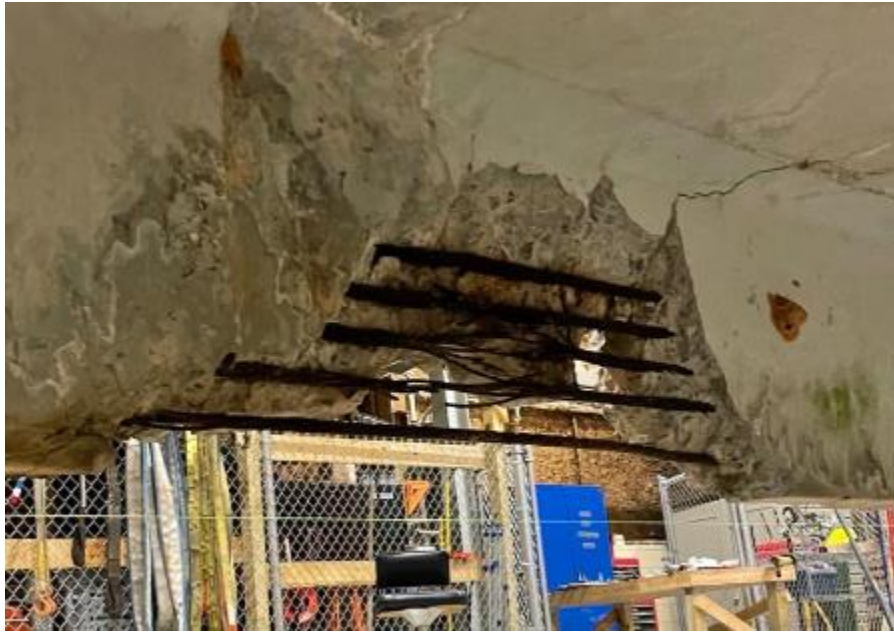
Figure A.18 C6 (NBI 1) imminent failure at midspan.

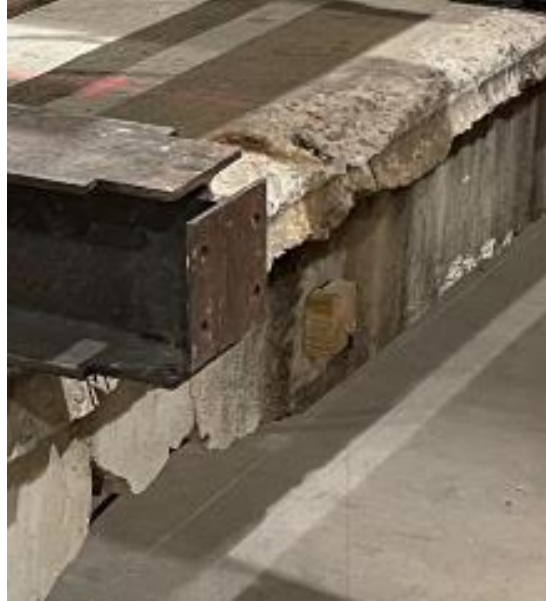
Figure A.19 C6 (NBI 1) severe deterioration.

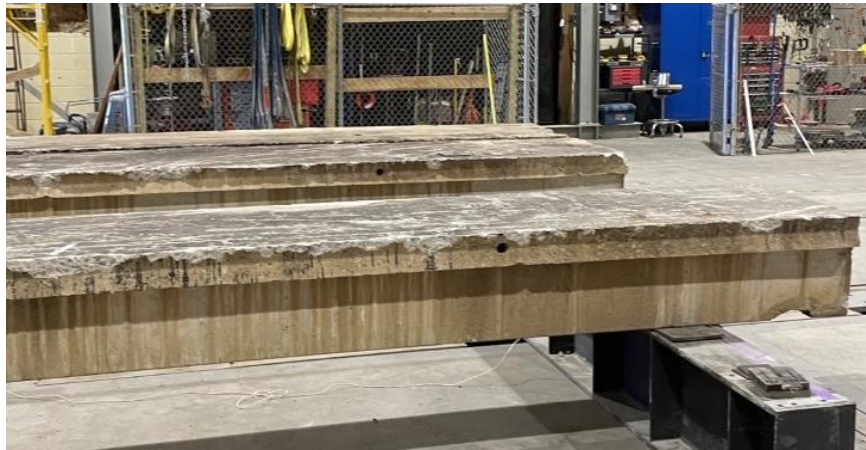
Figure A.20 C7 (NBI 6) widespread minor defects.

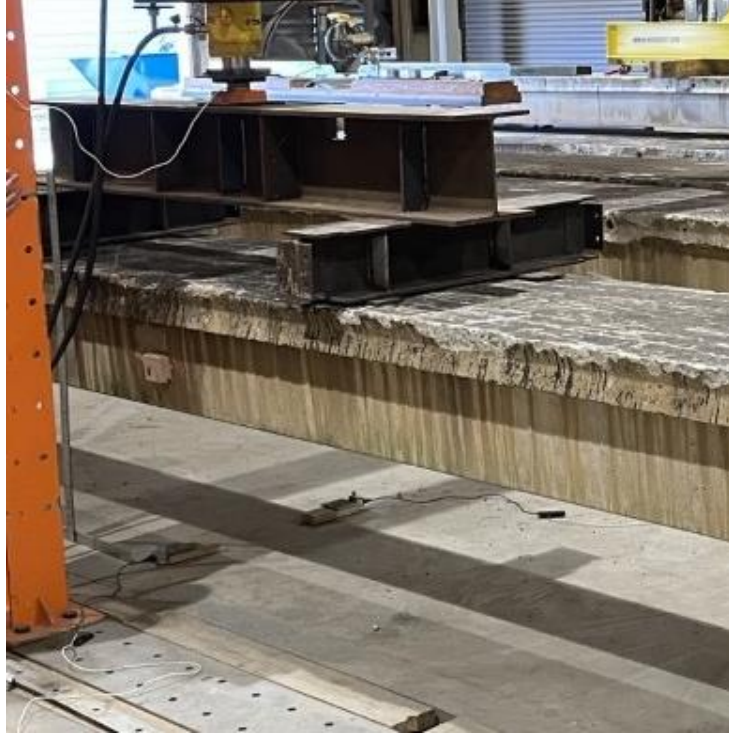
Figure A.21 C7 (NBI 6) flange spalling.

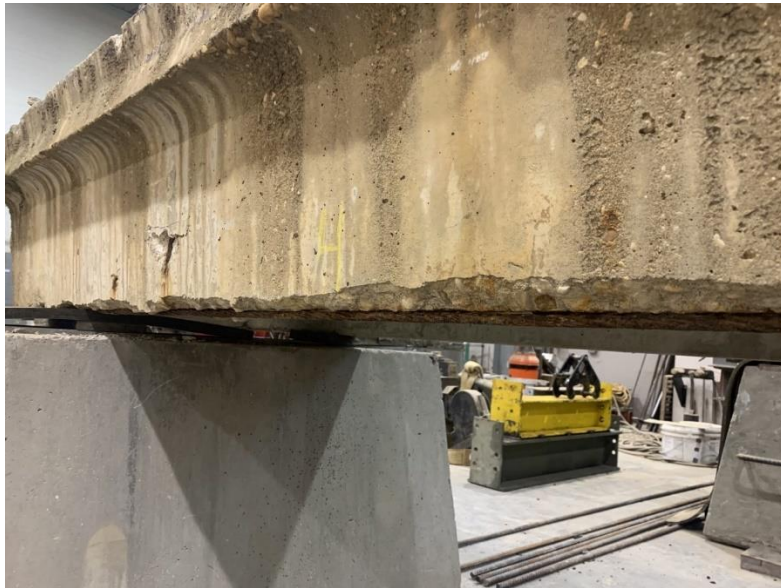
Figure A.22 C8 (NBI 3) major defect.

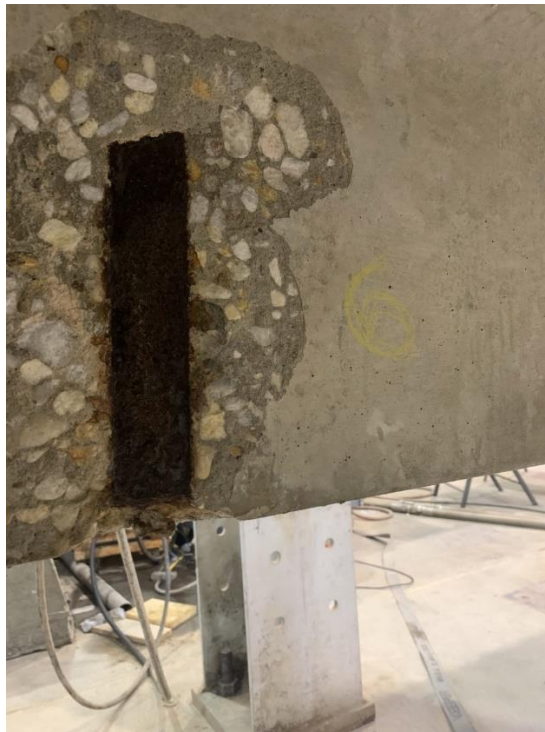
Figure A.23 C8 (NBI 3) moderate spall.

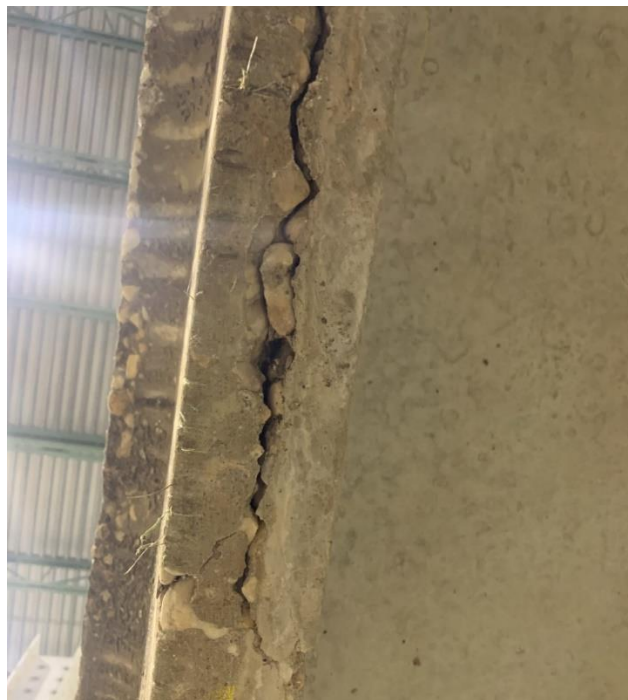
Figure A.25 C8 (NBI 3) wide crack.

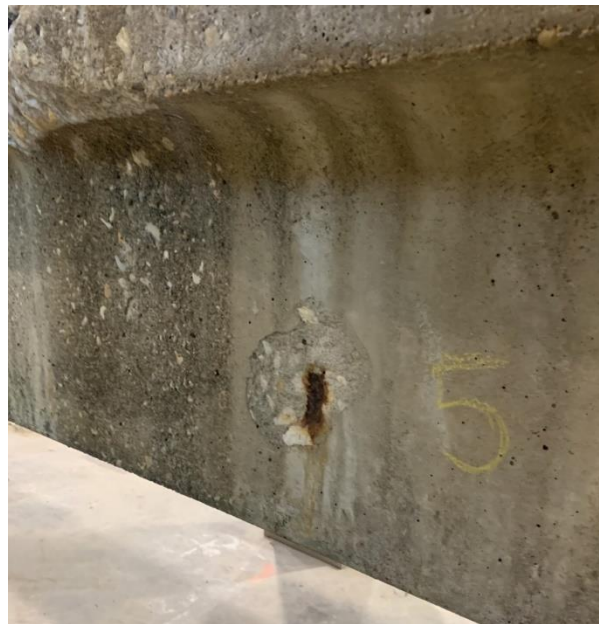
Figure A.27 C8 (NBI 3) minor defect.

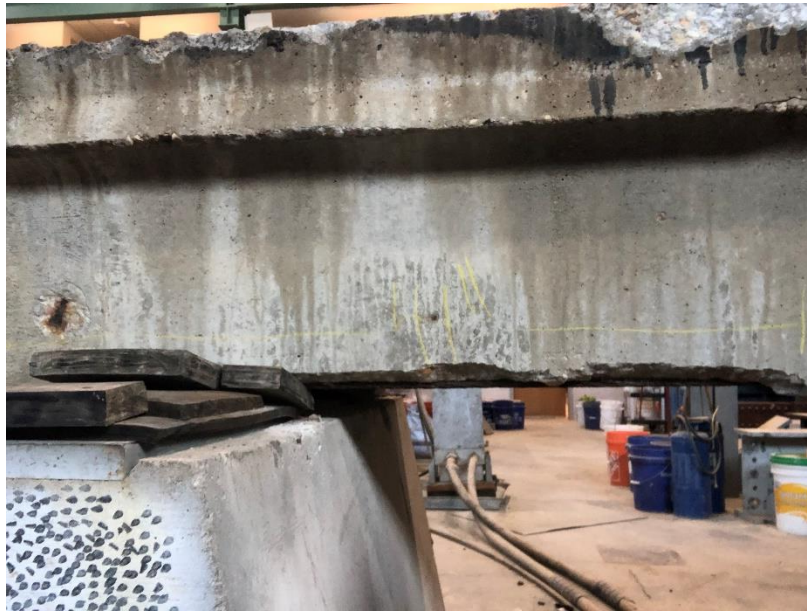
Figure A.28 C9 (NBI 3) major defect.

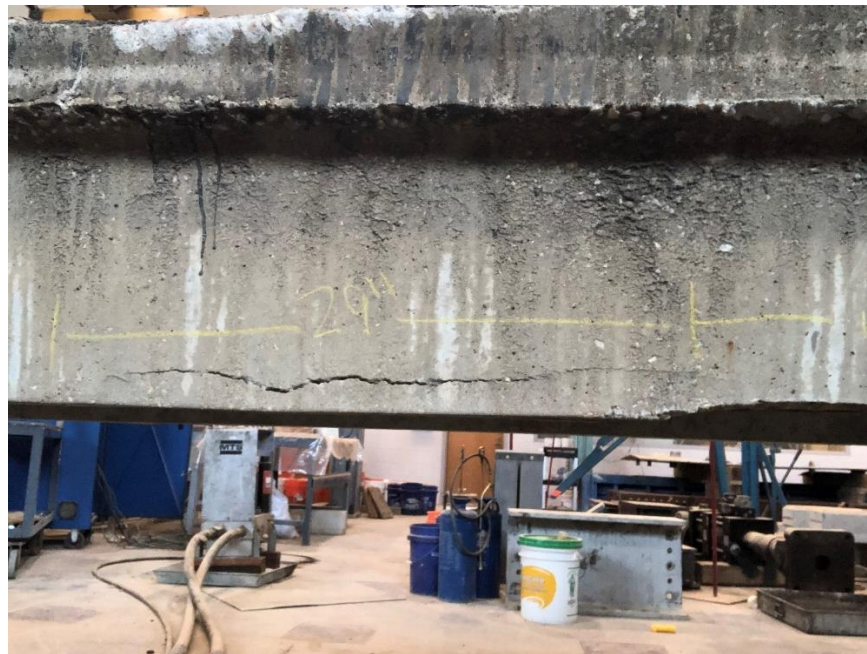
Figure A.29 C9 (NBI 3) moderate defect near quarter span.

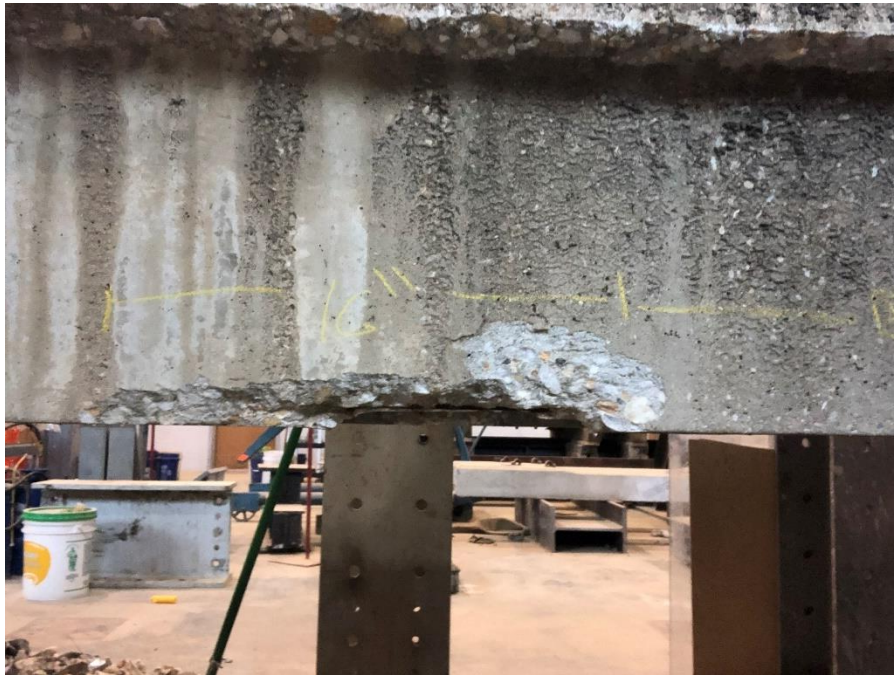
Figure A.30 C9 (NBI 3) moderate defect near midspan.

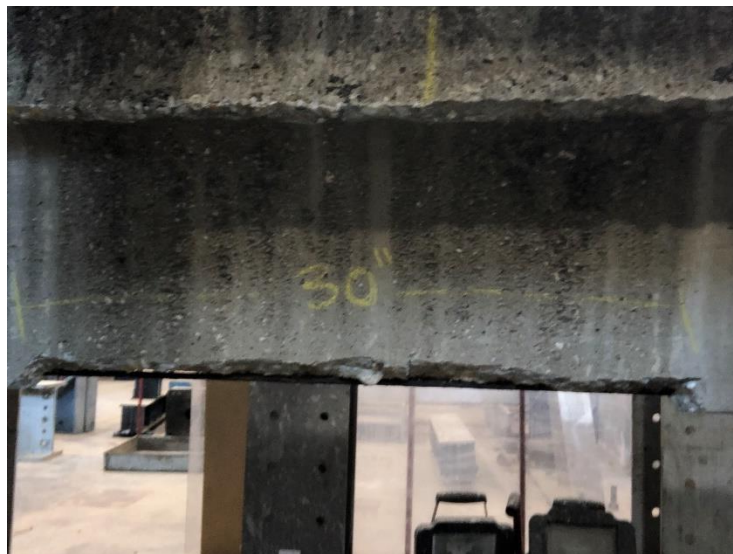
Figure A.31 C9 (NBI 3) major defect at midspan.

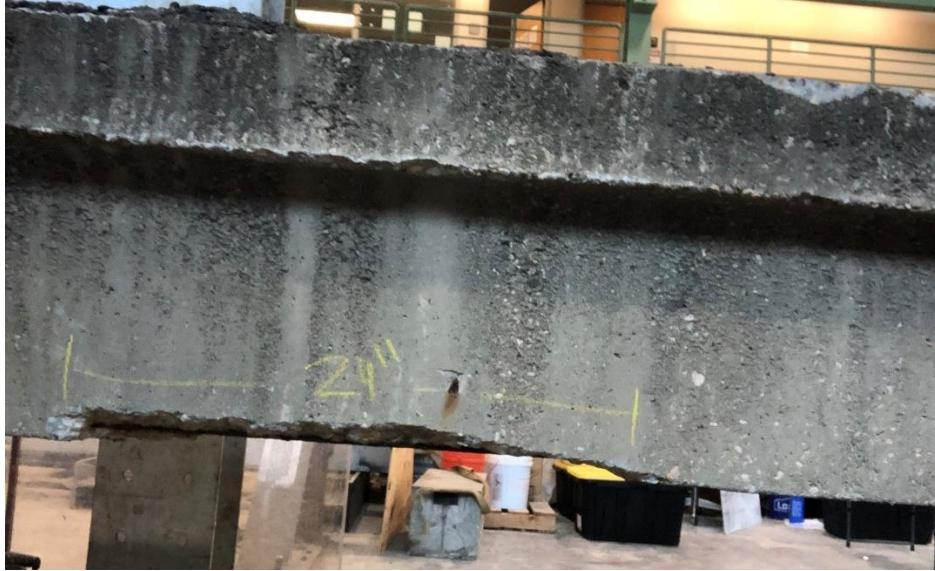
Figure A.32 C9 (NBI 3) major defect near midspan.

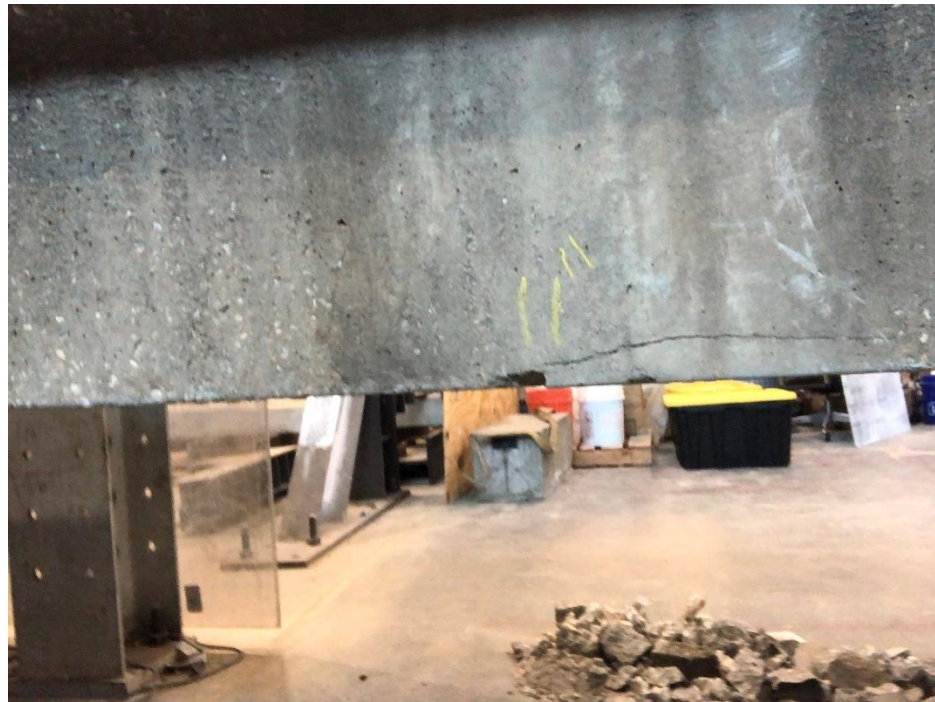
Figure A.33 C9 (NBI 3) medium crack, minor defect.

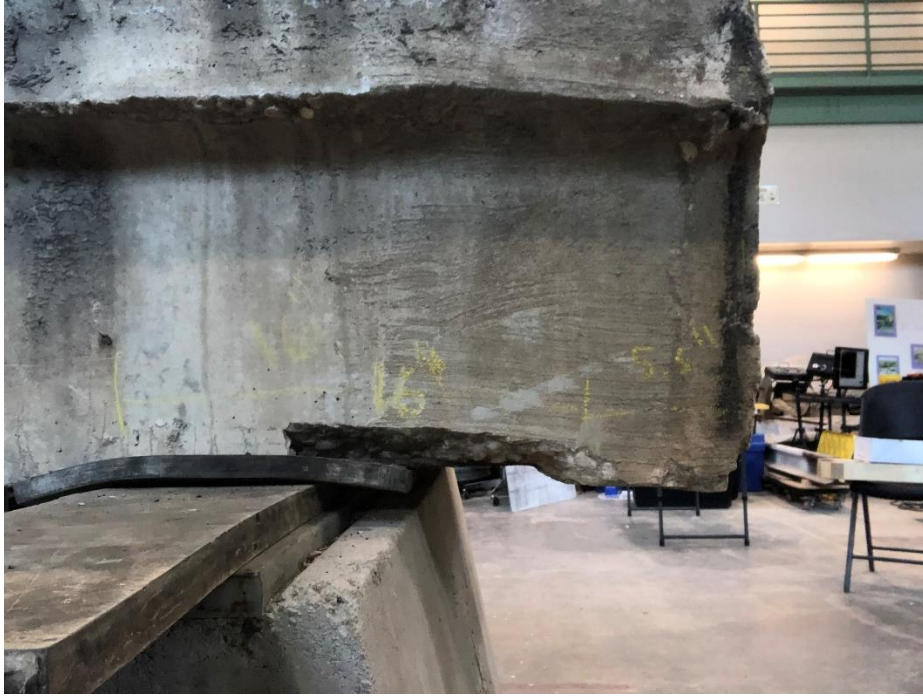
Figure A.34 C9 (NBI 3) large spall.

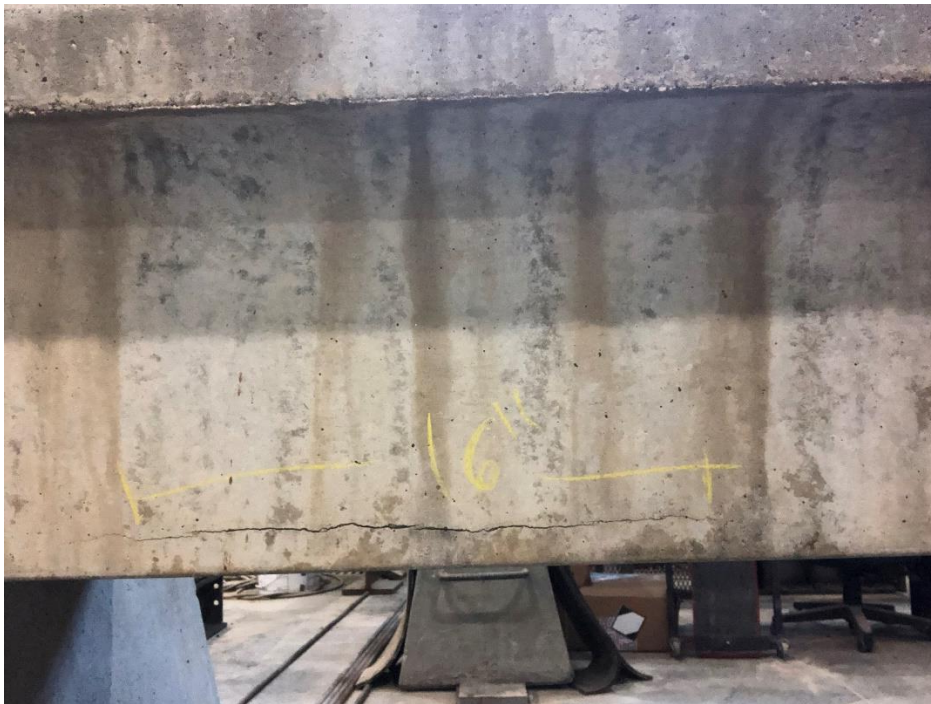
Figure A.35 C10 (NBI 2) medium crack.

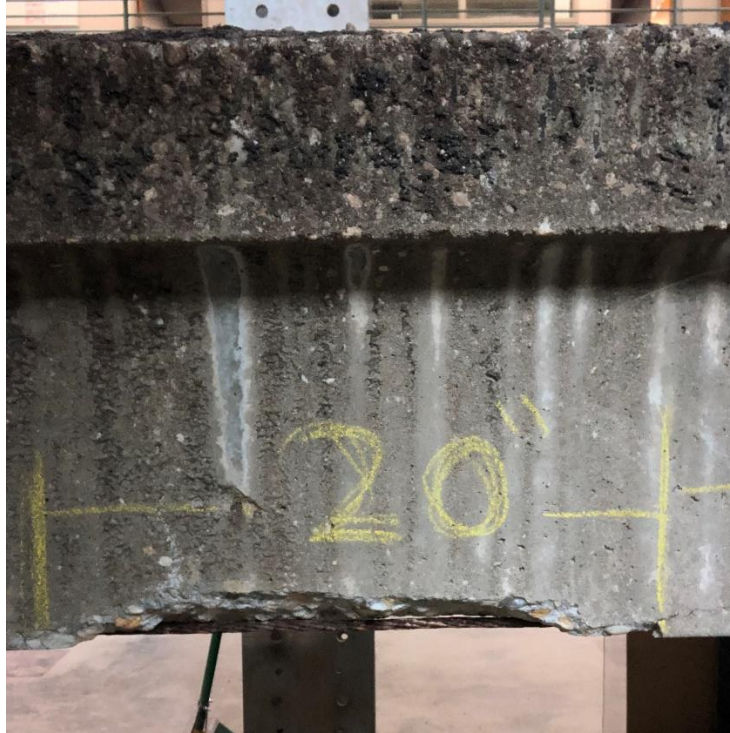
Figure A.36 C10 (NBI 2) moderate defect near midspan.

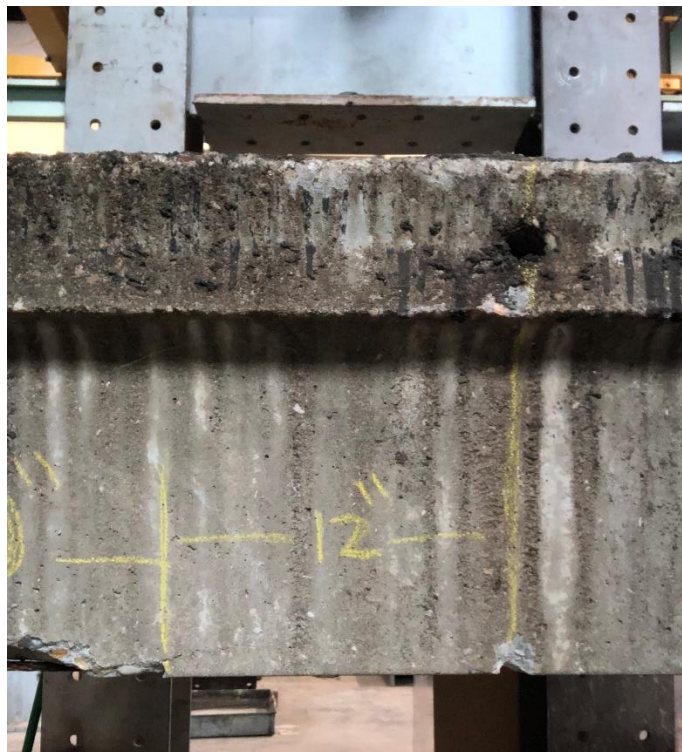
Figure A.37 C10 (NBI 2) small spall.

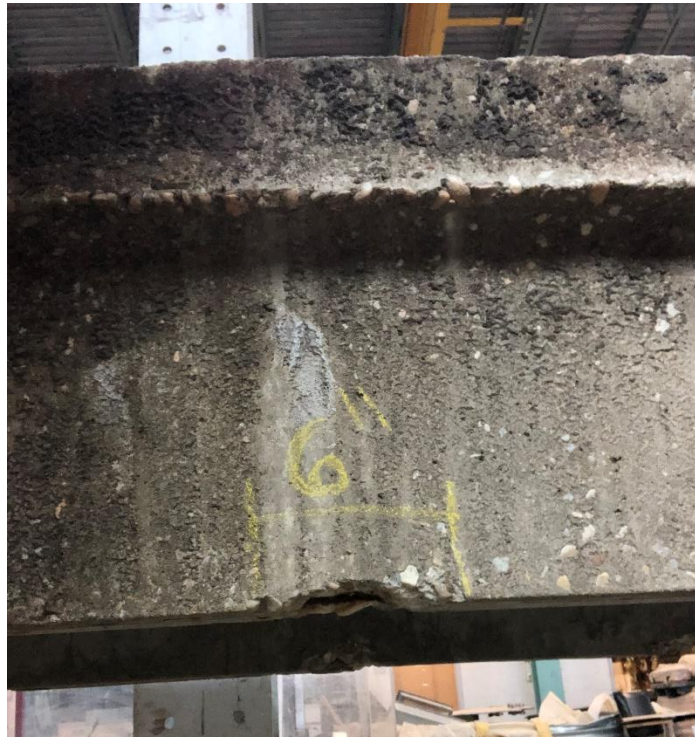
Figure A.38 C10 (NBI 2) small spall.

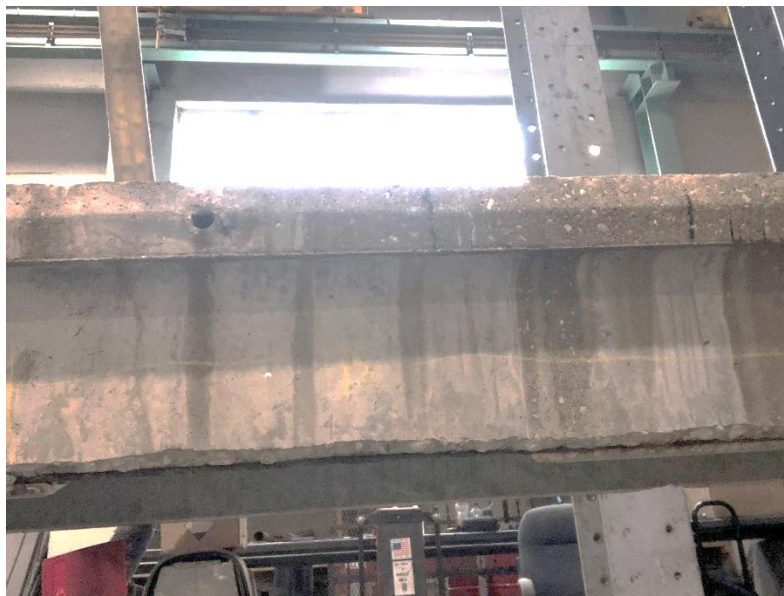
Figure A.39 C10 (NBI 2) major defect, severely compromised.

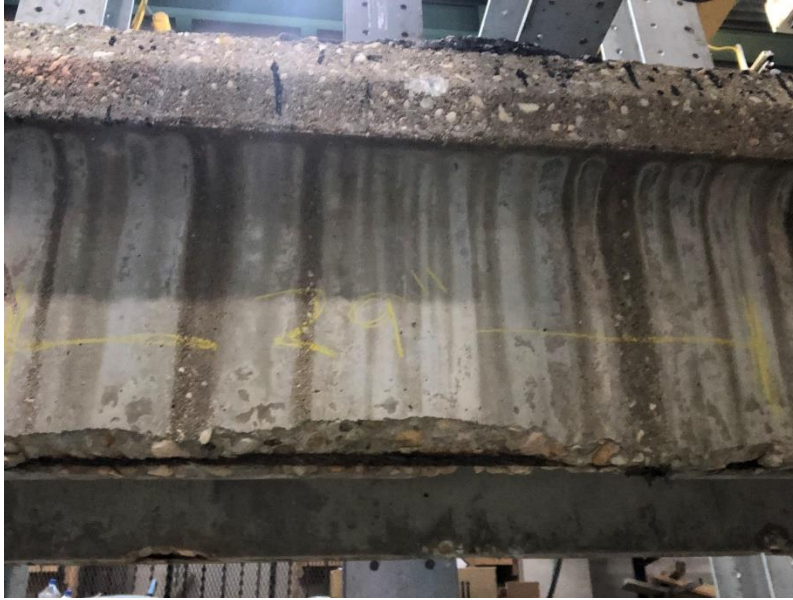
Figure A.40 C10 (NBI 2) major defect.

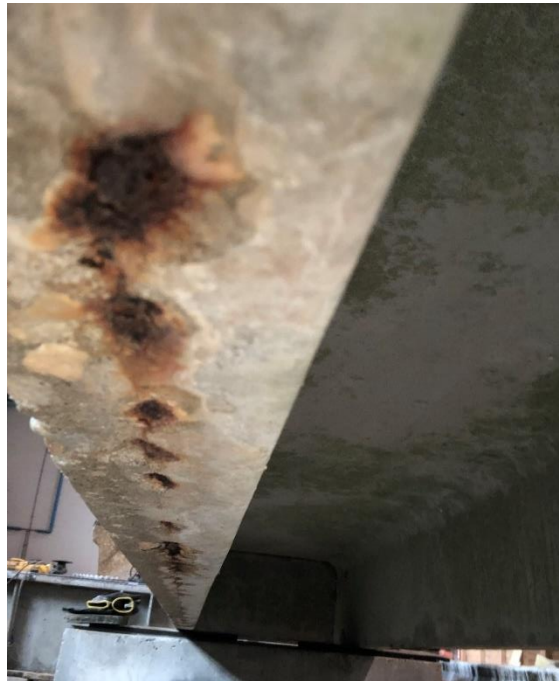
Figure A.41 C10 (NBI 2) rust staining, moderate defect.
