Load Rating Evaluation of Deteriorated Prestressed Channel Girders

LOAD RATING EVALUATION OF DETERIORATED PRESTRESSED
CHANNEL GIRDERS

For the Degree of Master of Science in

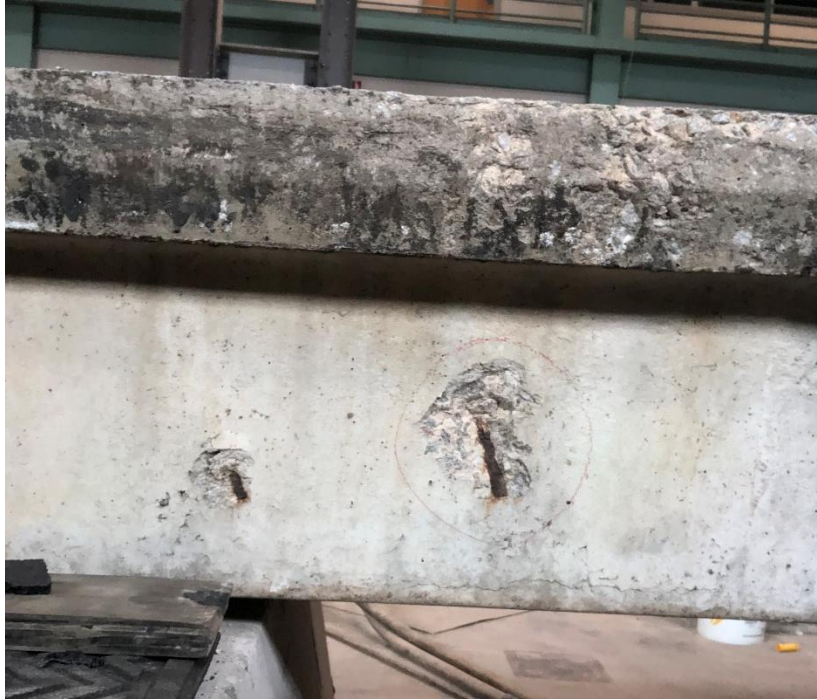
Figure A.42 C11 (NBI 6) small spalling.

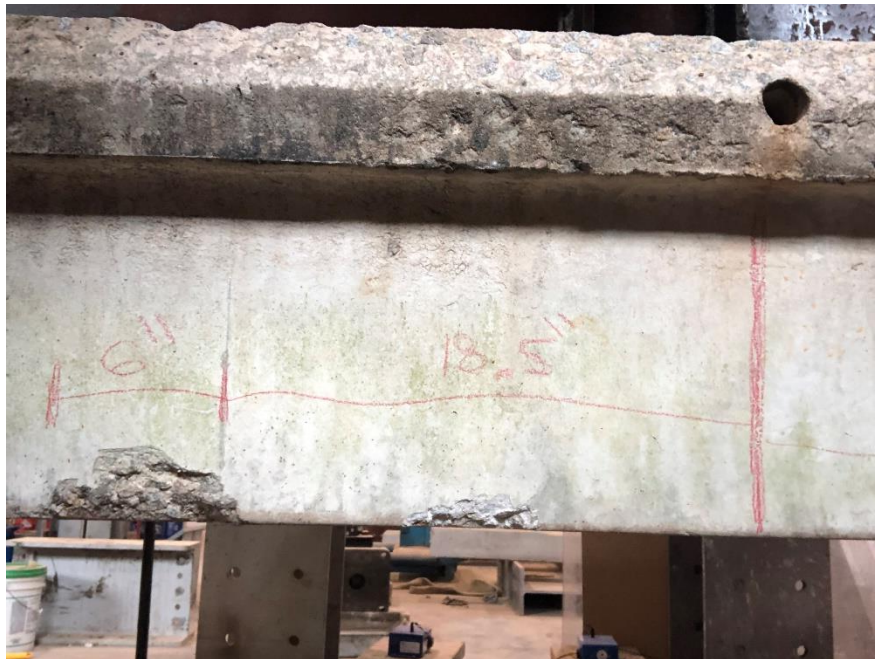
Figure A.43 C11 (NBI 6) small spalling near midspan.

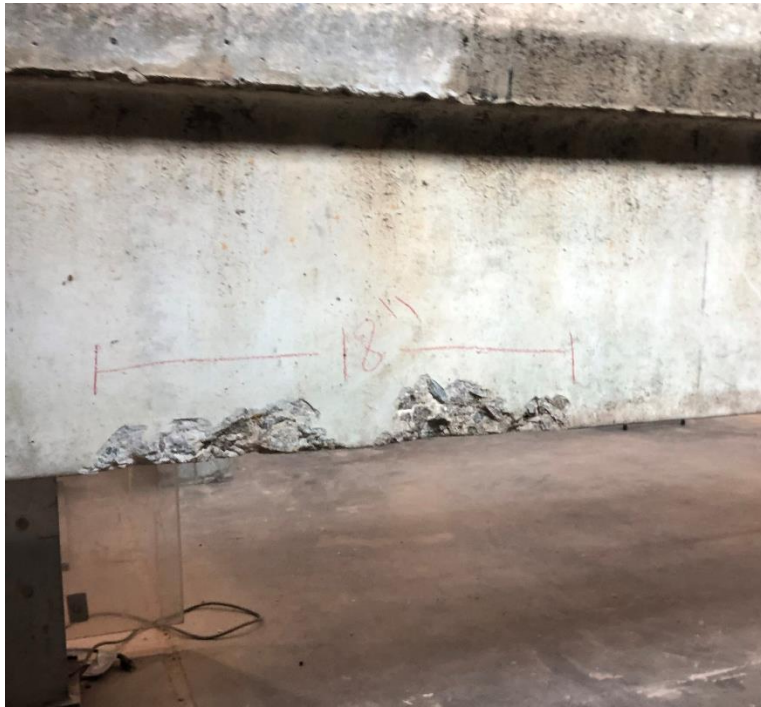
Figure A.44 C11 (NBI 6) small spalling.

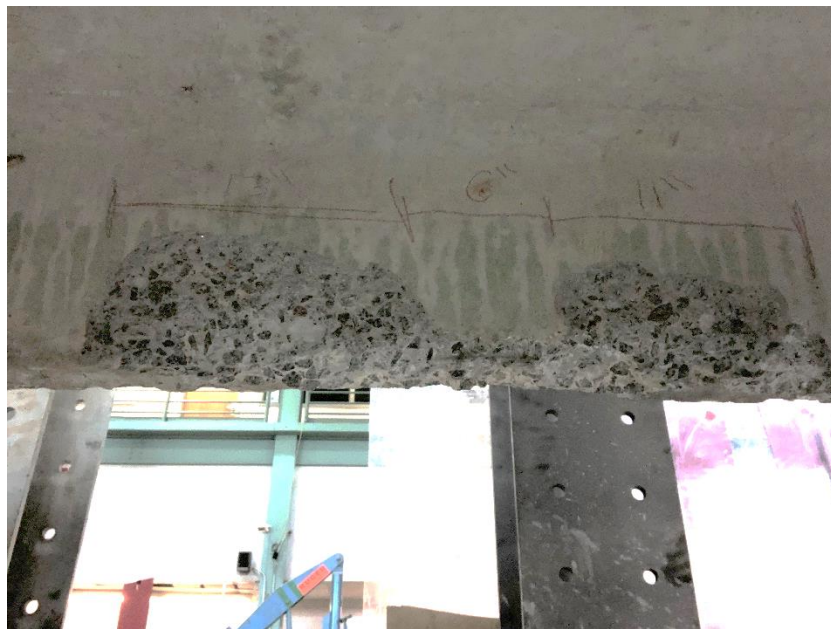
Figure A.45 C11 (NBI 6) large spalling.

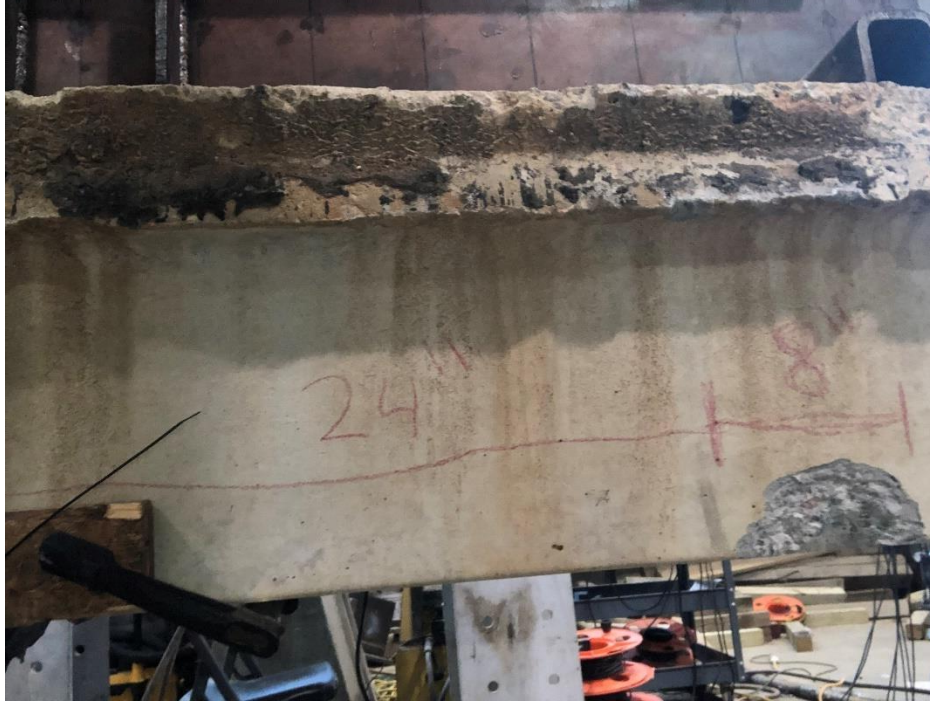
Figure A.46 C11 (NBI 6) large spall near midspan.

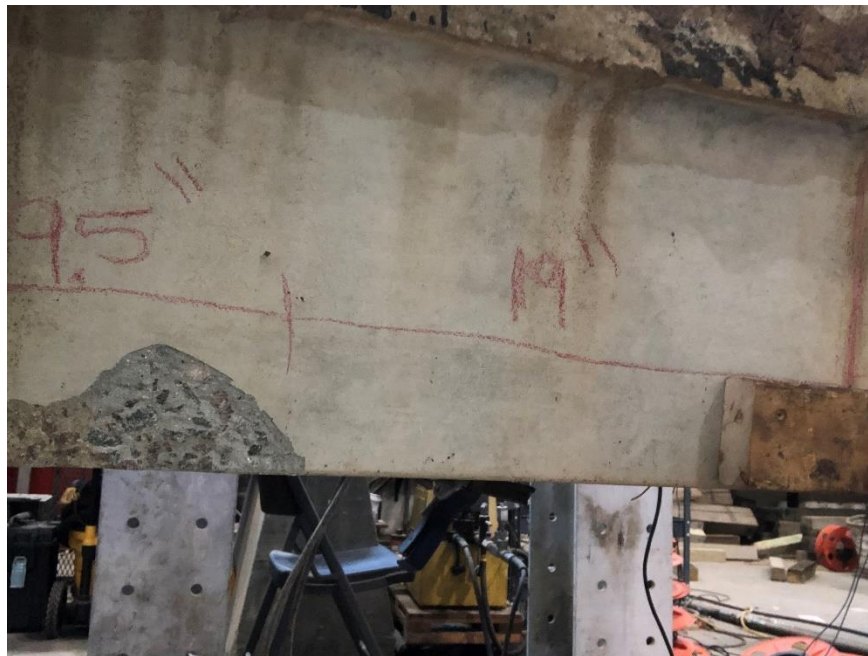
Figure A.47 C11 (NBI 6) large spall near midspan.

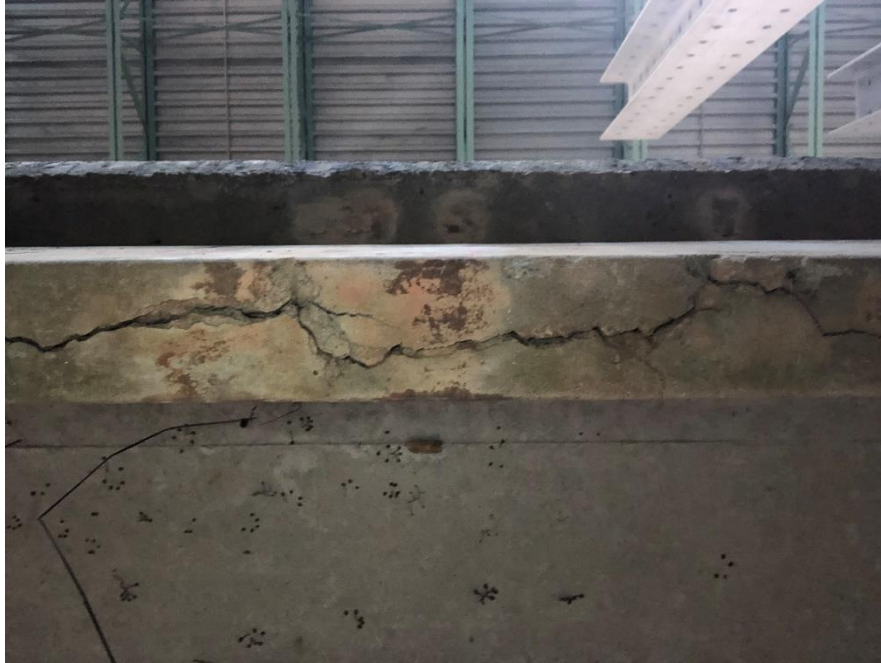
Figure A.48 C12 (NBI 4) wide crack, moderate defect.

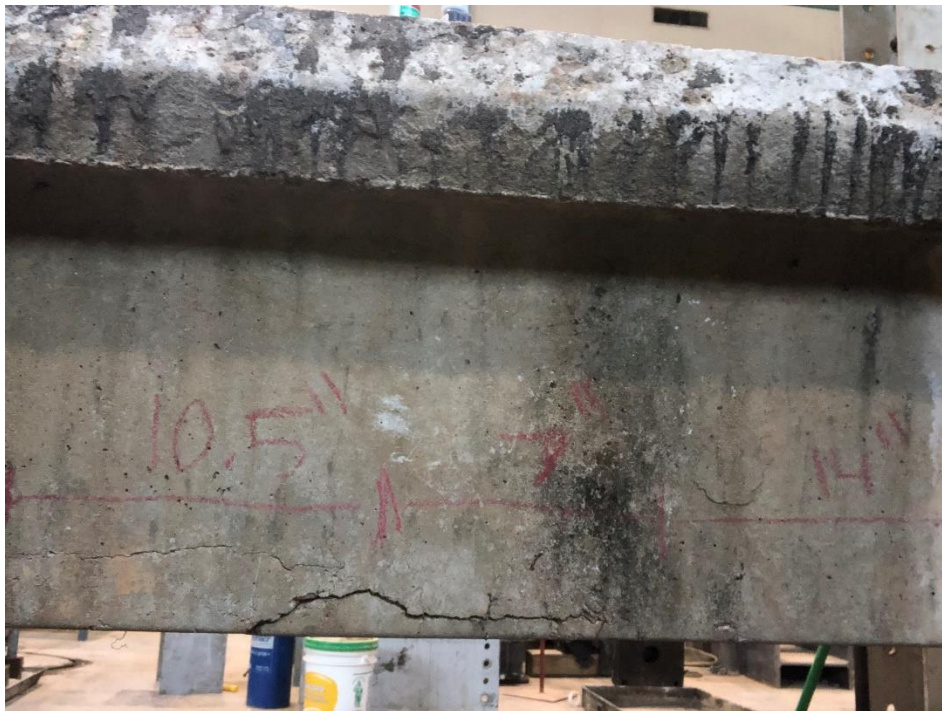
Figure A.49 C12 (NBI 4) wide crack near midspan.

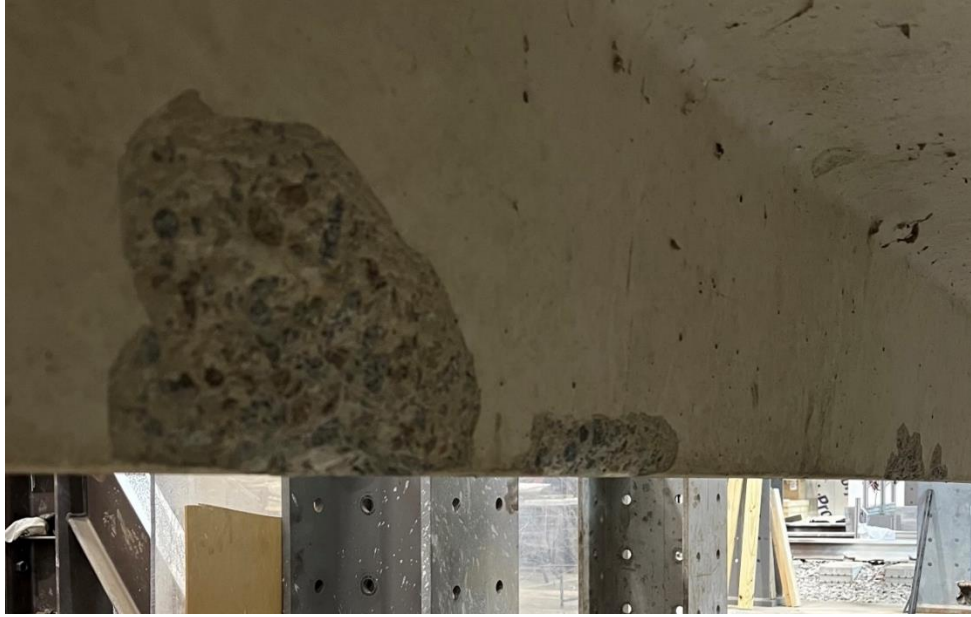
Figure A.50 C12 (NBI 4) large and small spalling.

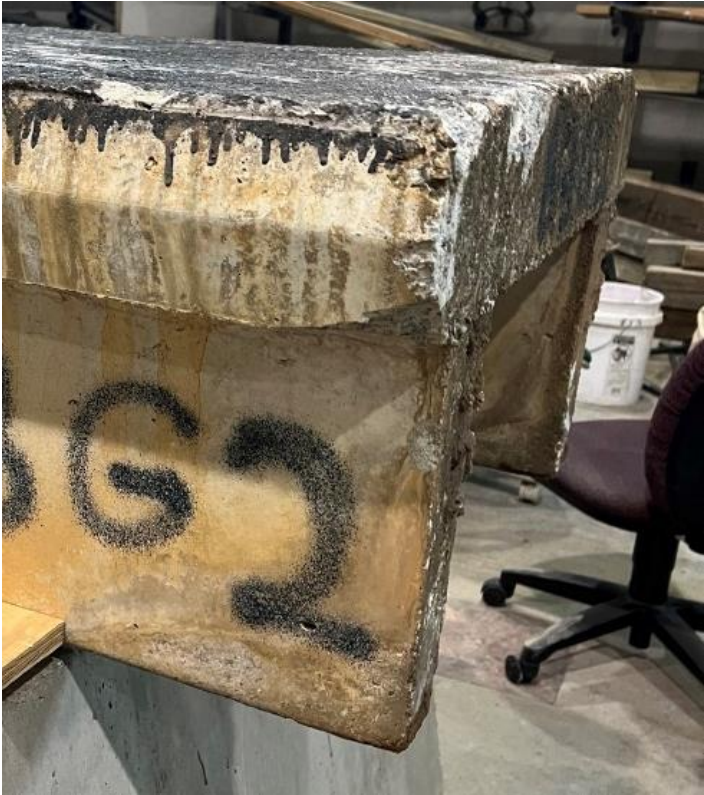
Figure A.51 C12 (NBI 4) end spalling.

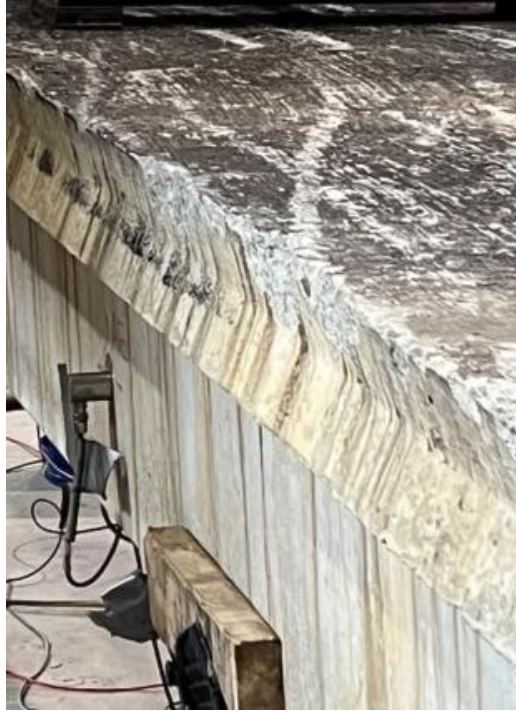
Figure A.52 C13 (NBI 7) flange spalling.

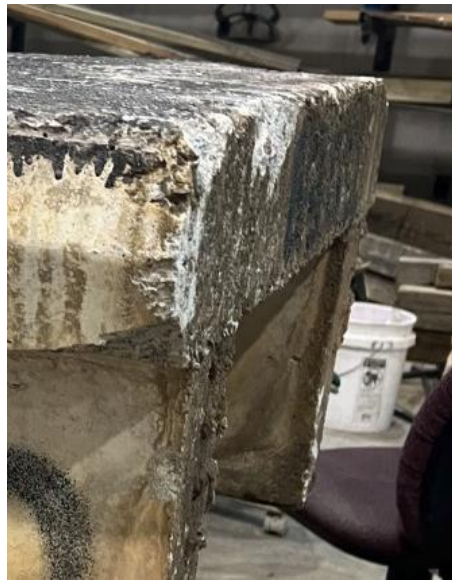
Figure A.53 C13 (NBI 7)
flange spalling.
