From Gunboat to Garbage Can: The Conservation of a Cannonball *Part 3*

From Gunboat to Garbage Can: The Conservation of a Cannonball Part 3

By Ashley Deming, Maritime Archaeologist, SDAMP Manager

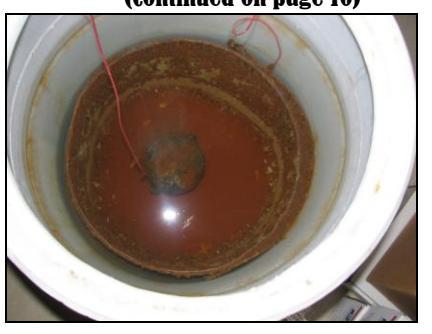
Figure 3 New steel anode ring and rust build up after a 3month period of electrolysis

Over the following three months, the amount of corrosion off the ball significantly decreased. The steel plates held up well as did the clips (Figure 3). This leads me to believe that the iron of the cannonball is becoming more stable. I made sure to check in on the set up at least once a week to make sure all of the wires and clips were still attached and it was still running happily at $\frac{1}{2}$ an amp. Thanks to the new white plastic drum. I could really see the ball in the solution to monitor its progress. The sodium carbonate and water solution should remain clear during the electrolysis process. If at any time

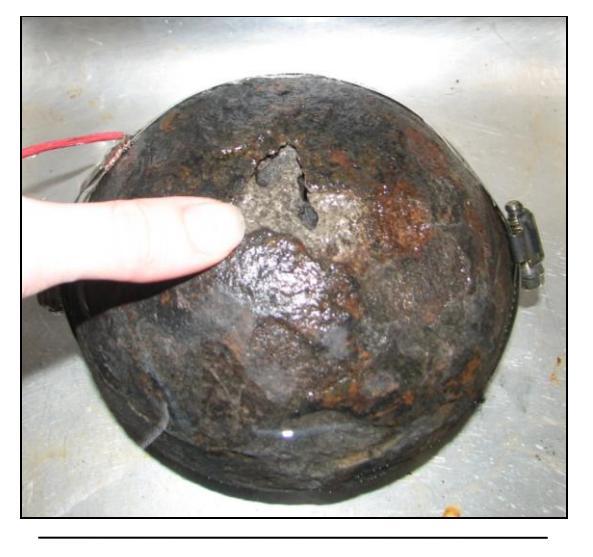
Figure 1 Vampire bite soft spots

The cannonball has now undergone the electrolysis process for 7 months. After the first four months. I removed the ball from the solution, removed any of the active corrosion present and rinsed it thoroughly. I noticed a few soft spots that were a little deeper than I would like. I cleaned them out gently using dental tools to remove all of the soft particulates from the rest of the harder iron. The spots turned out to be more like holes resembling a vampire bite (Figure 1). Each hole was about 1 inch deep toward the center of the ball. I was pretty worried about this, so I gave our cannonball conservation expert Freddie Clark a call. He assured me that this sort of thing happens all the time. Some areas just corrode differently

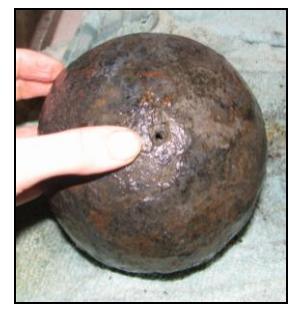
Figure 4 New soft spot at 7 months

Unfortunately, I did notice a couple more soft spots similar to the "vampire bites" of the previous cleaning stage. Figure 4 shows the deepest of these spots. The hole extends towards the center of the ball about an inch deep. I did my best to

clean out all the active corrosion. I am still hoping for the best. These relatively small areas are very solid around them, so they may not affect the surrounding iron much more than they already have. When the electrolysis process is complete, we will most likely use a wax solution to fill these holes to protect from any further corrosive activity.
