Evaluating the Efficacy of Sand Fences on Dunes Impacted by Hurricanes

EVALUATING THE EFFICACY OF SAND FENCES ON DUNES IMPACTED BY
HURRICANES

Submitted in Partial Fulfillment of the Requirements

For the Degree of Master of Science in

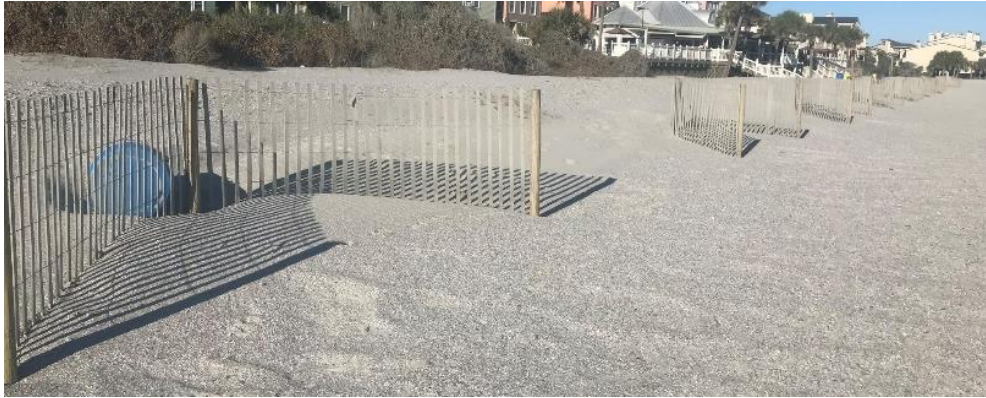
Figure 1.1 Sand fences installed in a V-shaped formation along a South Carolina beach. The apex of the “V” is pointing towards the dune crest.

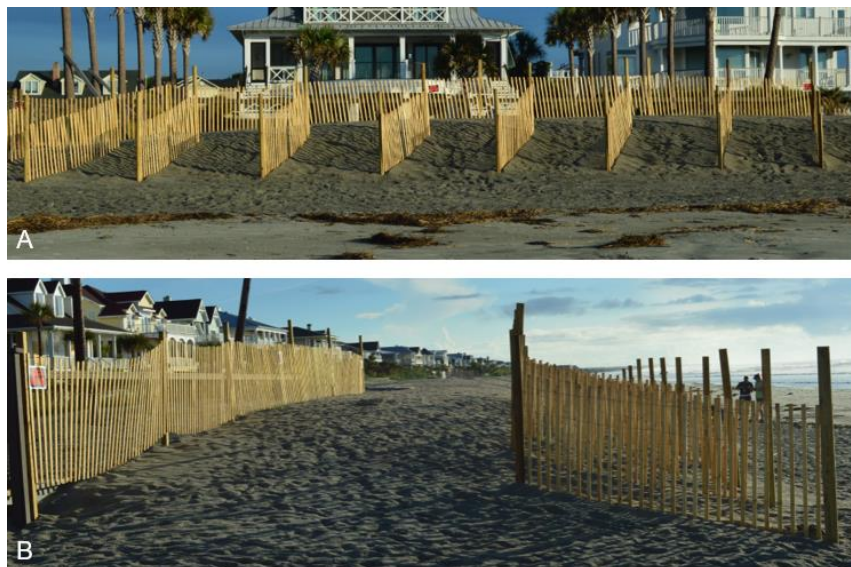
Figure 3.2. Photos of the fenced site taken on 9/11/18, where the wrack represented the high tide line from the recent king tide on 09/09/2018. A) View looking landward. B) View of site from southwestern extent, including the shore parallel fence (left side of image).

The fenced site has a linear distance of approximately 22 m. It contained ten oblique sand fences installed on a mechanical dune (Figure 3.2A) and a shore parallel fence installed landward (Figure 3.2B). The fences were oriented from the southwest to the northeast and numbered 1 through 10 (Figure 3.3). The fences were located approximately 2.3 m apart, and their average length was 3.1 m (Figure 3.3). The control site was located 18.5 m northeast of the

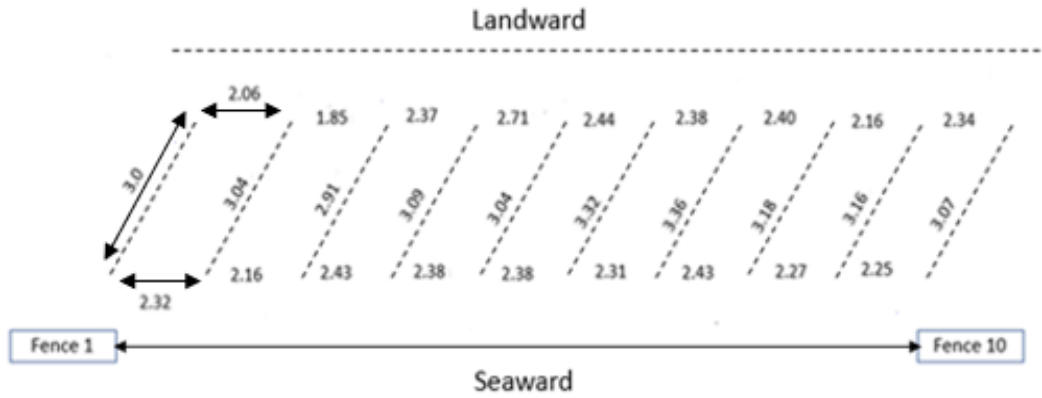
Figure 3.3. Schematic of the fenced site with measurements shown in meters. Dashed lines represent sand fences. The length of the study site was equivalent to the length of the back shore parallel fence (21.96 m). Fence numbers correspond to transect numbers (1-10).

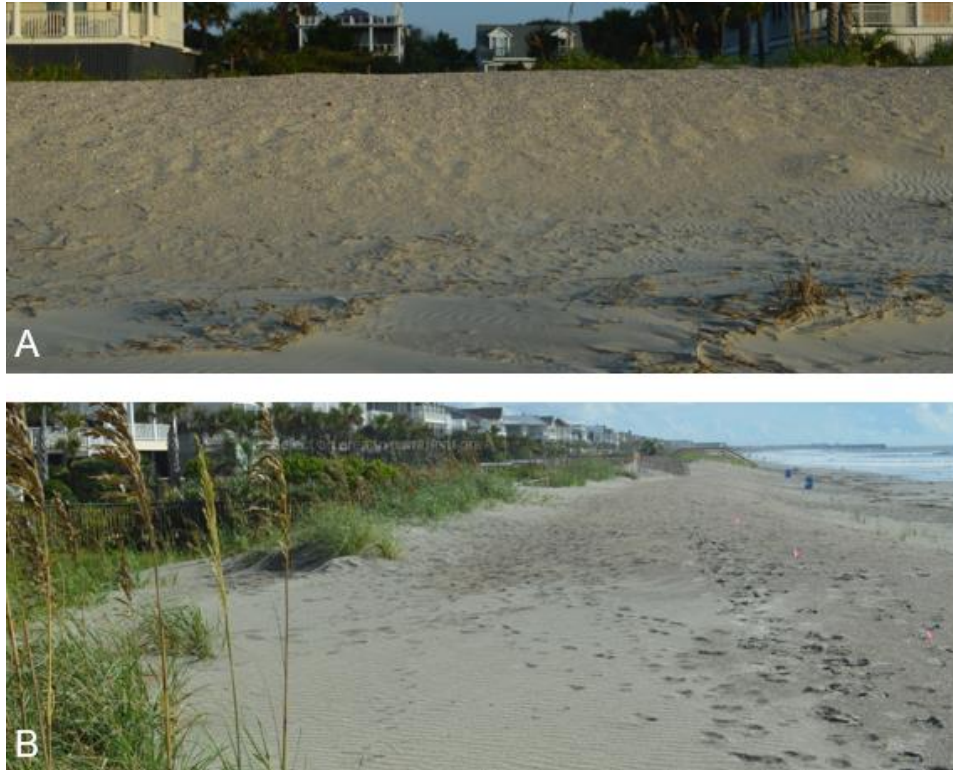
Figure 3.4. Photos taken of the control site on 09/11/18. A) View looking landward. B) Landward extent of control site (vegetation line).

fenced site and had a linear distance of 22 m. We segmented the site and generated five transects that were 5.5 m apart (Figure 3.4A). This site was also on the mechanical dune, but unlike the fenced site, there was no landward development. The landward extent of the site was delineated by the vegetation line (Figure 3.4B).

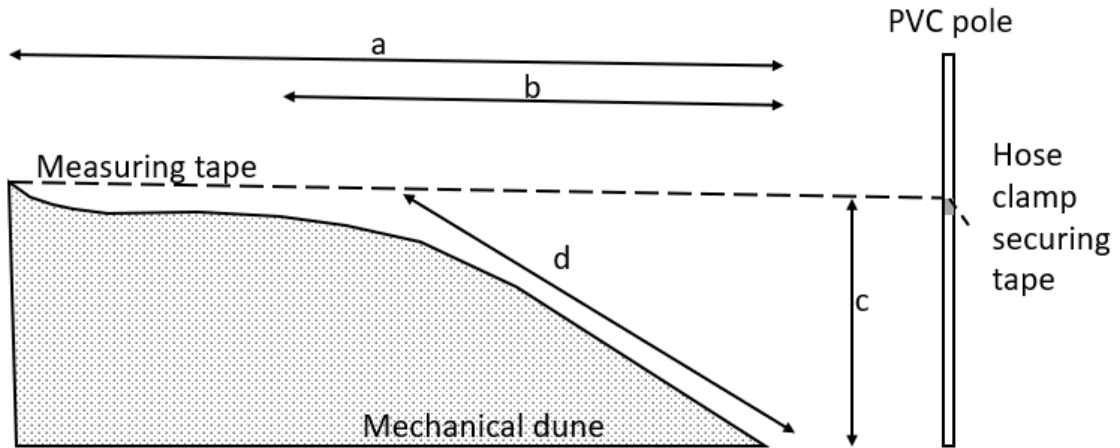
Figure 3.5. Summary of measurements using the PVC pole and measuring tape where a) is from the dune toe to the fence line/vegetation line (site dependent), b) is from the brink to the dune toe, c) is the height of the dune, and d) is the dune slope length. These measurements were gathered at both sites.

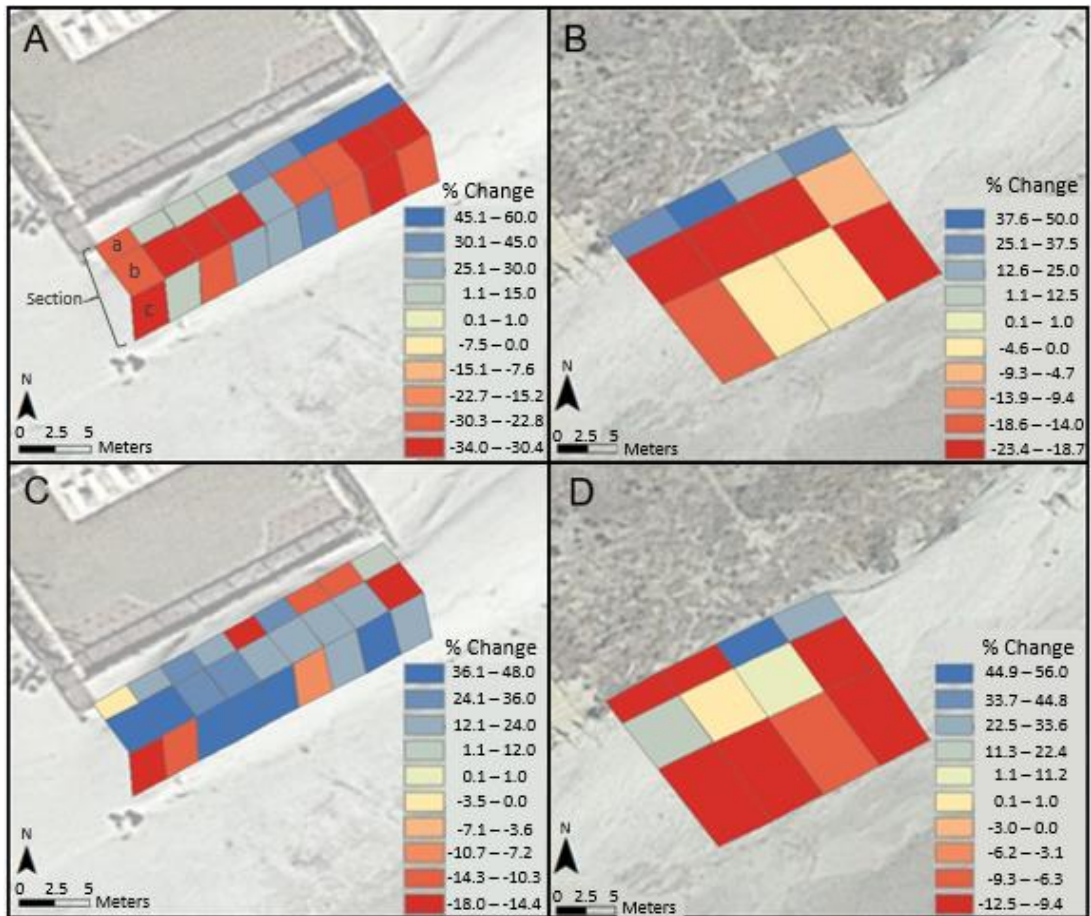
Figure 4.2. Schematics showing volumetric change (%) where positive and negative values indicate deposition and erosion. Sections a-c found in panel A apply to panels B-D. A) Fenced site change during time period one. B) Control site change during time period one. C) Fenced site change during time period two. D) Control site change during time period two.

Data suggested that the greatest morphologic change occurred during time period one. This result was supported by field measurements (Figure 4.2 A; B, Figure 4.3 A; B). However, the inclusion of field photographs (Figure 5.1 A; B; C) indicated that fine-scale depositional patterns were not thoroughly detected by the field measurements and as such, the results should be carefully considered when assessing volumetric change during period two when depositional patterns were most observed. At the conclusion of time period two (Figure 5.1C) results indicated that under maximum wind conditions, greater incipient dune growth was observed in the fenced site while erosion occurred concurrently in the control site (Figure 4.2 C; D). The exception to this occurred along the back dune (section a) where native plants aided in trapping sediment to stabilize and increase dune volume. This role was mimicked at the fenced site by the presence of the shore parallel fence. Field photos and in situ data within section a supported this depositional trend and landward migration witnessed at both field sites. The fenced dune site was largely unvegetated, with a stabilizing species appearing between fences 4-5 during time period one, which promoted an increase in volume. This observance supported the previous suggestion that sand fences and vegetation promote dune growth and recovery (Mendelssohn et al., 1991). Deposition was predominantly located around the native vegetation, between the oblique fences, and along the shore parallel fence. These depositional patterns support the functionality of sand fences for dune building and recovery (Miller, Thetford, and Yager, 2001; Khalil, 2008) in environments susceptible to aeolian transport. The depositional patterns and orientation follow

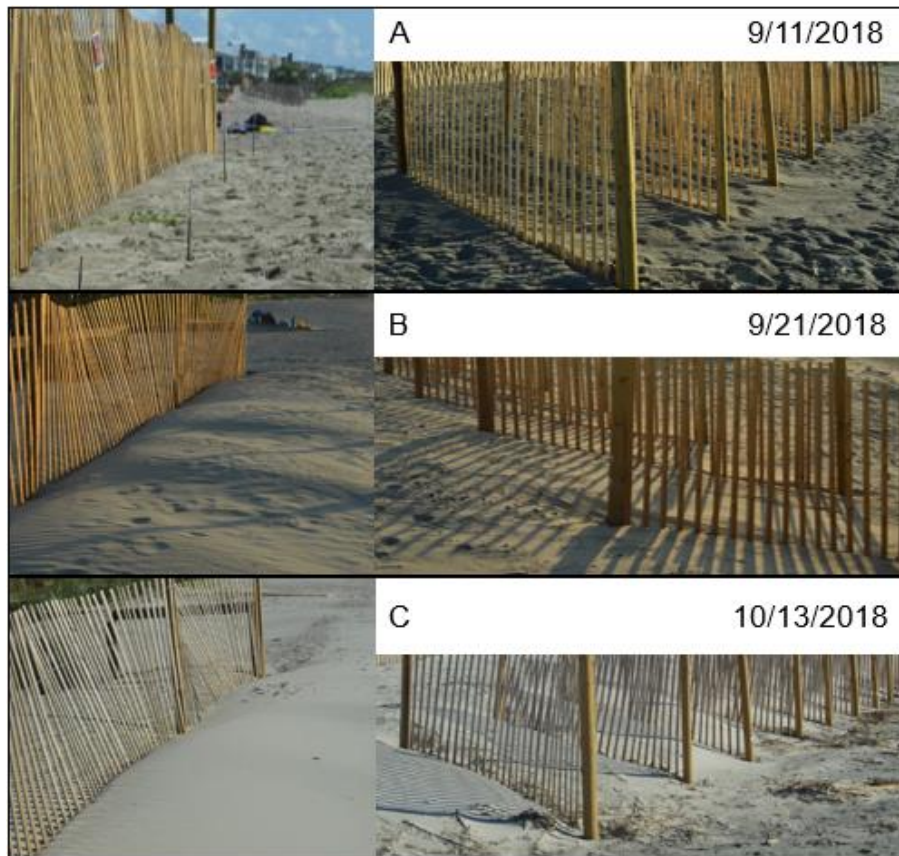
Figure 5.1. Photos of the fenced site on the three collection dates, featuring the shore parallel and oblique fences. A) Pre-Florence; B) Post-Florence/Pre-Michael; C) Post-Michael

the dominant wind direction observed during Hurricane Michael's path during time period two, supporting that the storm largely influenced the geomorphic change observed at the site.
